EXPERIMENTAL ANALYSIS AND FEA MODELING OF
SENSOR RESPONSE IN COMPOSITES FOR
STRUCTURAL HEALTH MONITORING

A THESIS

Submitted in partial fulfillment of the requirements
for the degree of Master of Science
in the Department of Electrical and Computer Engineering
in the Graduate School of
The University of Alabama

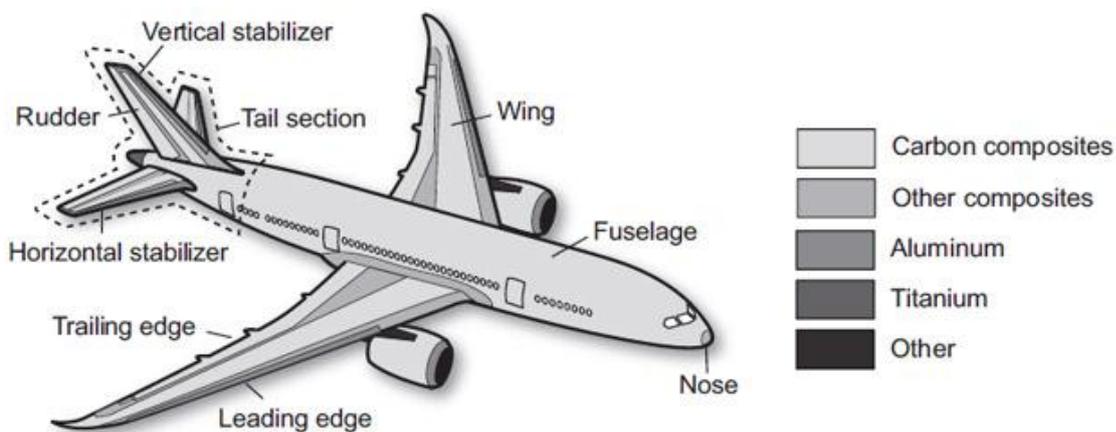
Figure 1.1. A pictorial representation of material composition of the Boeing 787 dreamliner [2].

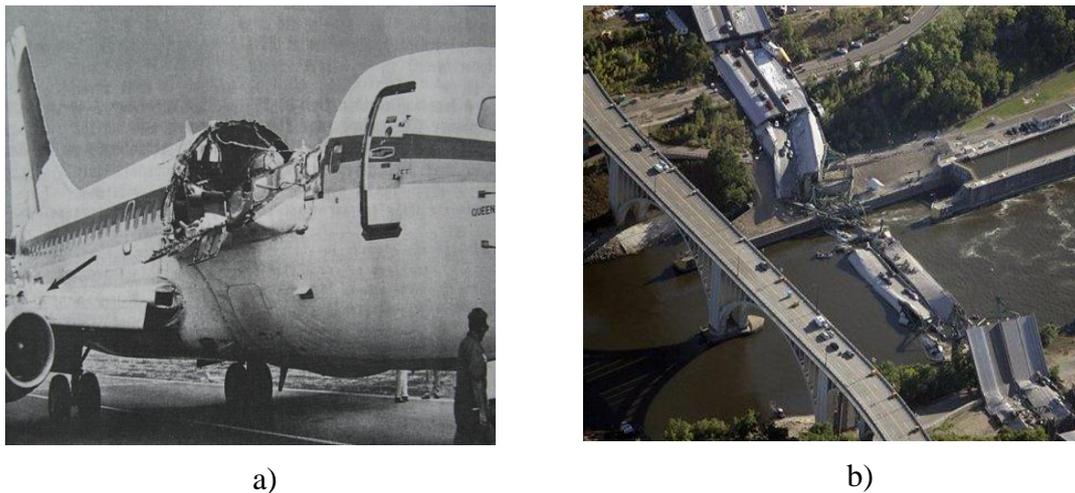
Figure 1.2. Photographs of structural failures leading to accidents due to corrosion and fatigue: a) the Aloha Airlines flight showing the ruptured aircraft skin [6] and b) I-35W Minnesota bridge collapse [7].

Several tragic accidents have occurred that motivate this field of research. The structural failure on Aloha Airlines flight 243 [4], the collapse of the I-35W bridge in Minneapolis, the fatigue failure of the Point Pleasant bridge spanning the Ohio river, a structural deficiency in the Seongsu bridge, and the Columbia space shuttle tragedy [5], emphasize the need for periodic structural inspection. Photographs illustrating two of these accidents are shown in Figure 1.2.

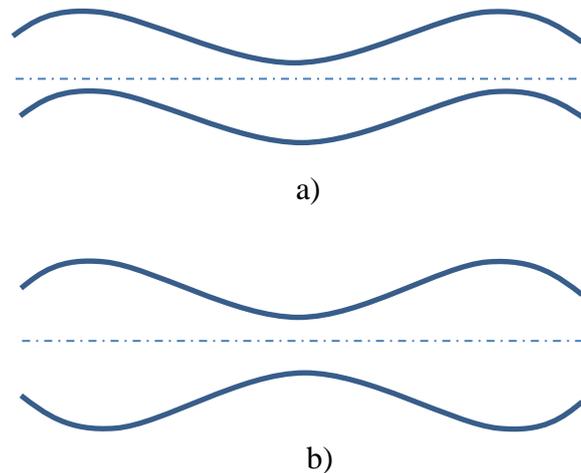
Figure 2.1. Graphical representation of Lamb wave modes: a) anti-symmetric and b) symmetric.

modes, and the average displacement is normal to the wave propagation. An actuator placed on one of the surfaces of a structure generates strong anti-symmetric mode Lamb waves while two co-located actuators placed on top and bottom surfaces, excited in-phase, generate strong symmetric mode Lamb waves in a structure [25].

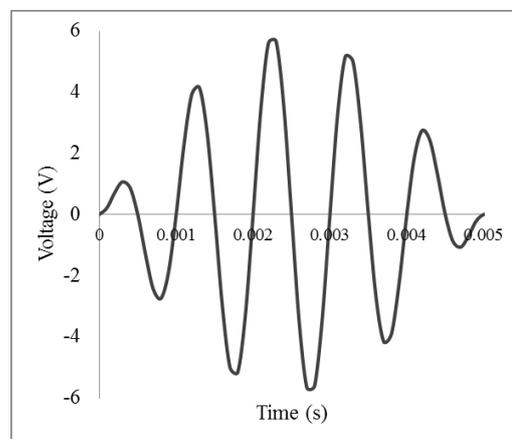
Figure 2.2. A typical PZT excitation input signal for the testing scheme used in this study.

[23, 37]. A higher voltage helps to generate stronger Lamb waves with a larger signal to noise ratio but at the cost of high power consumption [38]. High power consumption is not recommended as SHM systems typically have requirements of low power. A voltage of 5-10 V has been found to be optimum for most SHM applications. A signal with a larger number of peaks has a higher energy associated with it. This aspect helps in long distance propagation as it compensates for any attenuation due to damping. However, increasing the number of peaks increases the pulse width and, in turn, the interference [39, 40]. A three to five cycle Hanning modulated tone burst has been shown to be an optimal form of actuation because this method allows separating the anti-symmetric and symmetric modes and allows separating the reflection from the edges or from cracks [41]. Diamanti and Soutis [42] studied the use of low frequency for composite damage detection. Lower frequencies excite a smaller number of modes making them more distinguishable. The first order anti-symmetric (A_0) mode has a smaller wavelength for a given frequency compared to the first order symmetric (S_0) mode making A_0 waves more sensitive to small levels of damage. In addition, S_0 modes undergo higher attenuation during propagation [24, 40]. Given these characteristics, a five cycle tone burst of 1 kHz center frequency and an amplitude of 6 V to generate A_0 mode Lamb waves was considered in the testing protocol. The excitation input signal is shown in Figure 2.2.

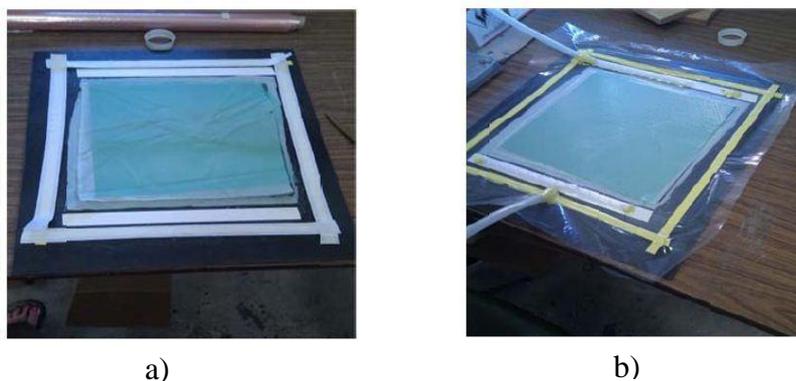
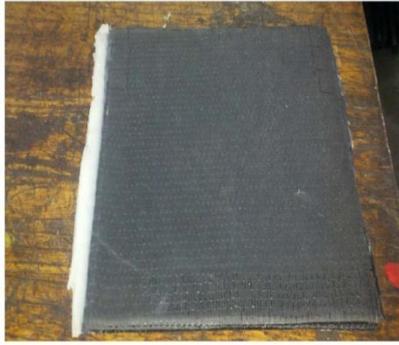
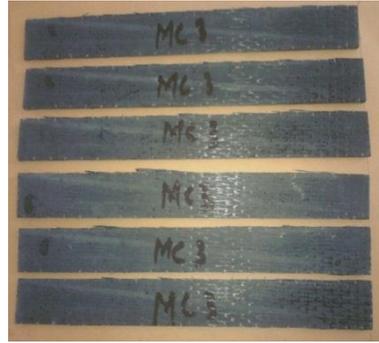
Figure 3.1. Two photographs to illustrate composite panel fabrication stages: a) fabric layup and b) resin infusion

SC780 resin, a two part epoxy mixed in a 4:1 ratio with the hardener, was used as the matrix material. The resin was infused into the panel and left for an additional 1.5 hours to allow complete resin distribution and fiber wet-out. The flow pattern and fill time of resin distribution have been investigated using finite element models by others [58, 59]. It was found that a release film placed between carbon fiber fabric and distribution mesh reduced the resin fill time. The vacuum was removed and after an overnight room temperature cure, the panel was cured in an oven for 6 hours at 71°C, and then 2 hours at 104°C to complete the resin cross-linking step. Some of the stages in composite fabrication are illustrated in Figure 3.1 and 3.2. The final panels were cut into 254 mm × 25.4 mm coupons for damage detection testing and 25.4 mm × 25.4 mm pieces for moisture and acid digestion testing. The fiber volume fractions of the fabricated composite panels were found to be in the range of 48-50%.

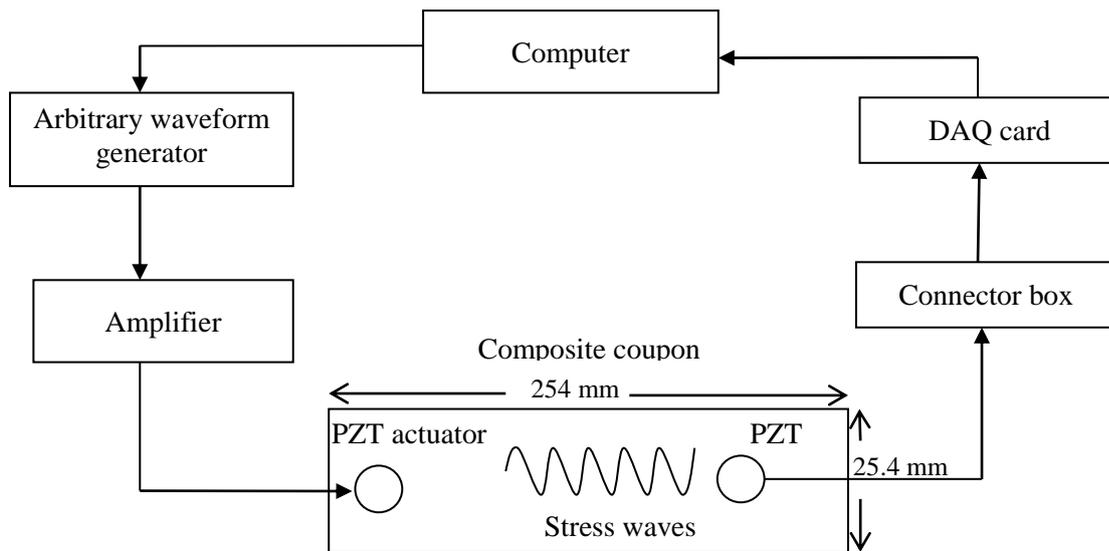
Figure 4.1. Data acquisition system using PZT actuators and sensors.

The composite coupon was fixed at one end with a PZT actuator surface-mounted on the free end. An AC signal applied to the terminals of a PZT actuator puts the coupon into vibrations by the inverse piezoelectric effect. A Hanning modulated five cycle tone burst signal at a center frequency of 1 kHz was used for Lamb wave excitation. The actuation signal was amplified by a factor of 20 using a piezo amplifier before sending to the actuator. The Lamb waves, generated by the actuator, were received by the sensor located 60 mm from the clamped end. The sensor generates a voltage equivalent to the induced strain by the direct piezoelectric effect. The sensor was connected to a data acquisition (DAQ) card through a connector box with a sampling rate of 100 kHz. National Instruments LabVIEW software was used to synchronize the actuation initiation (waveform generator) and sensor data collection (DAQ). Real time sensor data were collected for further analysis. The experimental setup is shown in Figure 4.1.

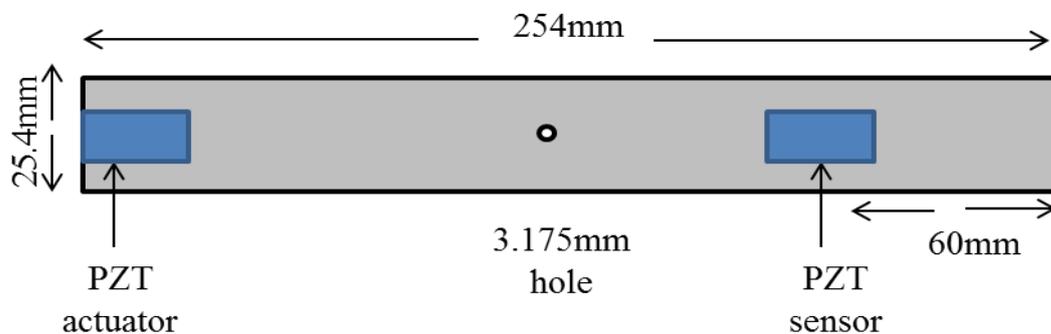
Figure 4.2. A pictorial representation of a damaged composite coupon illustrating the actuator and sensor placement.

Tests were performed on an undamaged coupon to obtain a baseline for reference. Holes with the following diameters: 1.58 mm, 1.98 mm, and 3.175 mm were introduced into the coupon and the data was recorded after each increase in hole size. The results from this test are shown in Figure 4.3.

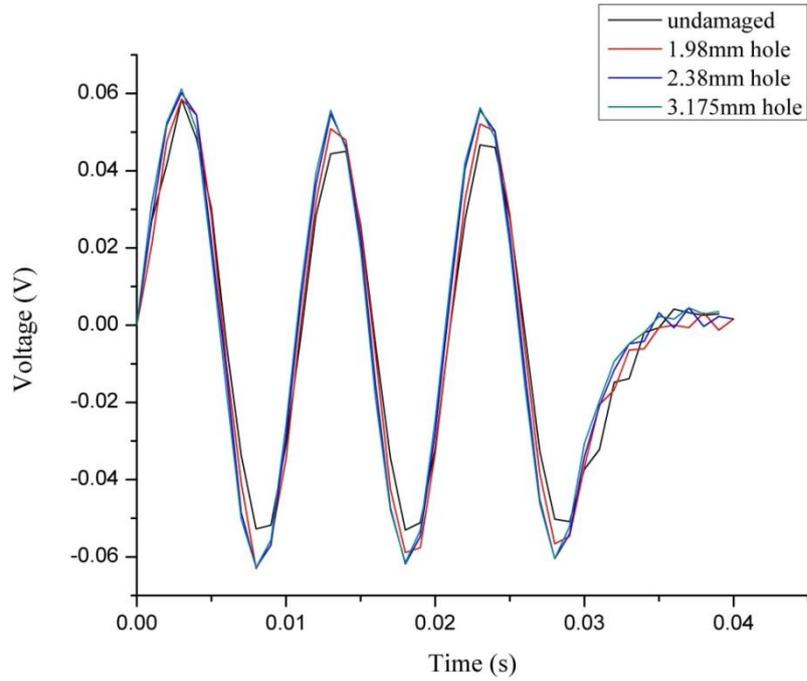
Figure 4.3. Experimental test results comparing the Lamb wave response of an undamaged coupon and coupons with varying hole size.

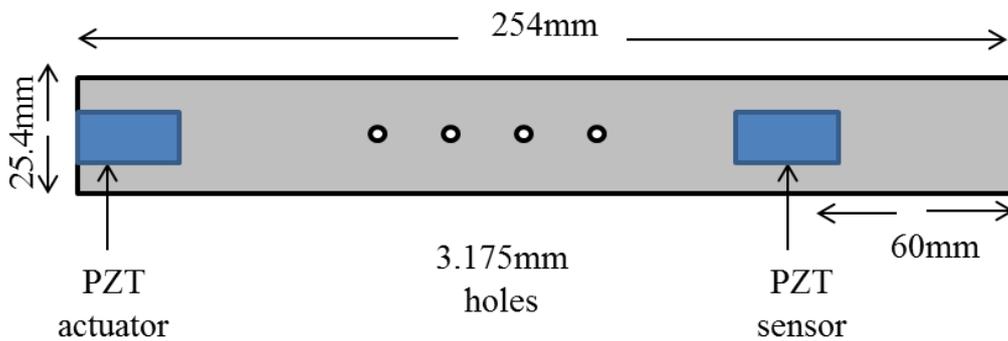
Figure 4.4. A pictorial representation of a composite coupon with four 3.175 mm diameter holes illustrating the actuator and sensor placement relative to the holes.

Another set of tests were conducted to investigate a coupon with a variable number of holes (1-4) at a fixed diameter of 3.175 mm. The holes were placed 20 mm apart as shown in Figure 4.4. Sensor output was measured after the addition of each hole and the results are shown in Figure 4.5.

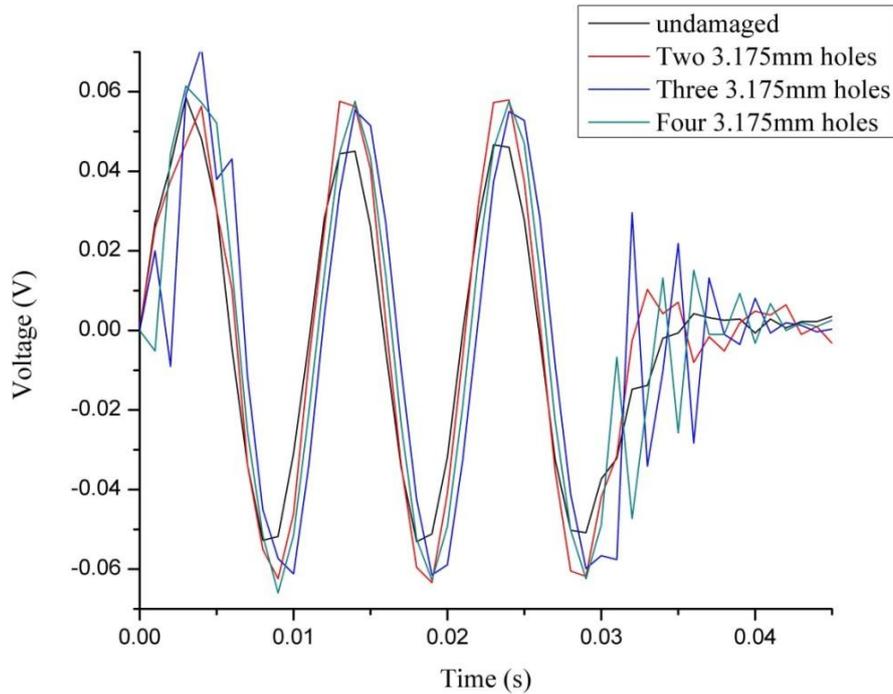
Figure 4.5. Experimental test results comparing the Lamb wave response of an undamaged coupon and coupons with varying number of holes.

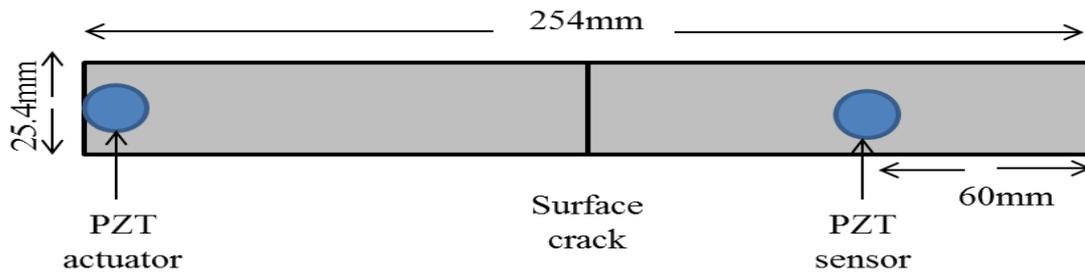
Figure 4.6. A pictorial representation of a composite coupon with a surface crack demonstrating the actuator and sensor placement relative to the crack.

actuator, were received by a PZT sensor located 60 mm from the clamped end as shown in Figure 4.6.

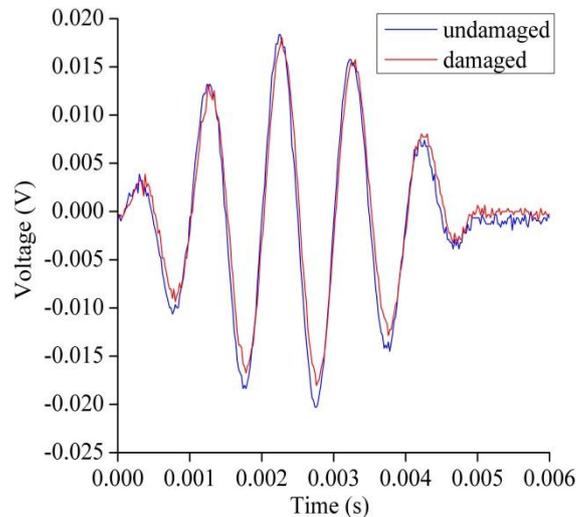
Figure 4.7. Experimental results comparing the Lamb wave response of a $[0_{16}]_T$ orientation undamaged coupon and a coupon with a surface crack in the first four plies.

The results from this experiment, comparing the Lamb wave response of an undamaged composite coupon and a coupon with a surface crack, is shown in Figure 4.7. The amplitude ratio of the incident wave for an undamaged coupon was slightly higher than a damaged coupon but the reflections were increased for the damaged coupon compared to the undamaged coupon; this is believed to be due to the presence of the crack.

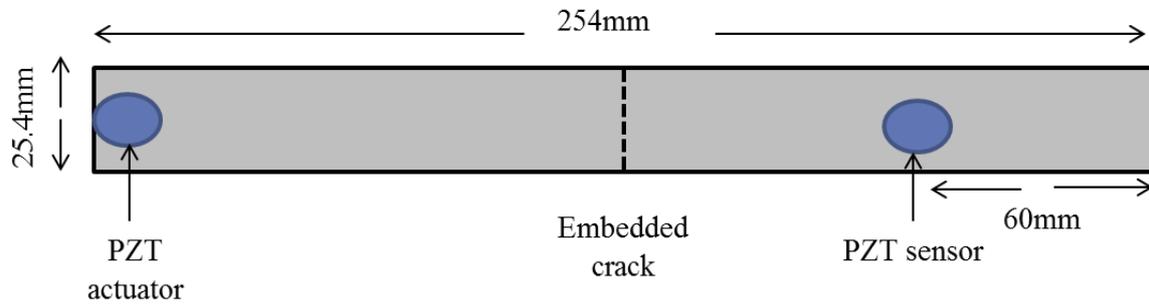
Figure 4.8. A pictorial representation of a composite coupon with an embedded crack demonstrating the actuator and sensor placement relative to the crack.

width. The composite coupons were fabricated using the procedure described in Chapter 3. The experimental setup is shown in Figure 4.8.

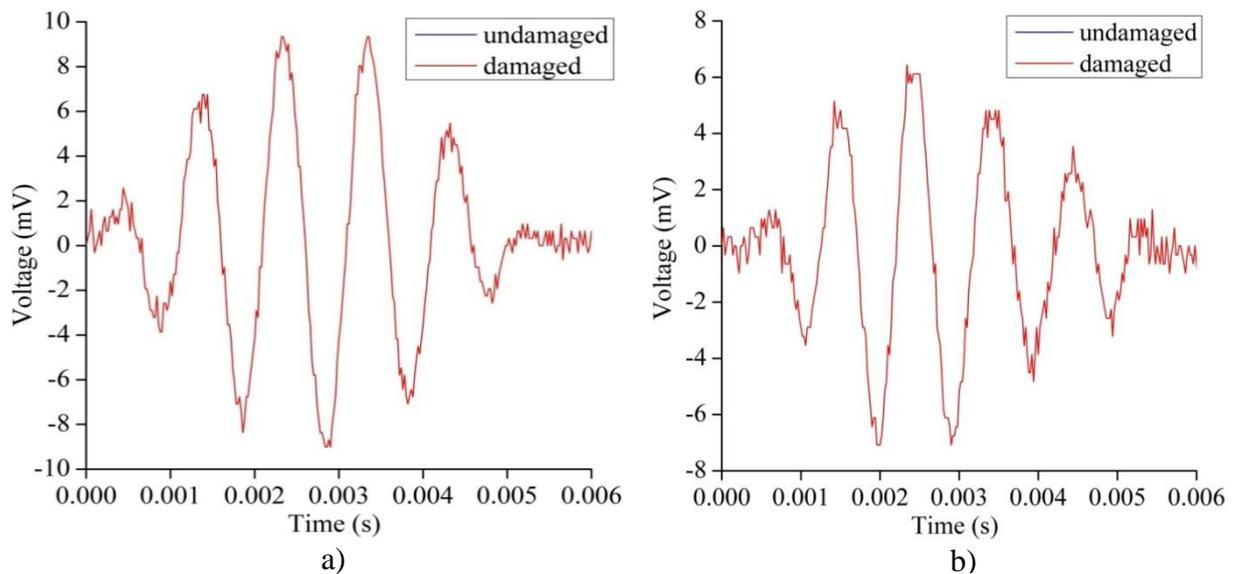
Figure 4.9. Experimental results comparing the Lamb wave response of an undamaged coupon and a coupon with an embedded crack for: a) a $[0_{16}]_T$ composite coupon and b) a $[0_6/90_4/0_6]_T$ composite coupon.

Figure 4.9 shows the comparison between an undamaged composite coupon and a coupon with a simulated crack for both $[0_{16}]_T$ and $[0_6/90_4/0_6]_T$ composites. Less than 1% difference was observed between an undamaged coupon and a coupon with an embedded crack for both orientation cases. Amplitude ratio and time of flight for both undamaged and damaged coupons were found to be essentially the same. The response of the damaged coupon was essentially identical to the undamaged coupon response.

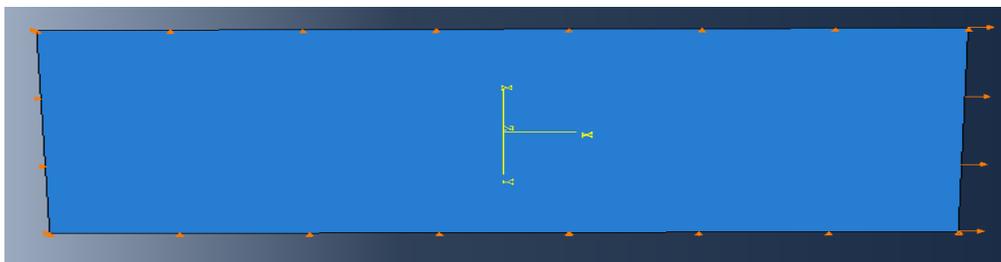
Figure 5.1. FE model of a composite coupon representing the load and boundary conditions for a pull test.

The pull test was performed on a $[0/45/-45/90]_s$ composite coupon, simply supported on three sides of the coupon, and subjected to an axial displacement load of 2 mm on the fourth side as shown in Figure 5.1. The composite coupon was meshed with 600 elements. The test was repeated for the four different types of elements under consideration. A sample von Mises stress result for a composite coupon meshed with S4R elements is shown in Figure 5.2.

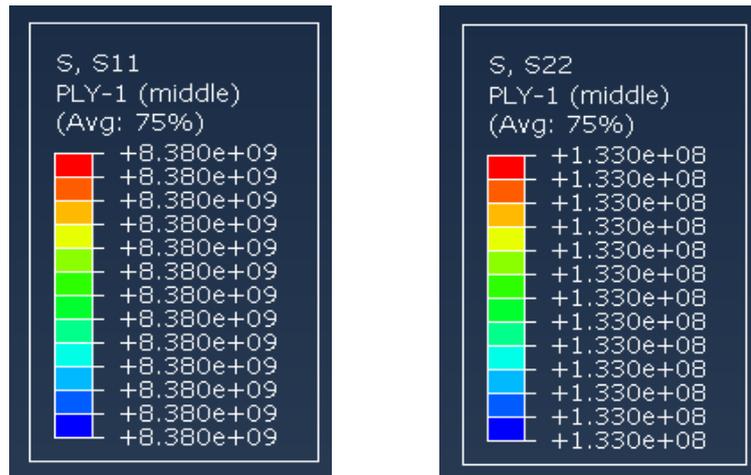
Figure 5.2. Abaqus results showing the von Mises stress contour legends of the longitudinal and transverse stresses (in Pa) for a composite coupon modeled with S4R elements under an axial displacement load.

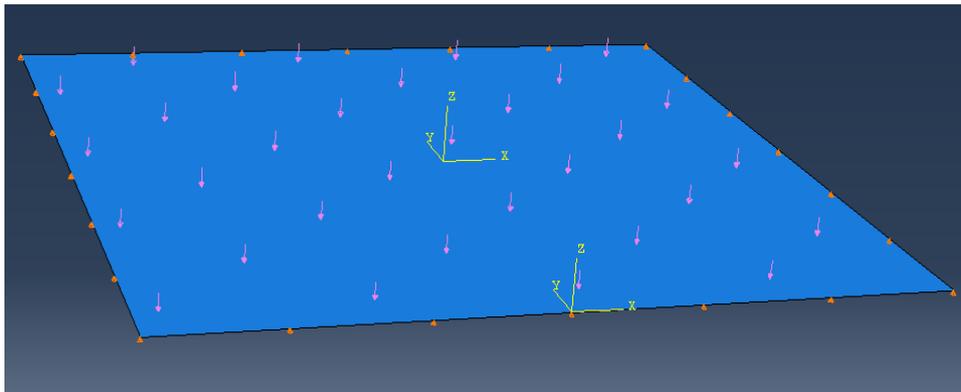
Figure 5.3. FE model of a composite plate meshed with 2D shell elements representing the load and boundary conditions.

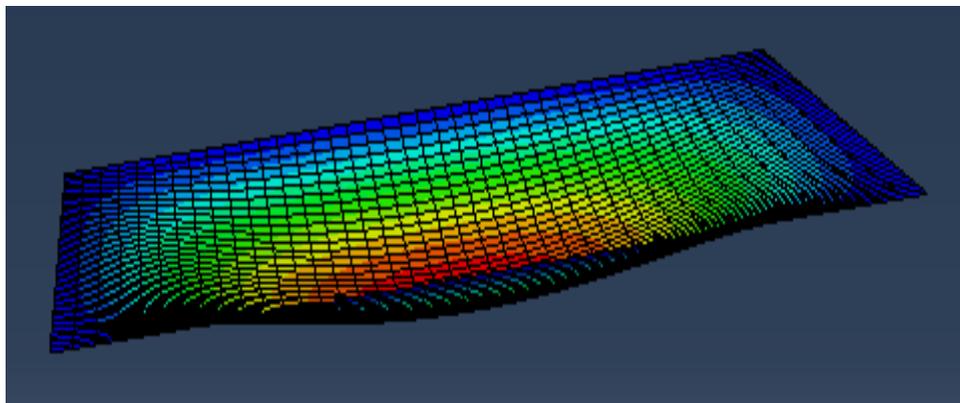
Figure 5.4. Abaqus results showing the deflection contour plot for a 2D shell composite plate under uniform transverse pressure load.

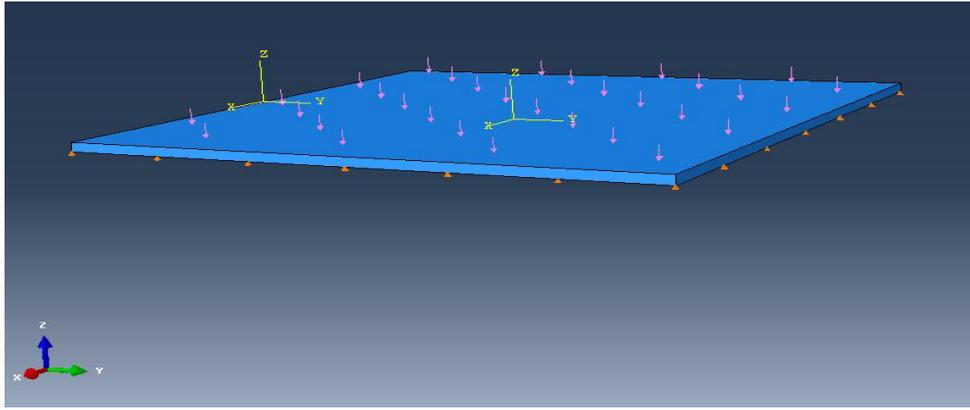
Figure 5.5. FE model of a composite plate meshed with 3D brick elements representing the load and boundary conditions.

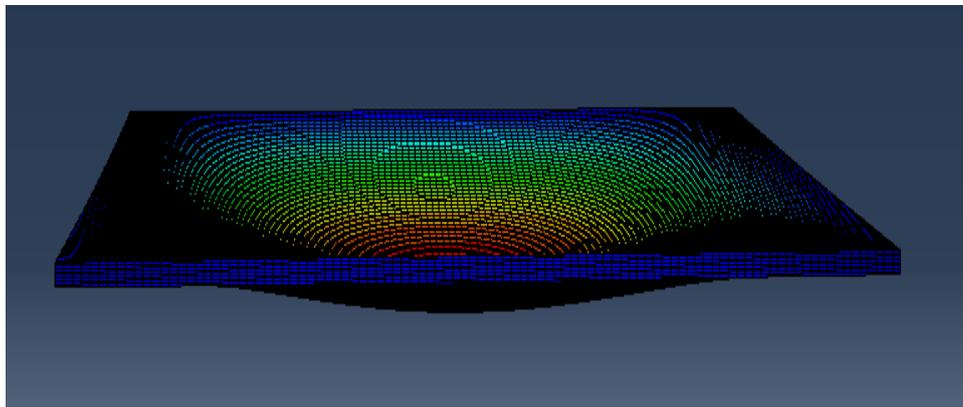
Figure 5.6. Abaqus results showing the deflection contour plot for a 3D brick composite plate under uniform transverse pressure load.

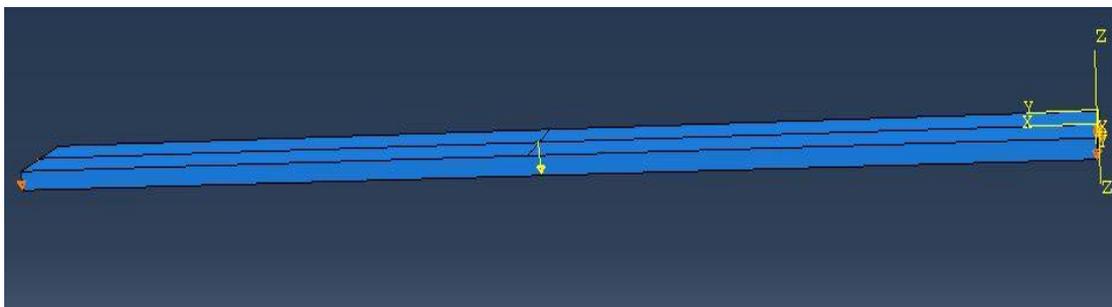
Figure 5.7. 3D FE model of an aluminum beam representing load and boundary conditions for the dynamic simulation test.

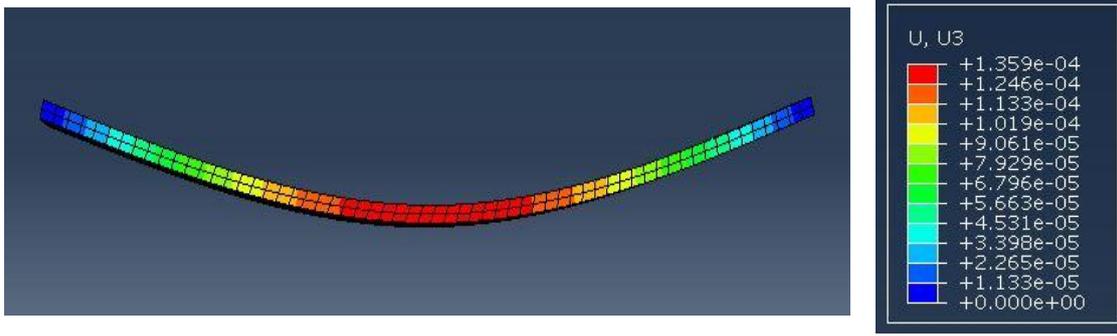
Figure 5.8. Abaqus results showing the deflection contour plot and legend for the dynamic simulation test in m.

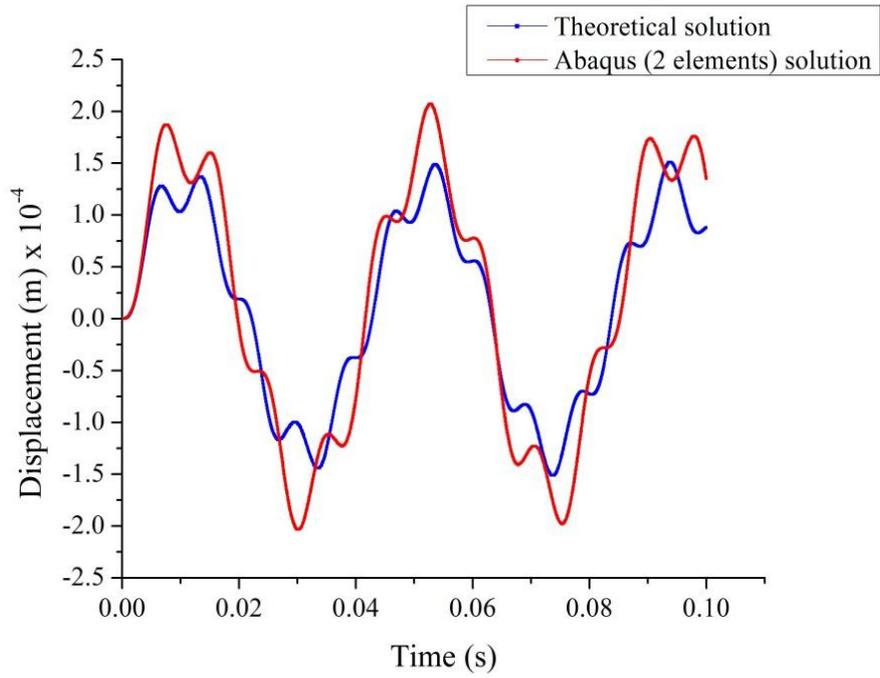
Figure 5.9. Comparison of exact deflection solution and Abaqus solution for an aluminum beam meshed with 2 elements and subjected to a dynamic load.

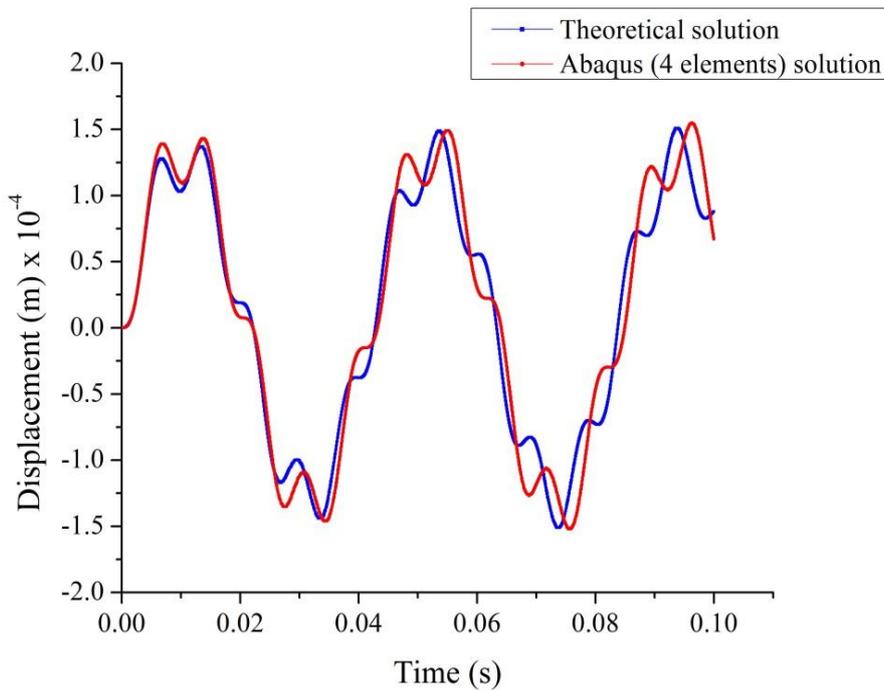
Figure 5.10. Comparison of exact deflection solution and Abaqus solution for an aluminum beam meshed with 4 elements and subjected to a dynamic load.

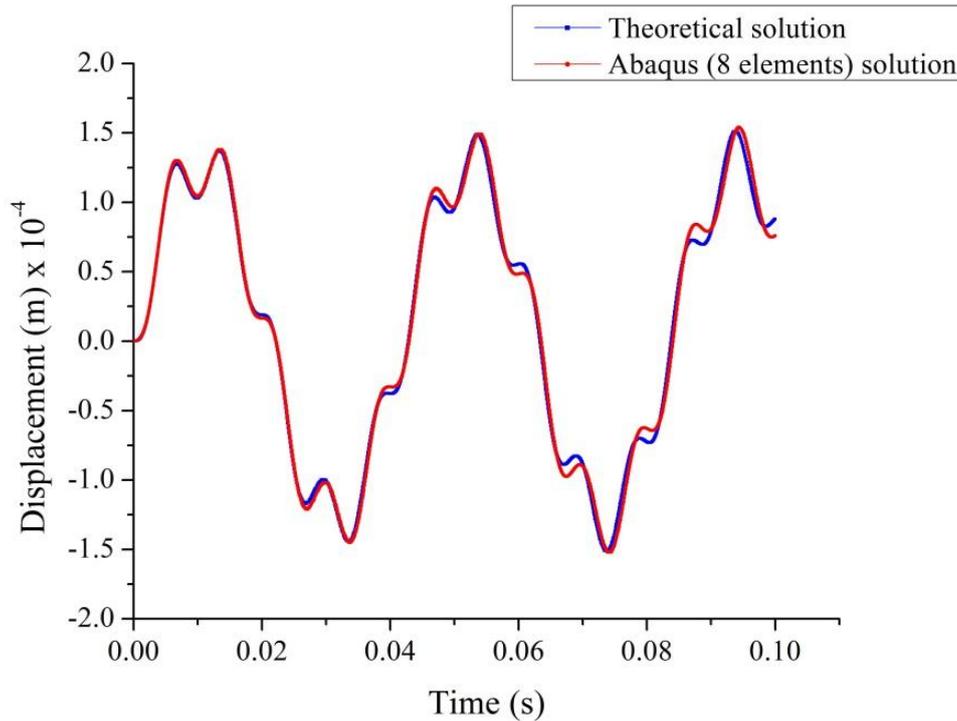
Figure 5.11. Comparison of exact deflection solution and Abaqus solution for an aluminum beam meshed with 8 elements and subjected to a dynamic load.

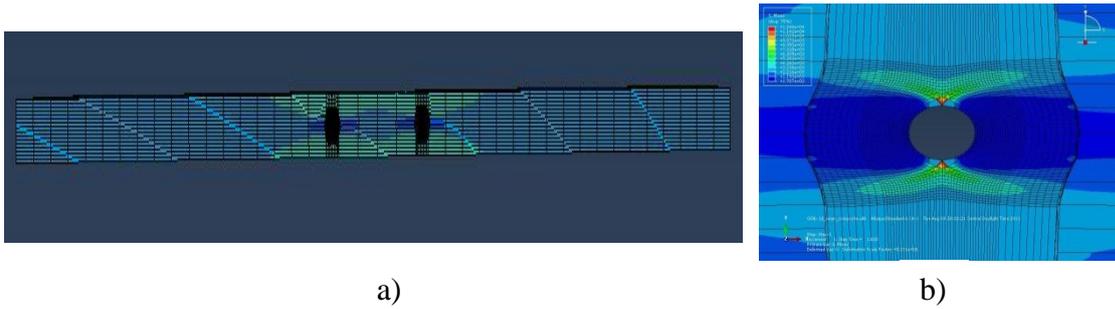
Figure 5.12. a) Abaqus stress contour plot for a composite coupon with two cracks under an axial load and b) an enlarged and exaggerated view near the crack showing the crack opening.

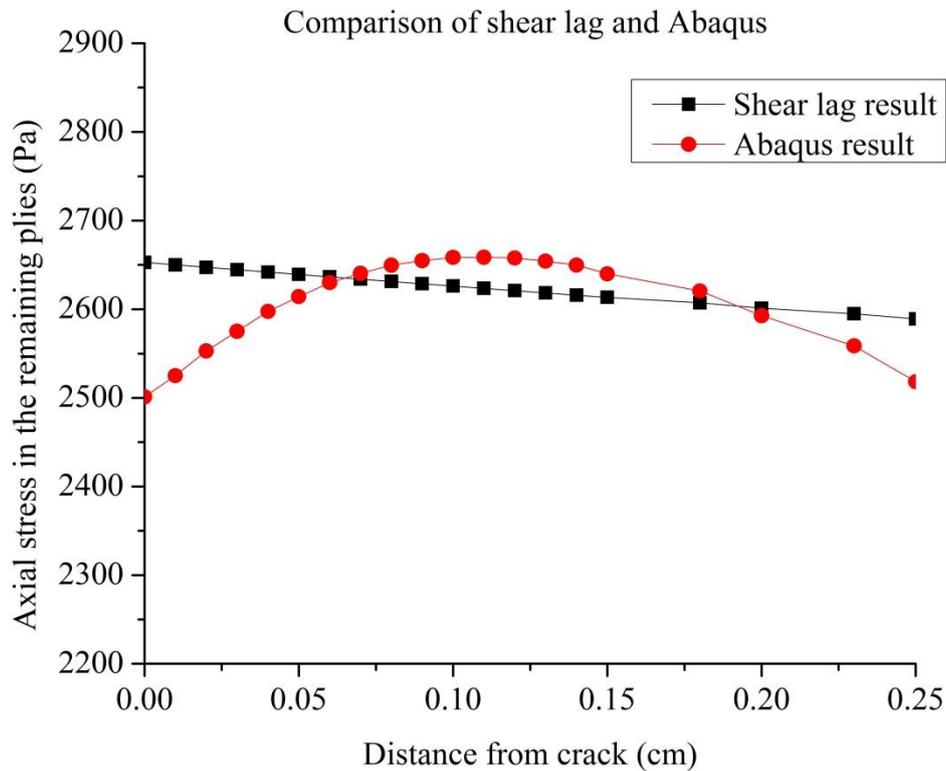
Figure 5.13. Comparison of shear lag model and Abaqus model results for a composite coupon with two transverse cracks.

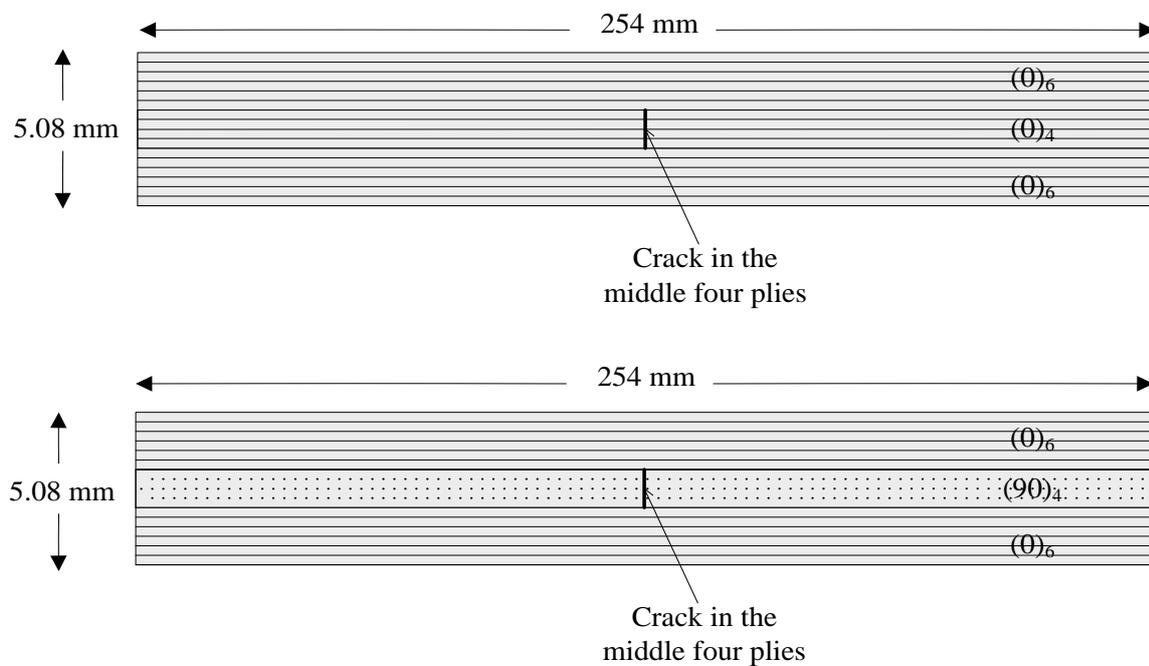
Figure 5.15. Pictorial representations of $[0_{16}]_T$ and $[0_6/90_4/0_6]_T$ composite coupons with an embedded crack in the middle four plies.

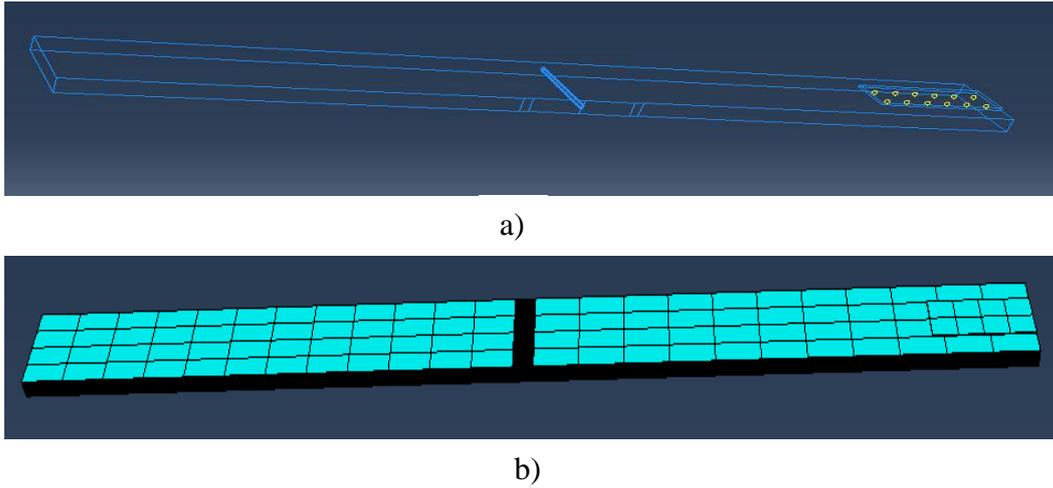
Figure 5.16. Abaqus models showing the embedded crack in a $[0_{16}]_T$ composite coupon: a) a wireframe model representation and b) a mesh representation.

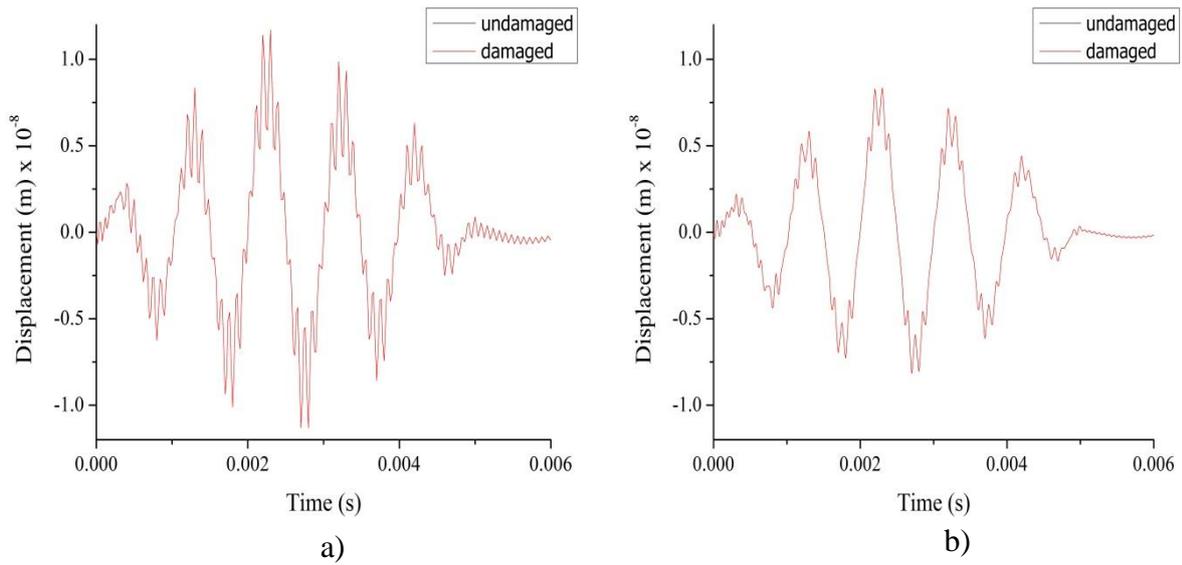
Figure 5.17. Finite element (FE) results comparing the lamb wave response of an undamaged coupon and a coupon with an embedded crack for: a) a $[0_{16}]_T$ composite coupon and b) a $[0_6/90_4/0_6]_T$ composite coupon.

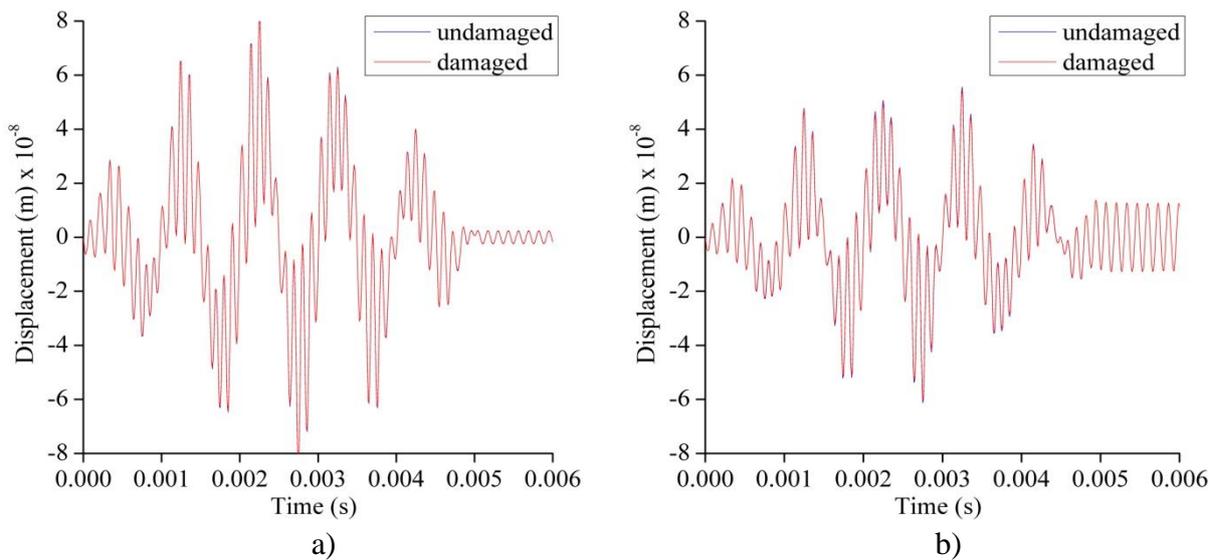
Figure 5.18. Finite element (FE) results comparing the lamb wave response of an undamaged coupon and a coupon with an embedded crack for: a) a $[0_{16}]_T$ composite coupon and b) a $[0_6/90_4/0_6]_T$ composite coupon for larger actuator.

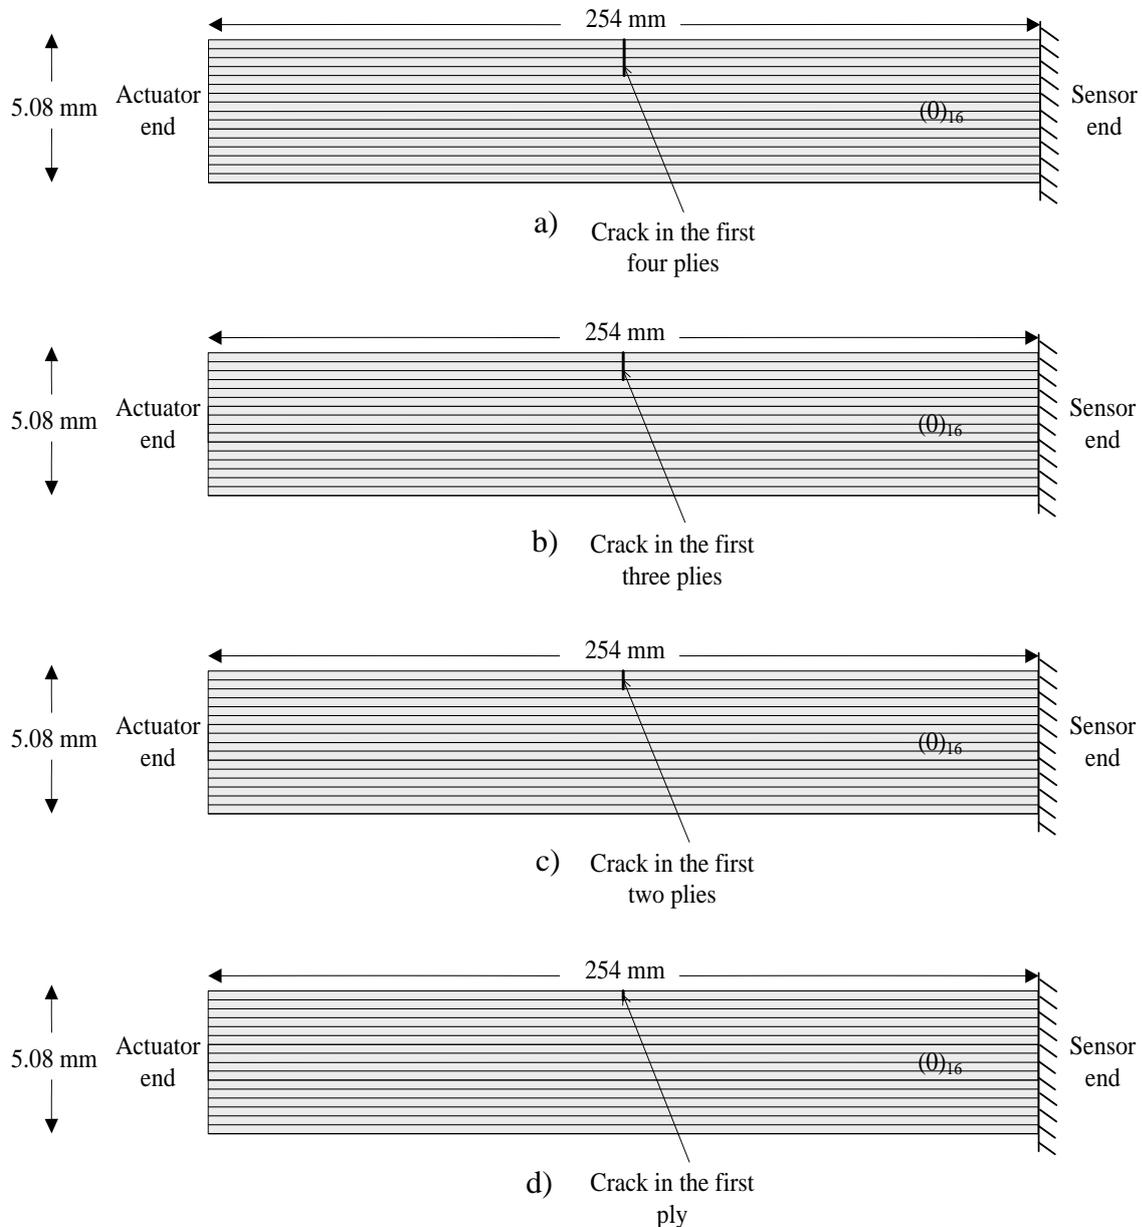
Figure 5.19. Pictorial representation of a $[0]_{16}$ composite coupon with surface cracks of varying depth: a) a surface crack in the first 4 plies; b) a surface crack in the first 3 plies; c) a surface crack in the first 2 plies; and d) a surface crack in the first ply only.

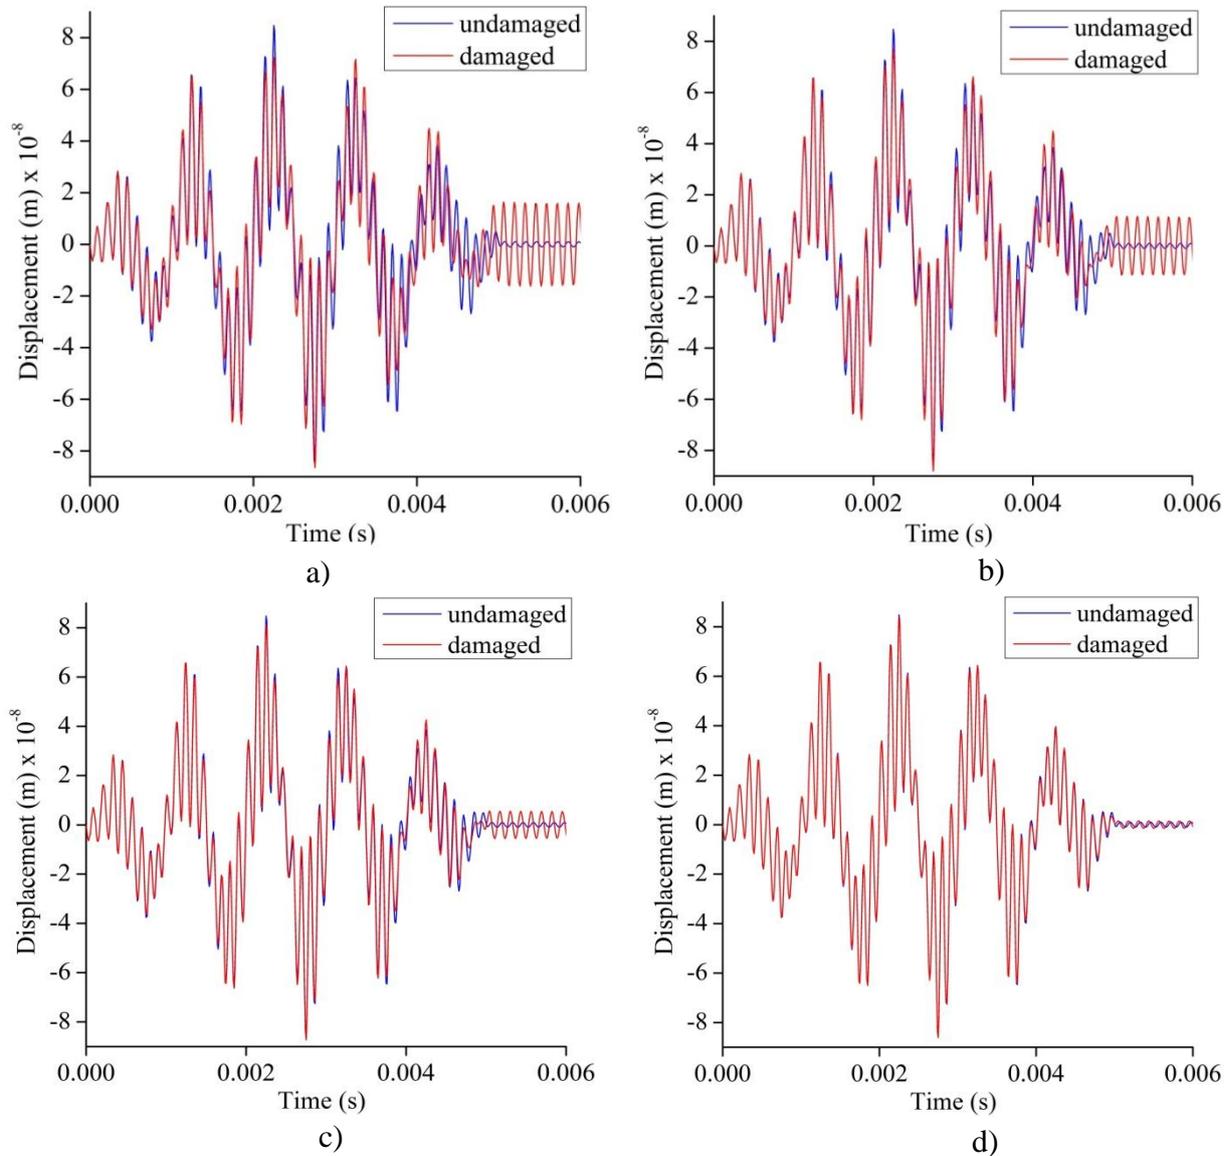
Figure 5.20. Finite element results comparing the lamb wave response of an undamaged $[0_{16}]_T$ composite coupon and a coupon with a surface crack for: a) a surface crack in the first 4 plies; b) a surface crack in the first 3 plies; c) a surface crack in the first 2 plies; and d) a surface crack in the first ply only.

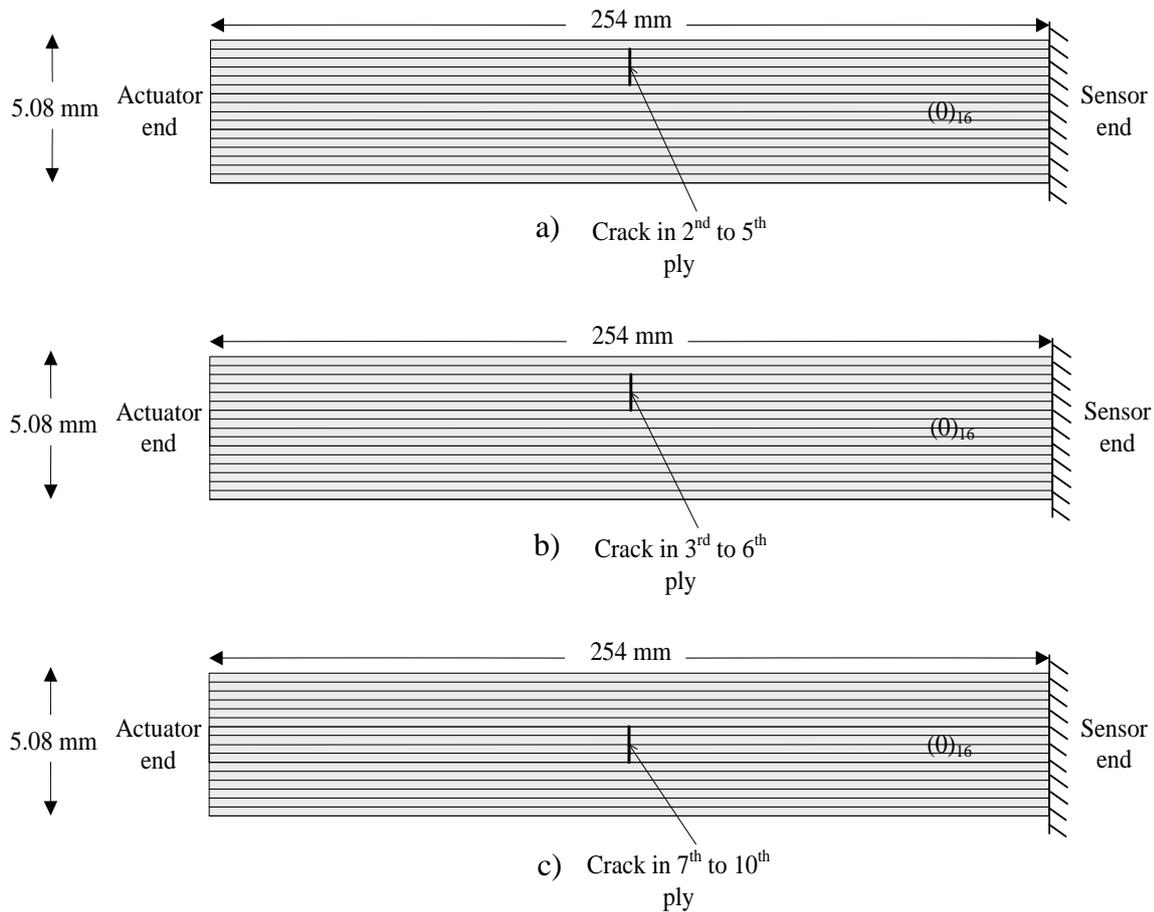
The crack was closer to the surface on which the actuator was placed.

Figure 5.21. Pictorial representation of a $[0_{16}]_T$ composite coupon with a 4 ply deep embedded crack in: a) 2nd to 5th ply; b) 3rd to 6th ply; and c) 7th to 10th ply.

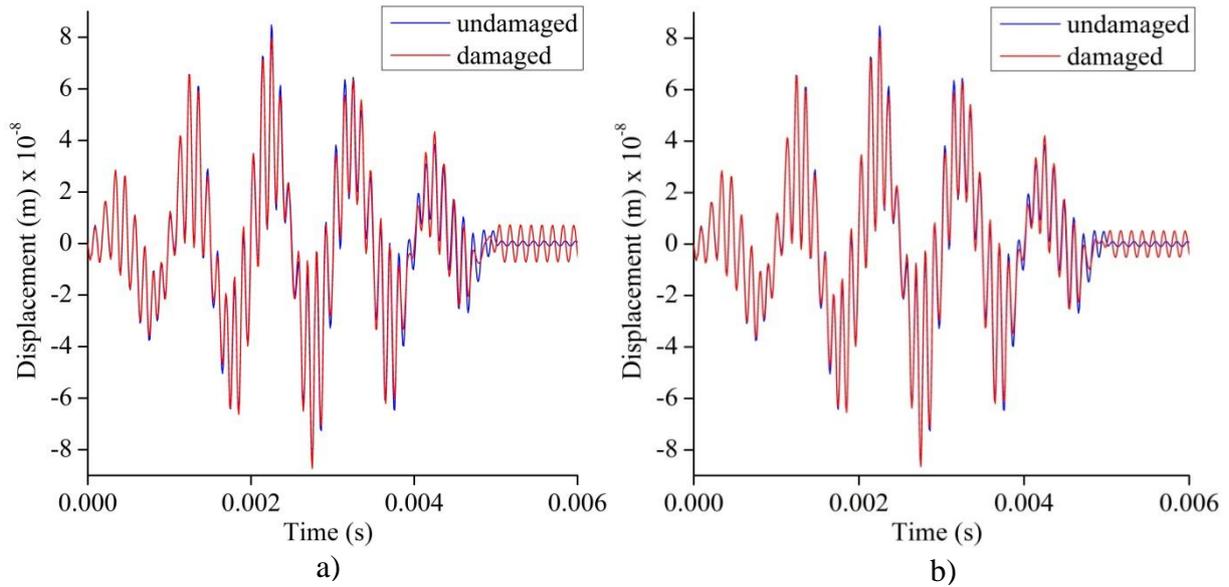
Figure 5.22. Finite element results comparing the Lamb wave response of a $[0_{16}]_T$ undamaged coupon and a coupon with a 4 ply deep embedded crack in: a) 2nd to 5th ply and b) 3rd to 6th ply.
