EXPERIMENTAL ANALYSIS AND FEA MODELING OF
SENSOR RESPONSE IN COMPOSITES FOR
STRUCTURAL HEALTH MONITORING

A THESIS

Submitted in partial fulfillment of the requirements
for the degree of Master of Science
in the Department of Electrical and Computer Engineering
in the Graduate School of
The University of Alabama

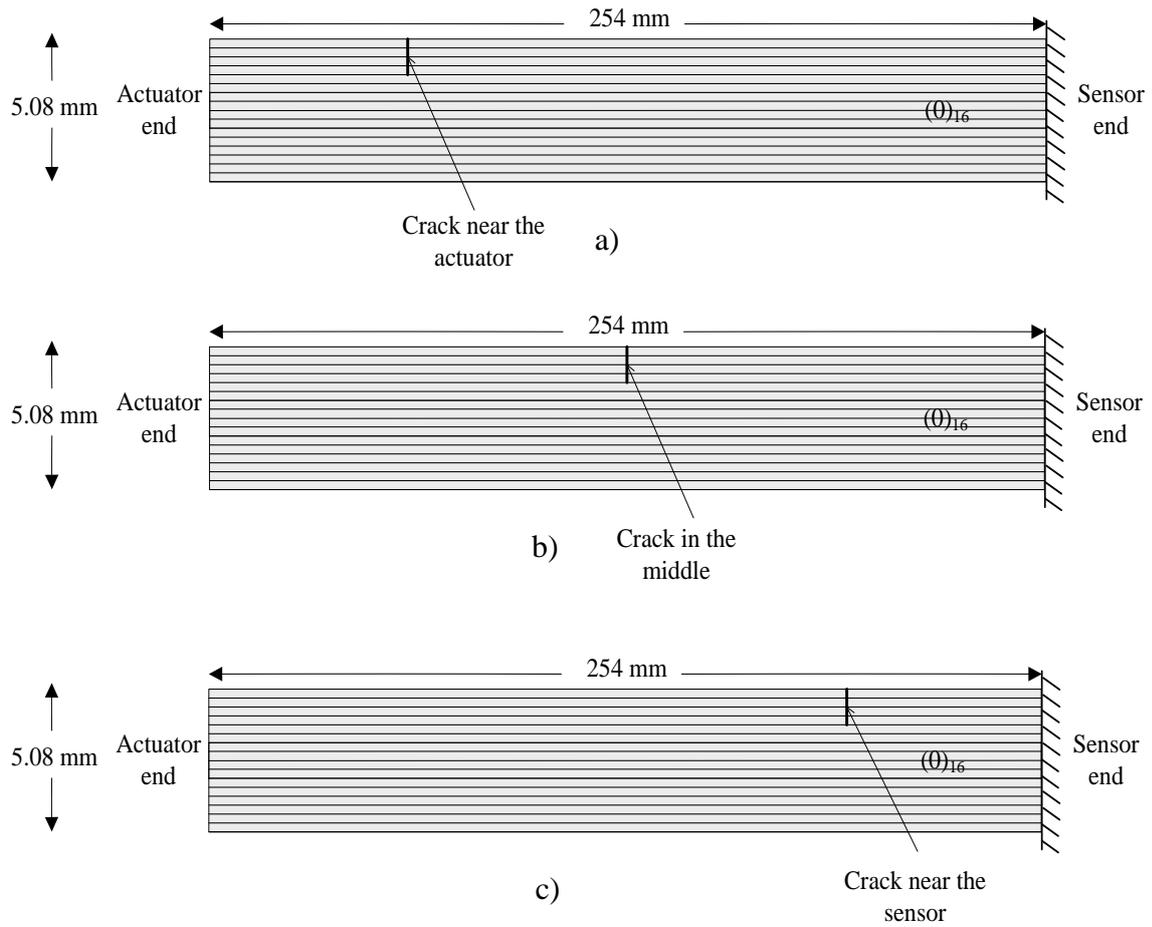
Figure 5.23. Pictorial representation of a $[0]_{16}_T$ composite coupon with a surface crack in the first four plies located: a) near the actuator end; b) in the middle; and c) near the sensor end.

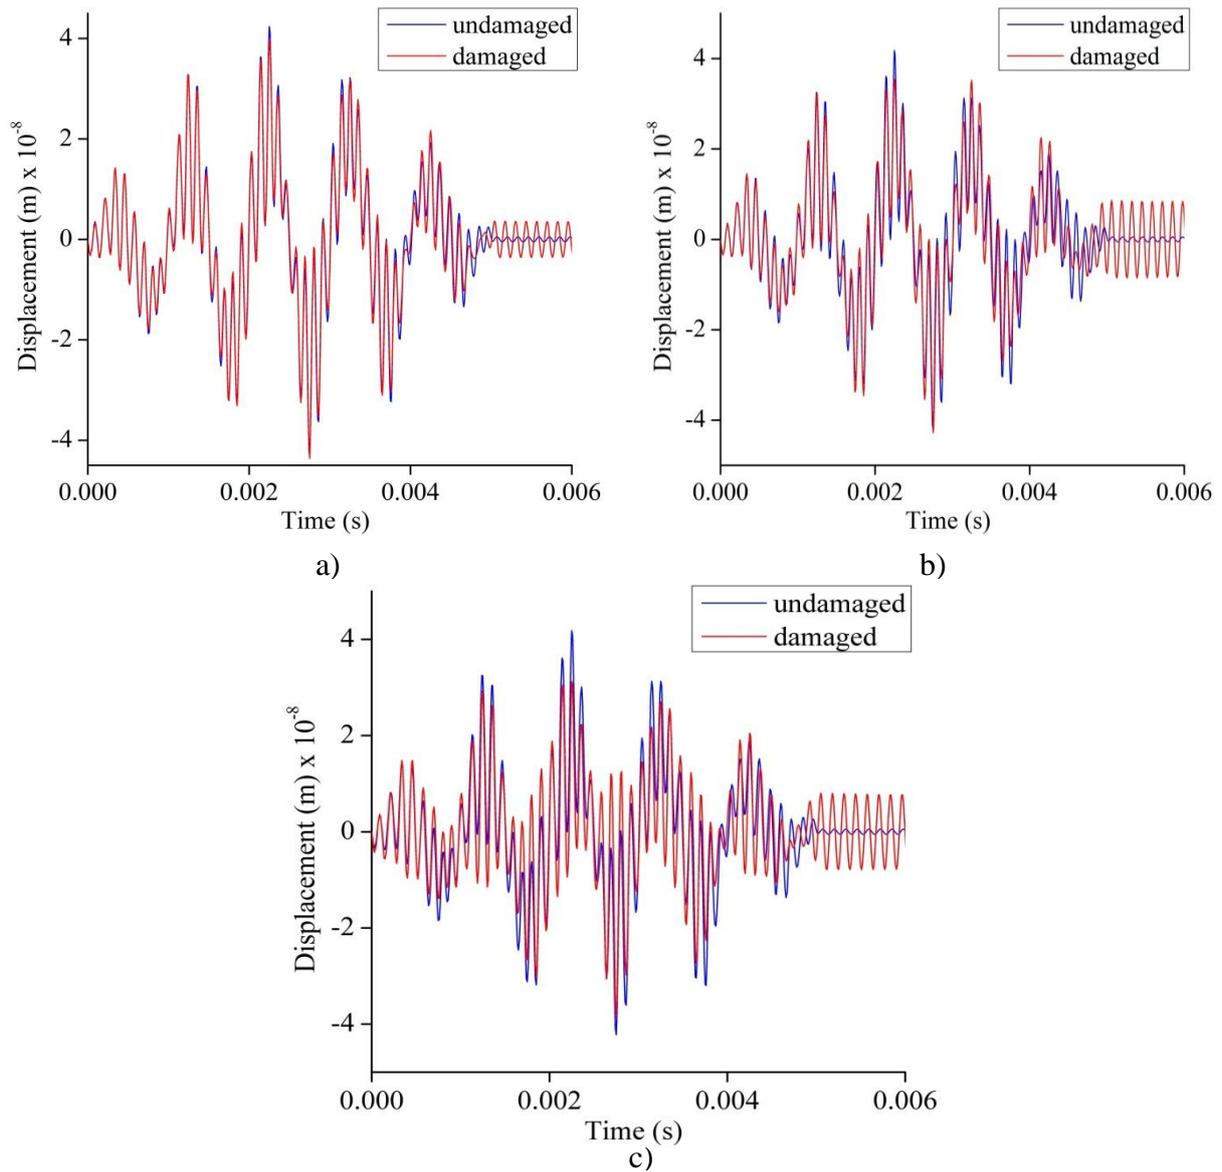
Figure 5.24. Finite element results comparing the Lamb wave response of a $[0_{16}]_T$ oriented undamaged coupon and a coupon with a surface crack in the first four plies located: a) near the actuator end; b) in the middle; and c) near the sensor end.

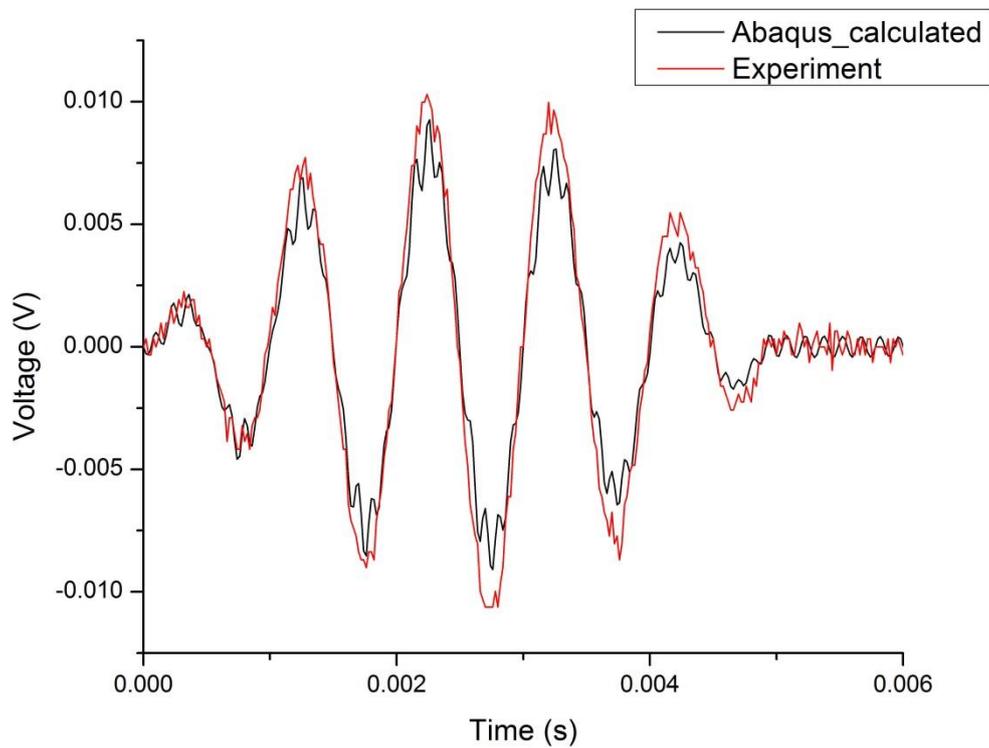
Figure 6.1. Comparison of experimental and Abaqus modeling results for an undamaged coupon.

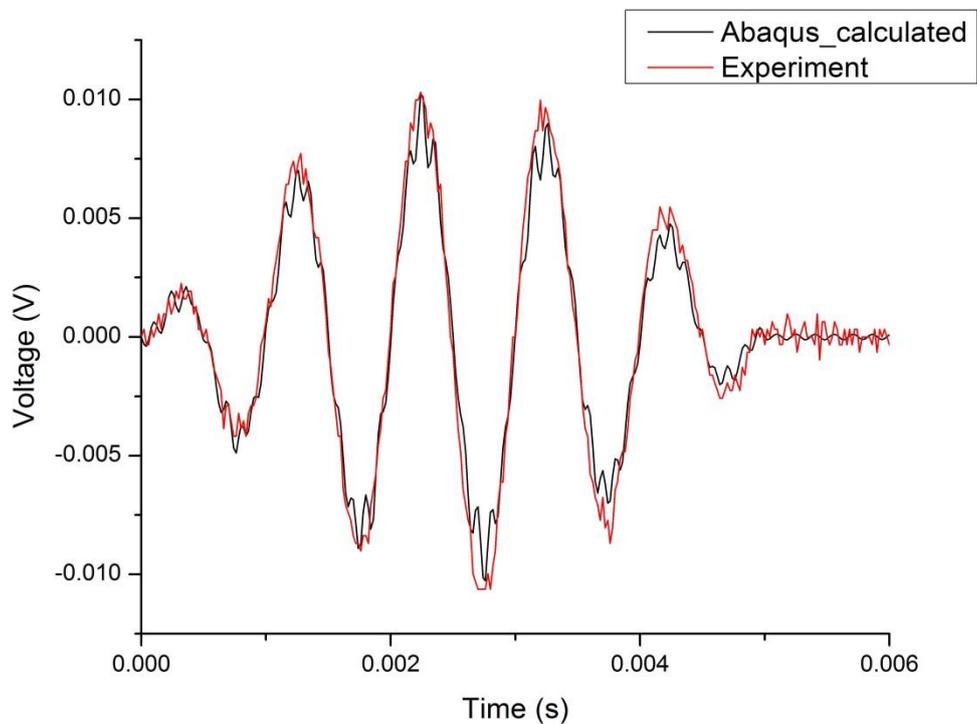
Figure 6.2. Comparison of experimental and Abaqus modeling results for an undamaged coupon after adjusting the modulus.

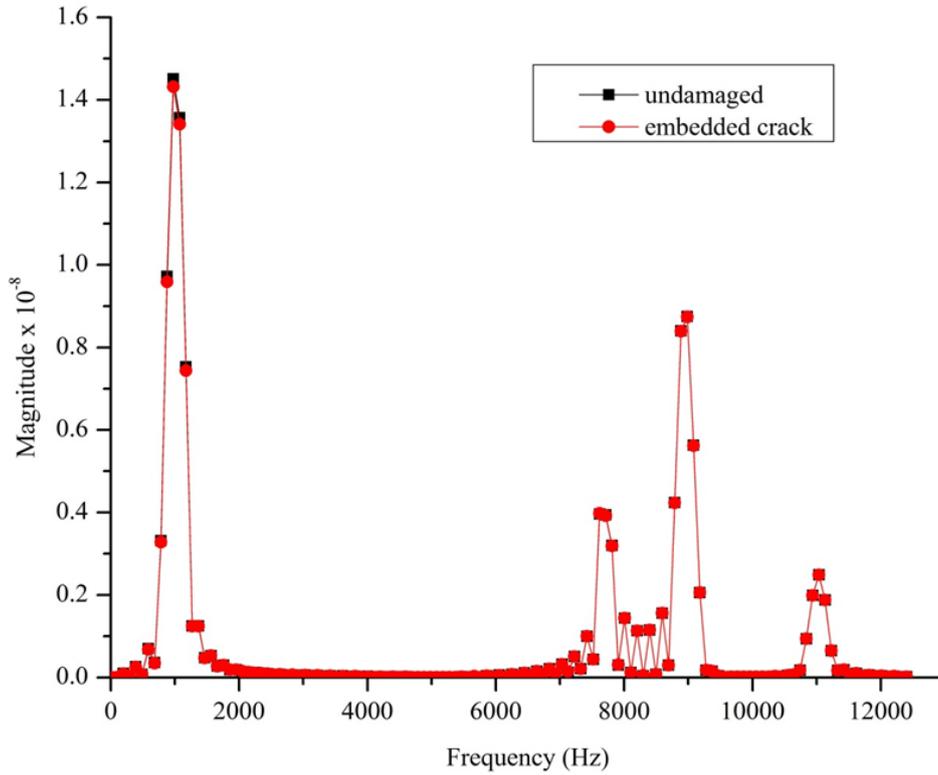
Figure 6.3. FFT spectrum based on Abaqus results comparing the frequency response of a $[0_{16}]_T$ orientation undamaged coupon and a coupon with an embedded crack in the middle four plies.

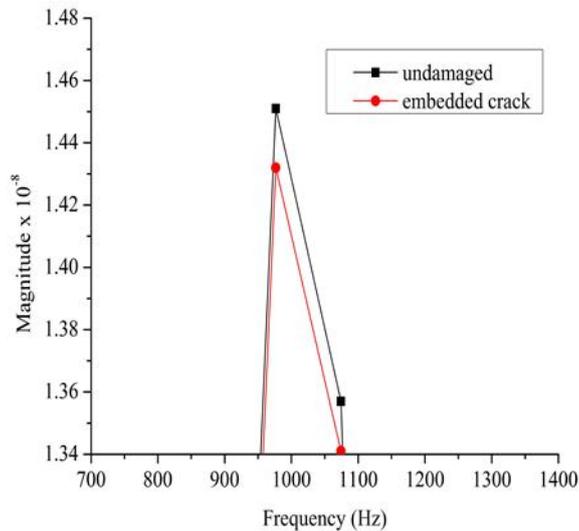
Figure 6.4. Enlarged view of a FFT spectrum at frequencies near 976.6 Hz showing less than 1% difference between the frequency response of a $[0_{16}]_T$ orientation undamaged coupon and a coupon with an embedded crack in the middle four plies.

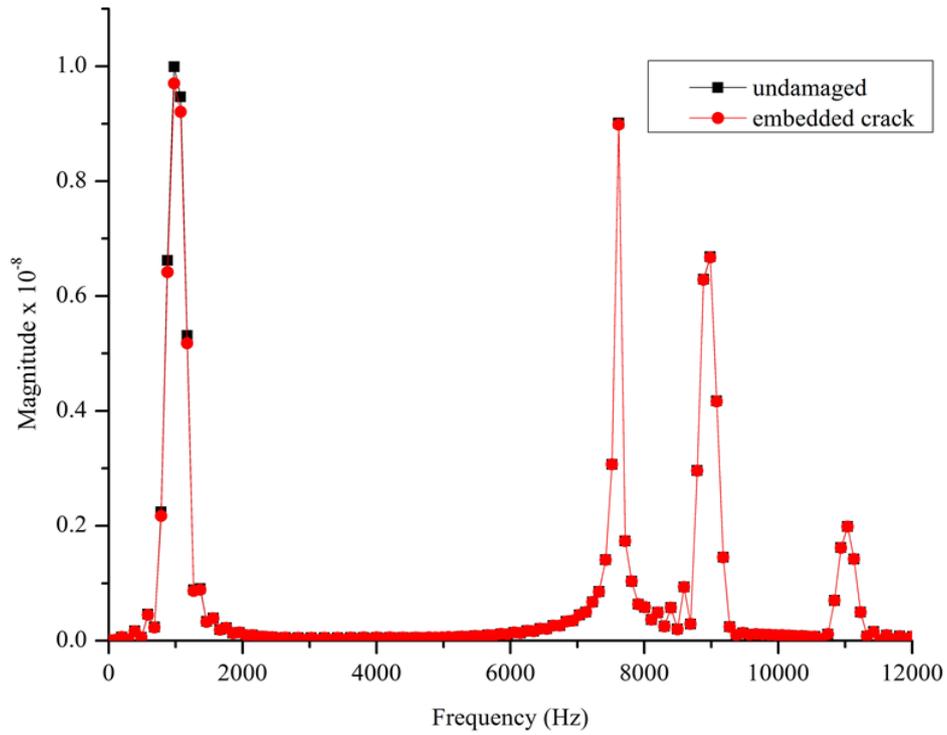
Figure 6.5. FFT spectrum based on Abaqus results comparing the frequency response of a $[0_6/90_4/0_6]_T$ orientation undamaged coupon and a coupon with an embedded crack in the middle four plies.

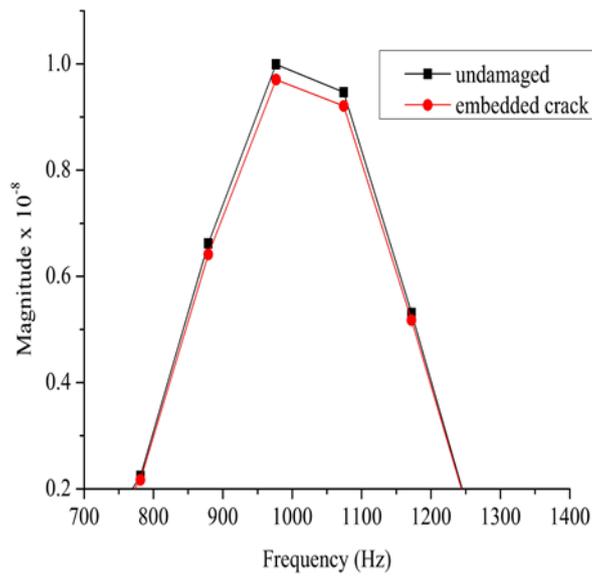
Figure 6.6. Enlarged view of a FFT spectrum at frequencies near 976.6 Hz showing less than 2% difference between the frequency response of a $[0_6/90_4/0_6]_T$ orientation undamaged coupon and a coupon with an embedded crack in the middle four plies.

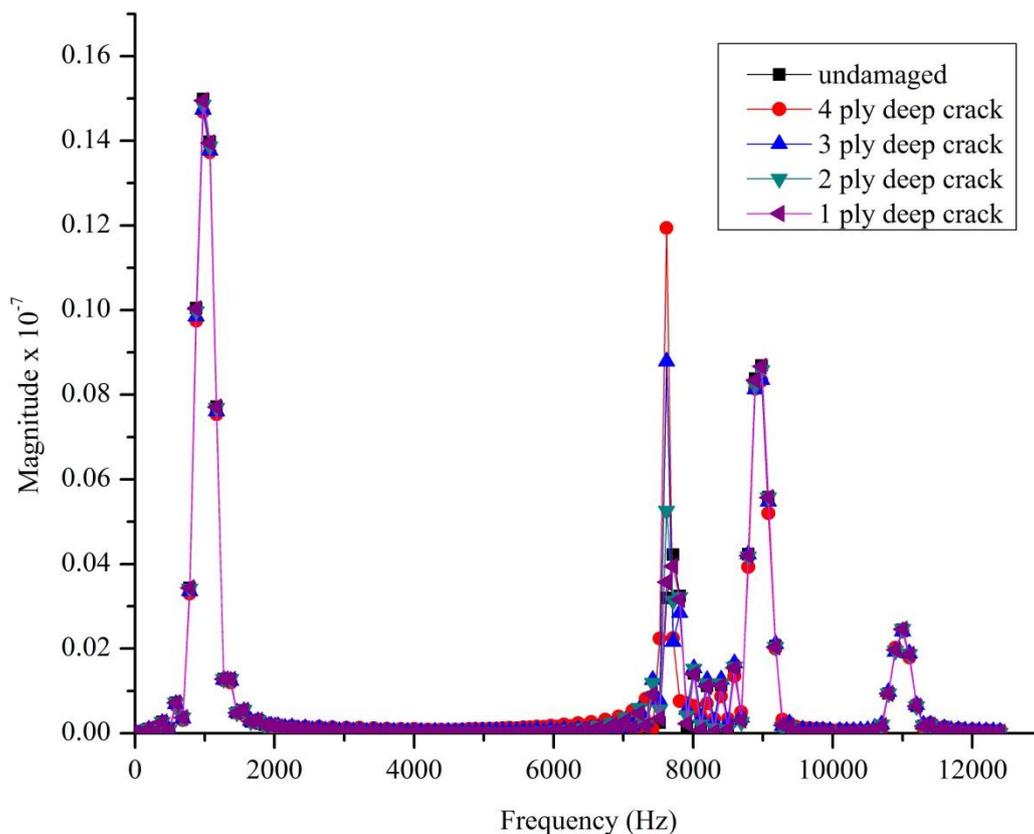
Figure 6.7. Complete FFT spectrum for $[0_{16}]_T$ composite coupons comparing the frequency response of undamaged to damaged coupons that is provided by varying the depth of a surface crack.

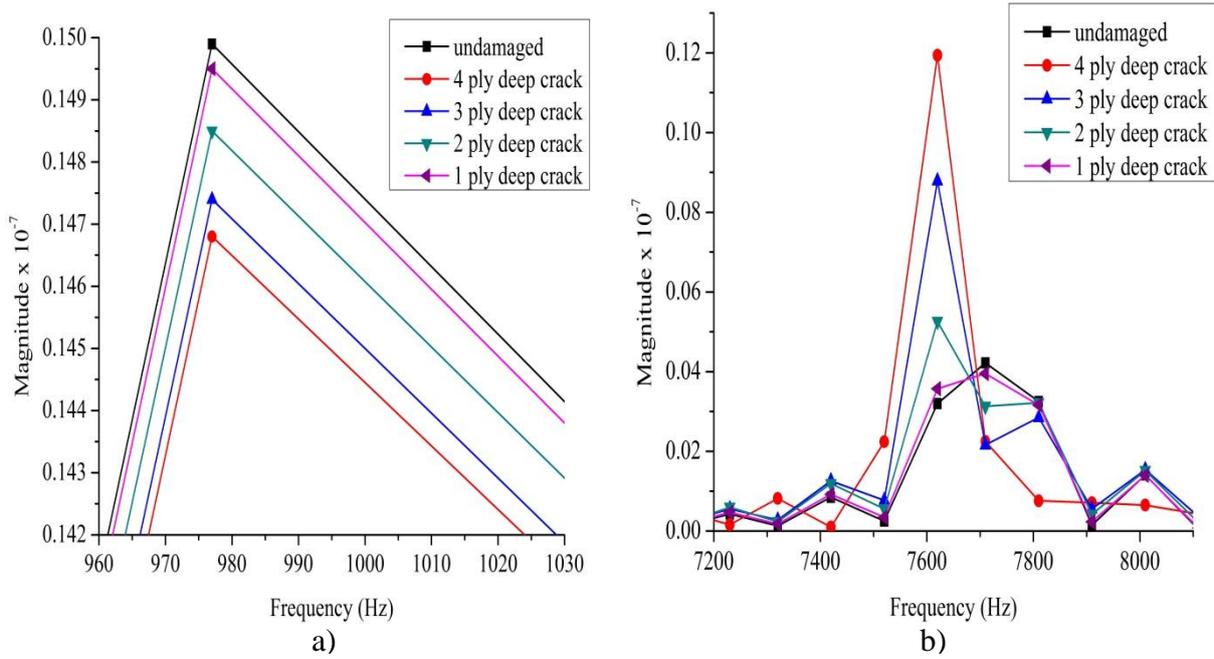
Figure 6.8. An enlarged view of FFT spectrum for an $[0_{16}]_T$ undamaged composite coupon and coupons with a surface crack of various depths for frequencies near: a) 976.6 Hz and b) 7.617 kHz.

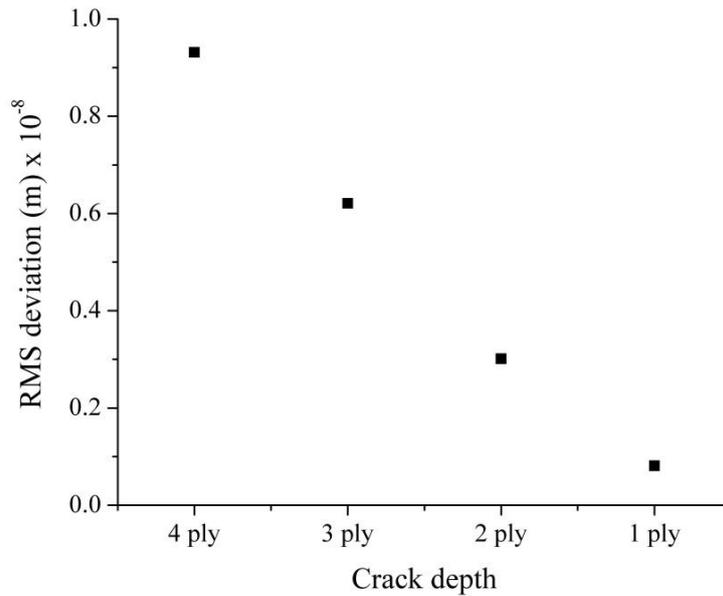
Figure 6.9. A graphical representation of RMS deviation between a $[0_{16}]_T$ undamaged coupon and coupons with a surface crack of various depths as a function of crack depth.

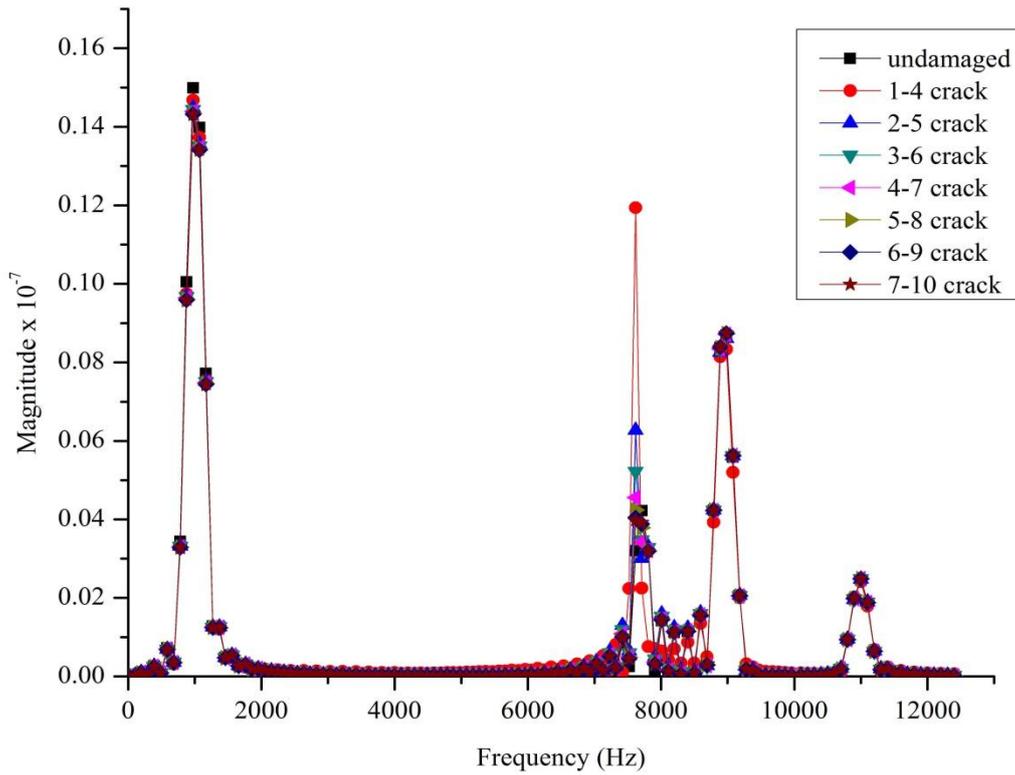
Figure 6.10. Complete FFT spectrum for $[0_{16}]_T$ composite coupons comparing the frequency response of an undamaged coupon to coupons with a four ply deep crack at various depths.

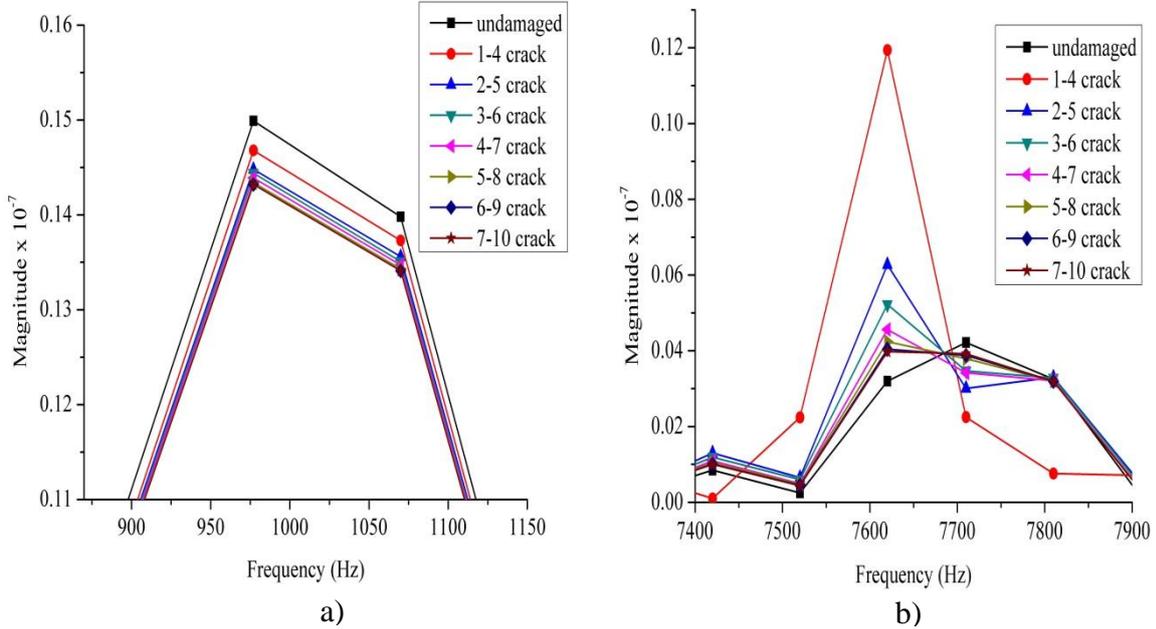
Figure 6.11. An enlarged view of a FFT spectrum for an $[0_{16}]_T$ undamaged composite coupon and coupons with a four ply deep surface crack at various depths at frequencies near: a) 976.6 Hz and b) 7.617 kHz.

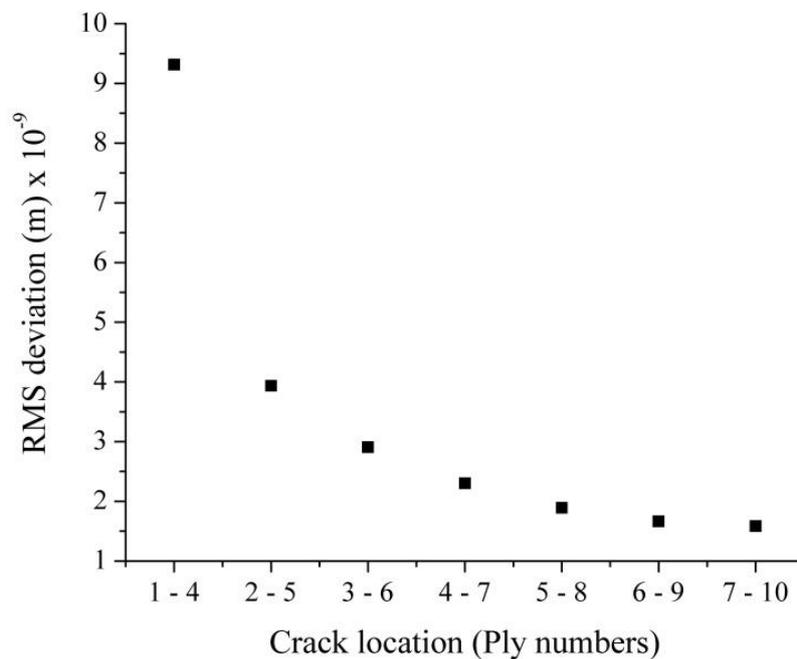
Figure 6.12. A graphical representation of RMS deviation between a $[0_{16}]_T$ undamaged composite coupon and coupons with a four ply deep crack at various depths as a function of crack location.

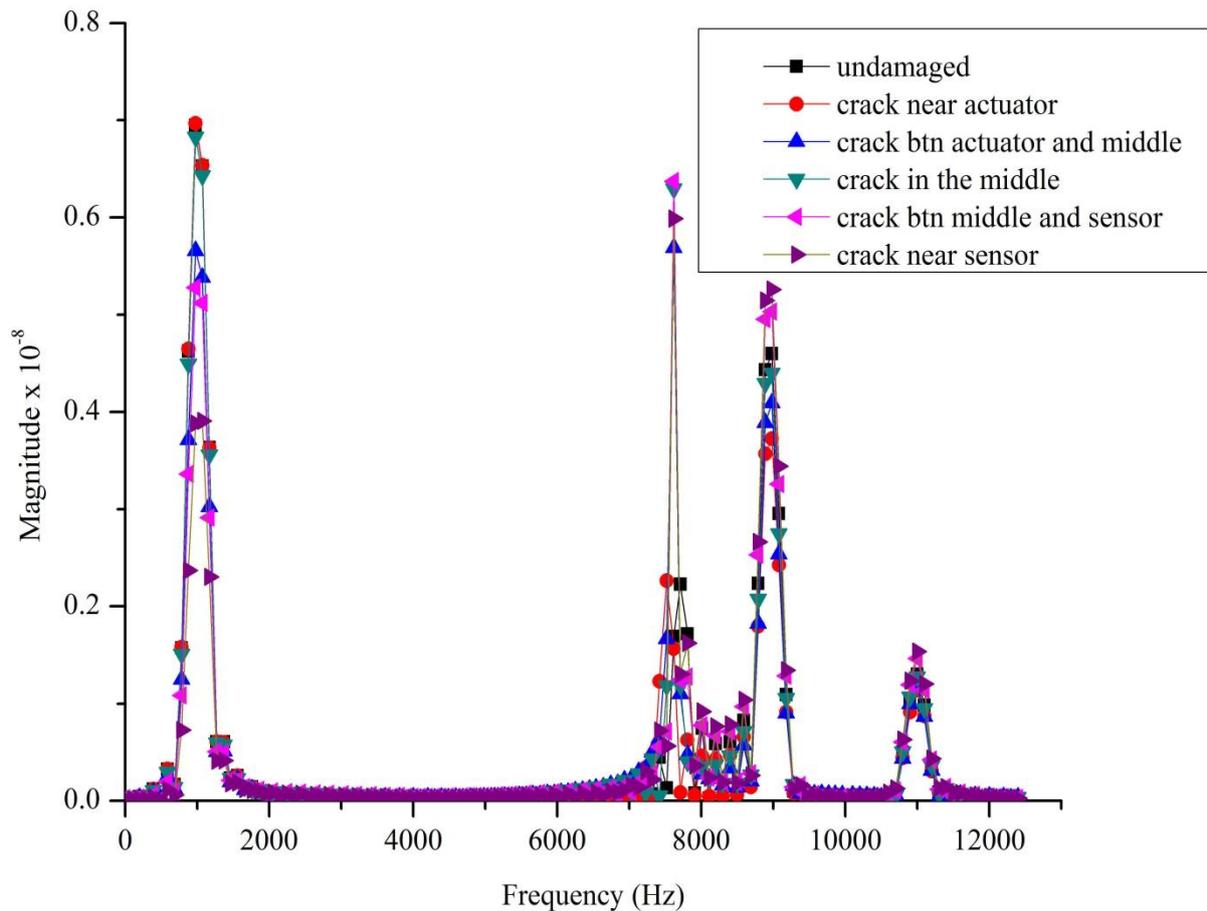
Figure 6.13. Complete FFT spectrum for $[0_{16}]_T$ composite coupons comparing the frequency response of undamaged coupon to coupons with a four ply deep surface crack at various locations across the coupon.

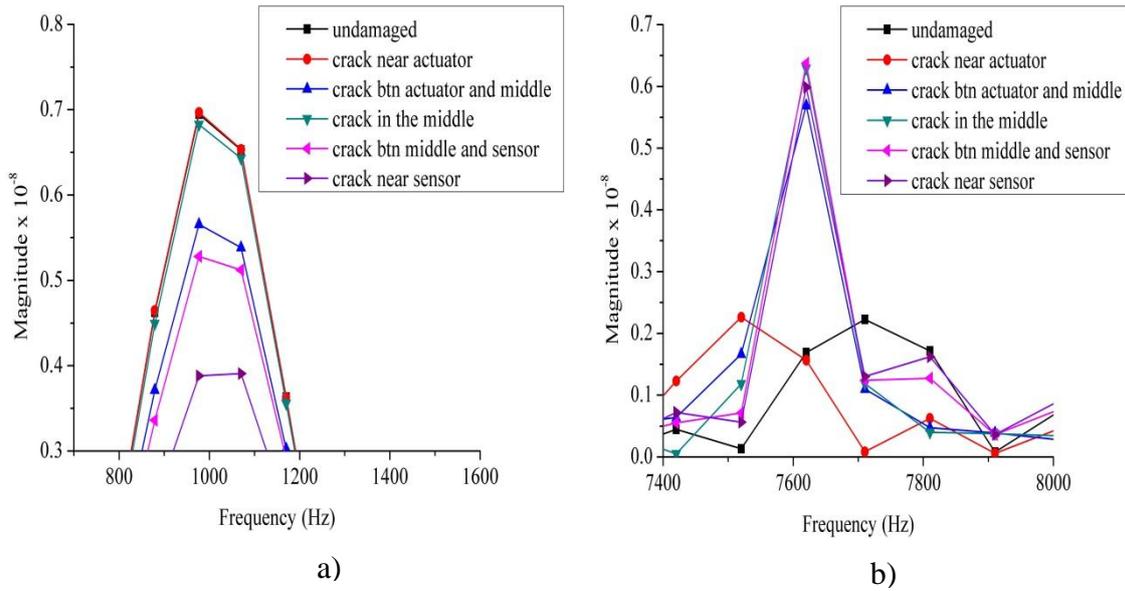
Figure 6.14. Enlarged view of FFT spectrum for an $[0_{16}]_T$ undamaged composite coupon and coupons with a four ply deep surface crack at various locations at frequencies near: a) 976.6 Hz and b) 7.617 kHz.

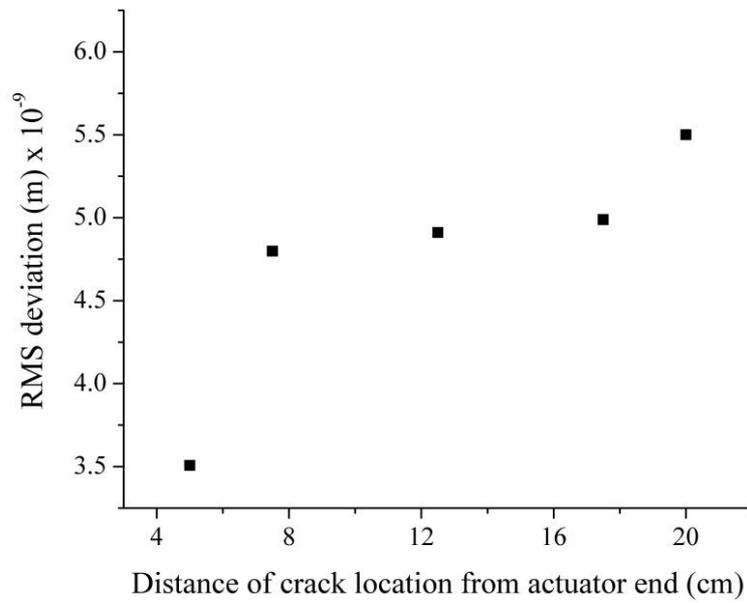
Figure 6.15. A graphical representation of RMS deviation between an $[0_{16}]_T$ undamaged composite coupon and coupons with a four ply deep surface crack at various locations across the coupon.

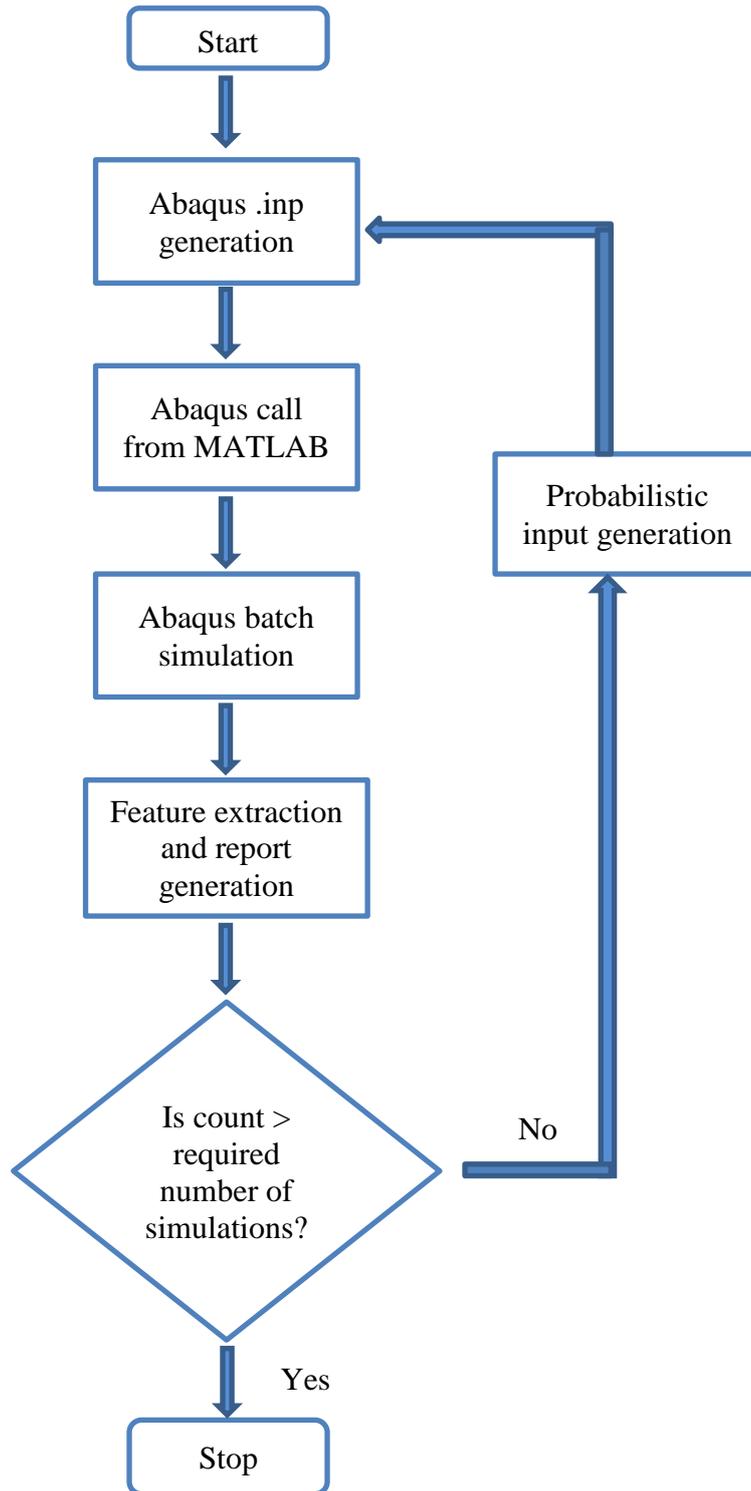
Figure 7.1. A flow chart demonstrating the interface between MATLAB and Abaqus that used for generating data set for sensor placement optimization (where count is the iteration number).

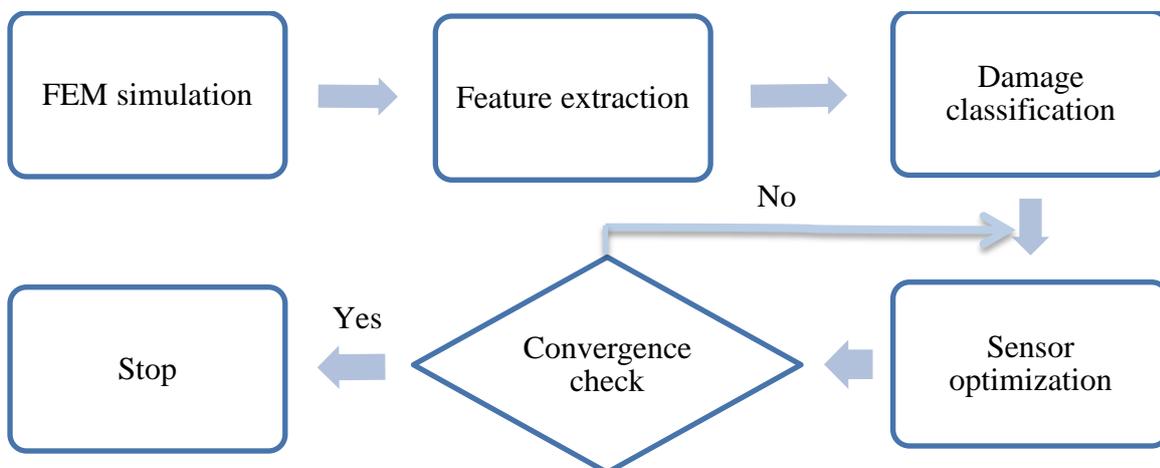
Figure 7.3. A flow chart demonstrating the sensor placement optimization process.

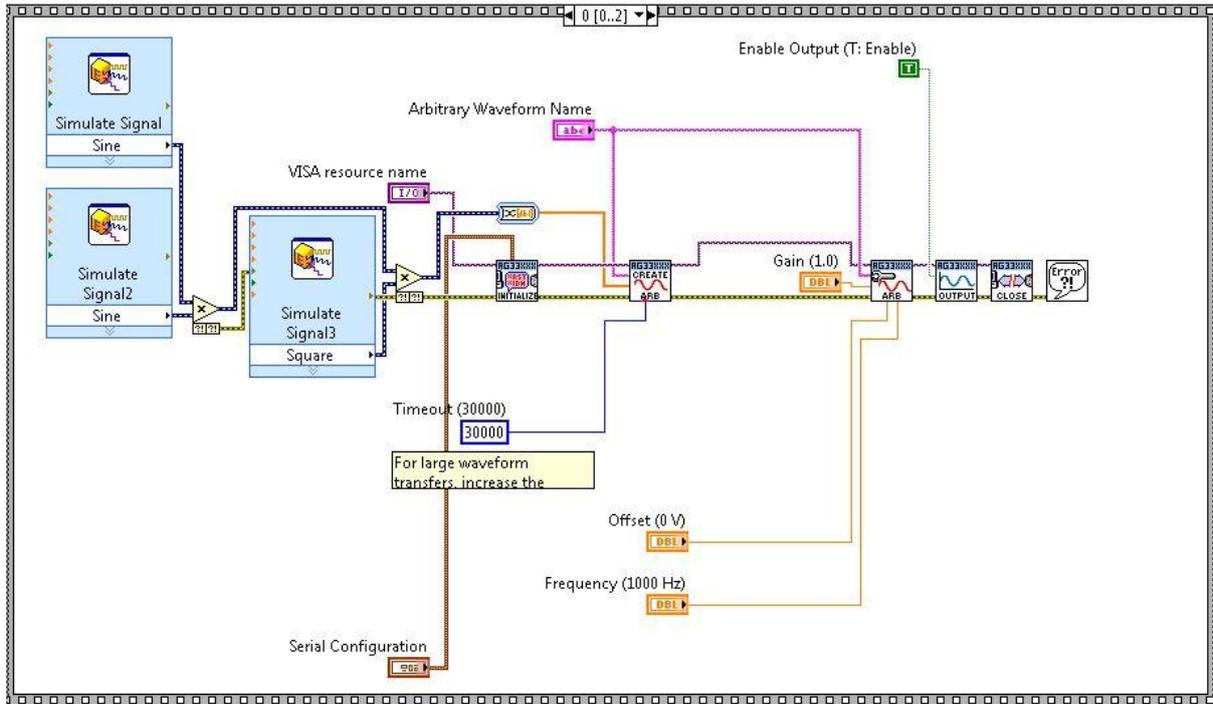
LabVIEW program developed to read from the DAQ.
