METHODOLOGY FOR A GIS-BASED DAMAGE ASSESSMENT  
FOR RESEARCHERS FOLLOWING  
LARGE SCALE DISASTERS

A THESIS

Submitted in partial fulfillment of the requirements  
for the degree of Master of Science  
in the Department of Civil, Construction, and Environmental Engineering  
in the Graduate School of  
The University of Alabama

2014

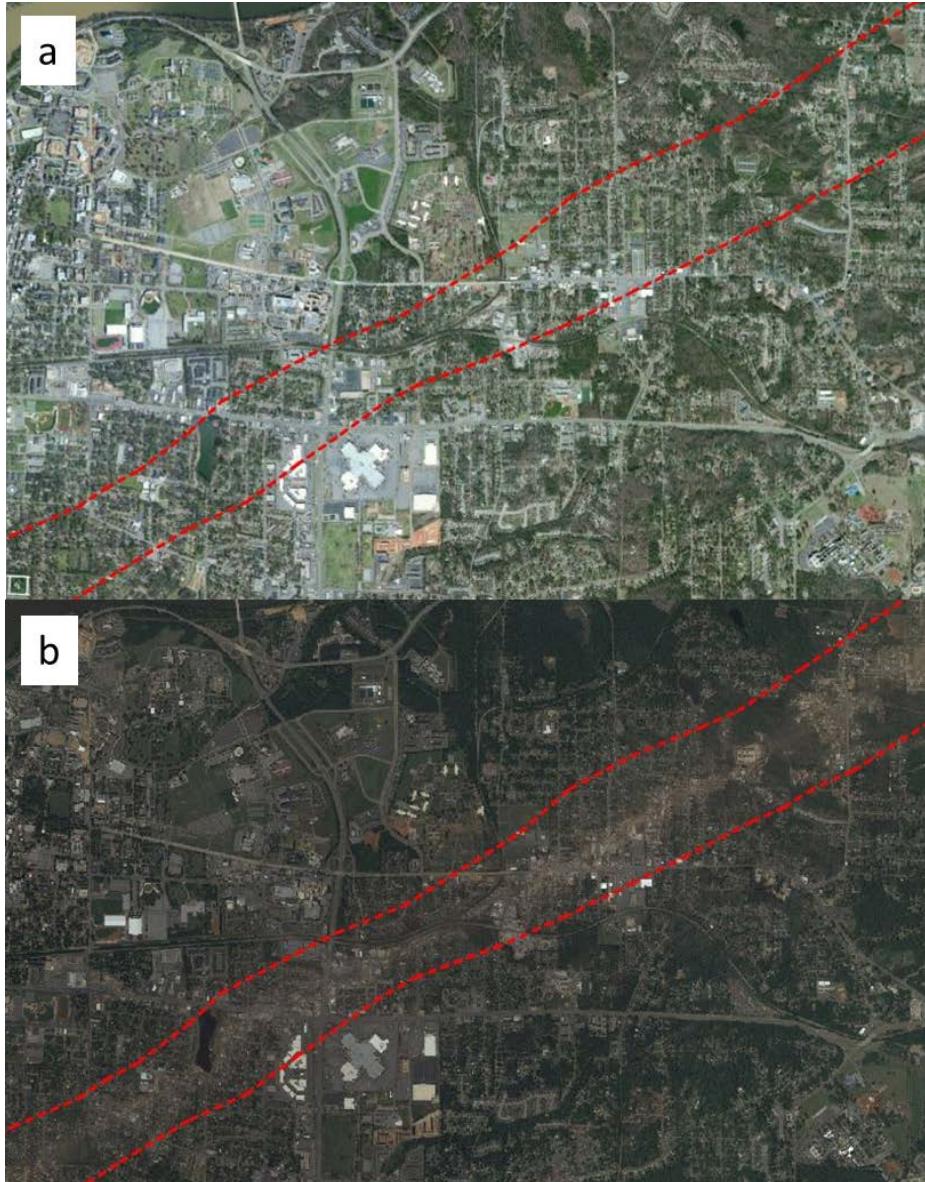
Figure 2.1. Aerial images of Tuscaloosa, Alabama (a) before the May 20, 2013 tornado and (b) after the tornado with the damage boundary denoted by dashed red lines.

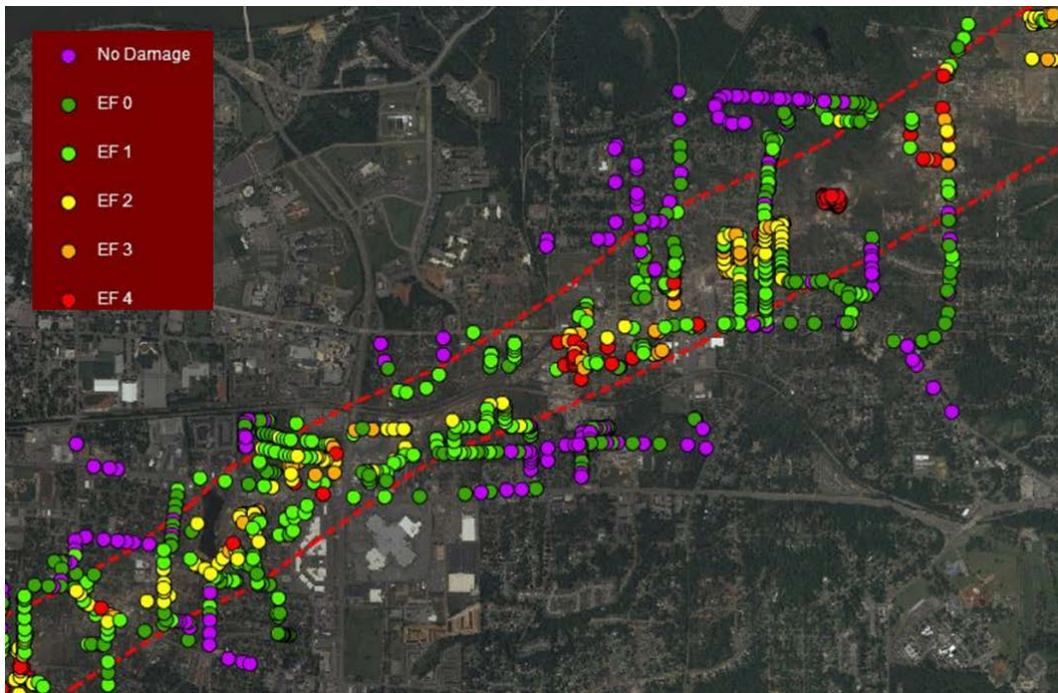
Figure 2.2. Tuscaloosa, Alabama damage assessment with geographically located inspection points color-coded by EF-scale damage (Graettinger, 2012).

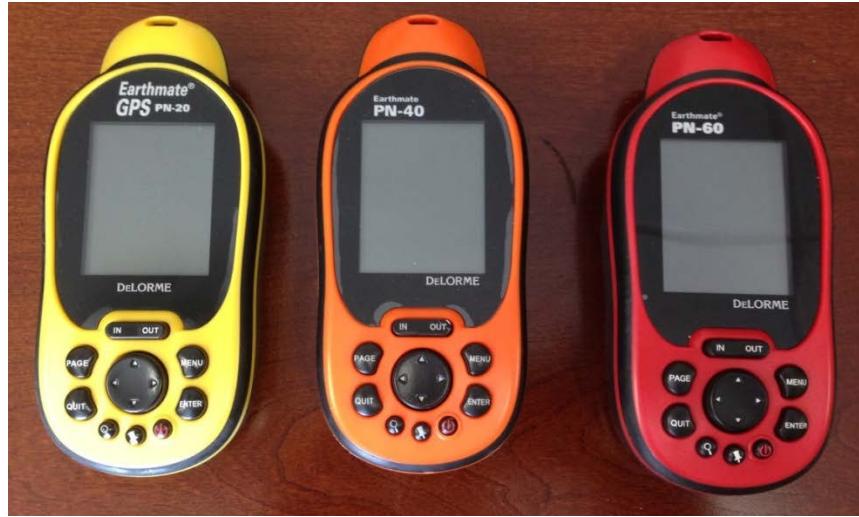
Figure 3.1. Example of GPS devices which capture GPS tracks.

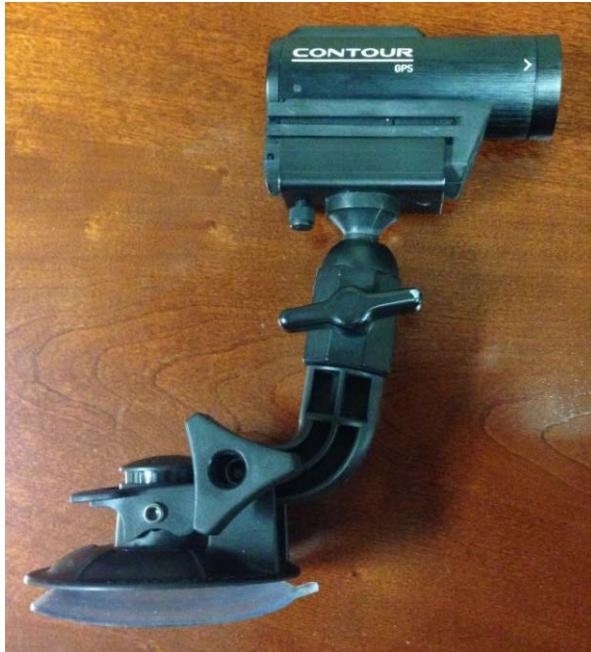
Figure 3.2. GPS-enabled camera that can be set to take pictures at a time interval.

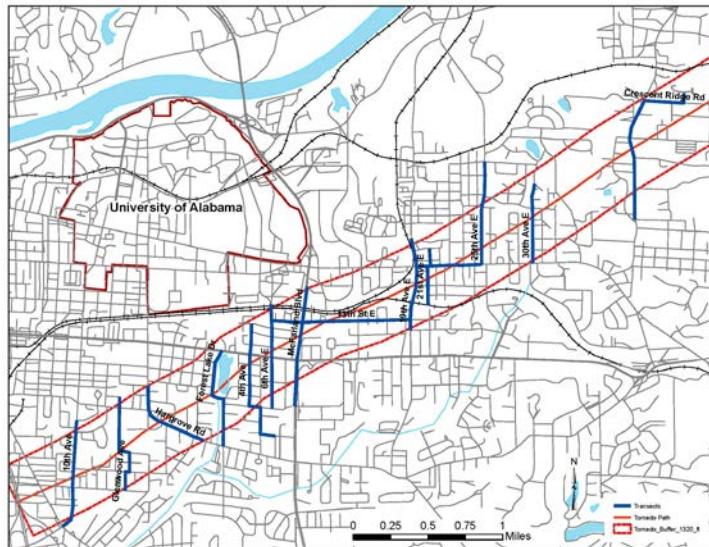
Figure 3.3. April 2011 Tuscaloosa, Alabama tornado damage assessment transect map.

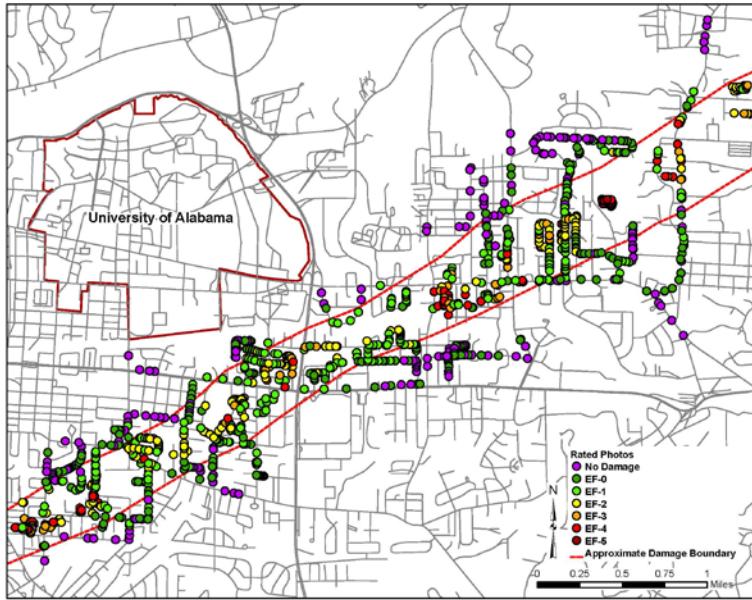
Figure 3.4. Photograph locations for the Tuscaloosa tornado damage assessment.

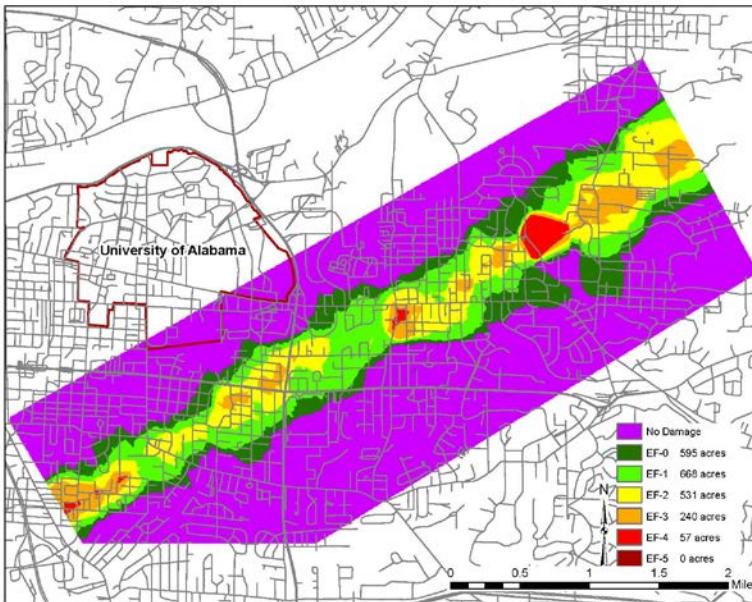
Figure 3.5. The damage contour map color coded based on EF scale and containing areas of each EF rating (Graettinger et al, 2012).

damage, but The methodology allows for any inspection topic to be documented. Figure 3.6 shows the three-dimensional damage contour which was created from the data collected in Tuscaloosa. The damage contour for the Tuscaloosa tornado damage assessment is based on damage rated on the enhanced Fujita (EF) scale. The damage contour can be created by interpolating any designation that the team gives to collected photographs.

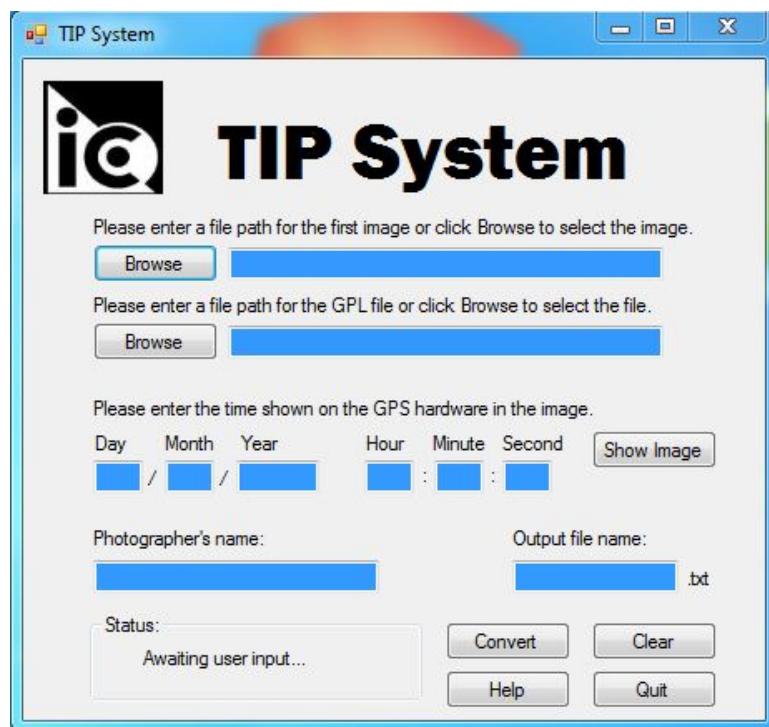
Figure 3.6. TIP System startup screen containing fields for all inputs, browse buttons allowing the user to locate a folder of inspection photographs, and a button allowing the user to view the first image in the folder.

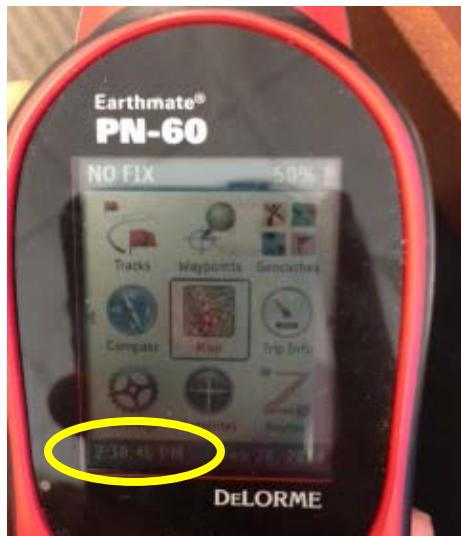
Figure 3.7. Photograph of a GPS screen with the time visible.

GPS equipment produces a .GPL file format but if other GPS devices are used, an internet converter can be used to convert .GPX files into .GPL files. The most efficient method to process photographs and GPS tracks involves each team member taking a photograph of their GPS unit showing the time displayed on the GPS unit before they take any other photographs. Figure 3.8 shows a picture of a Delorme GPS device with the time on the screen. This picture will be used to reconcile the time difference of the GPS unit and the photographs. The TIP software will read the timestamp of the photograph and compare it to the time of the GPS unit entered by the user. This time difference will be carried through the remaining photographs to find the latitude and longitude of each photograph. The output of the software is a .txt file that contains the image names, corresponding latitudes, corresponding longitudes, and photographer name. Figure 3.9 shows the flow diagram for the TIP system.

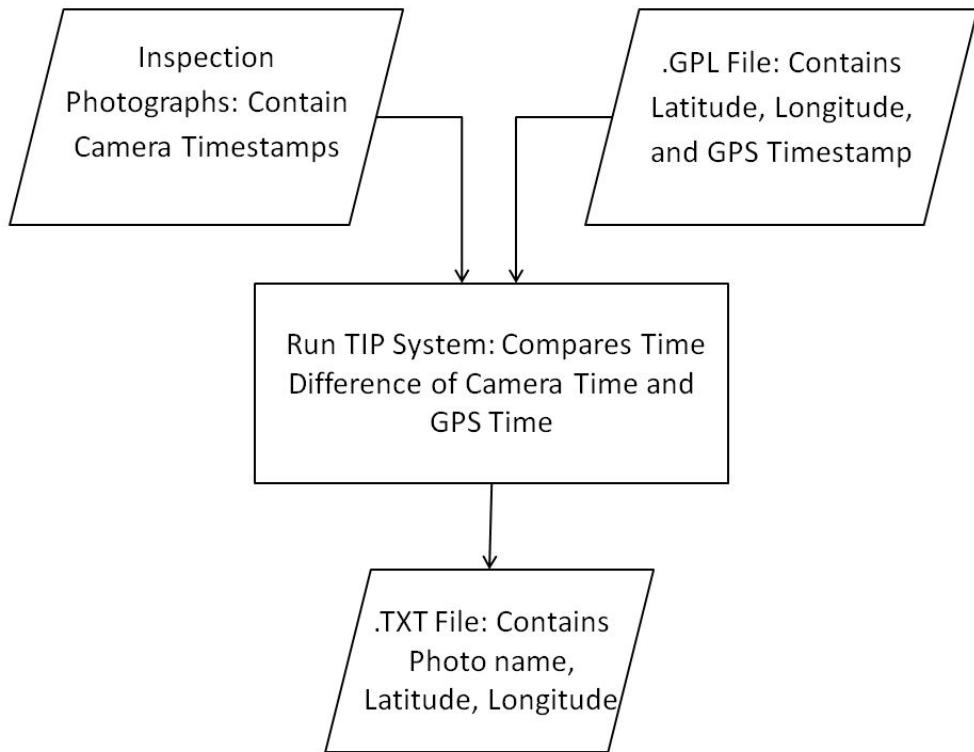
Figure 3.8. Flow diagram of the TIP data collection method.

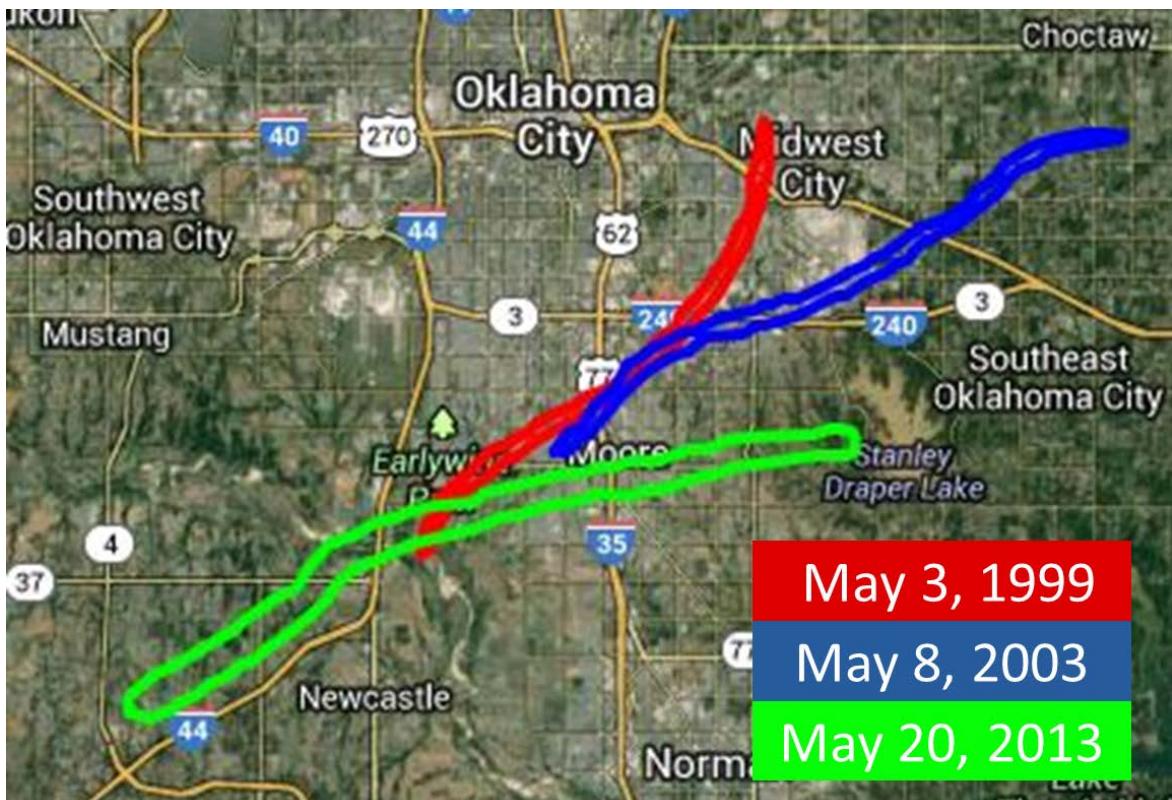
Figure 4.3. Map of the paths of the three major tornadoes to hit Moore in the past 15 years with the May 20th, 2013 tornado shown in red(kfor.com).

Moore has been hit by several large tornadoes in the past two decades, including an F5 tornado on May 3, 1999, an F4 tornado on May 8, 2003, and the 2013 EF5 tornado. Figure 4.3

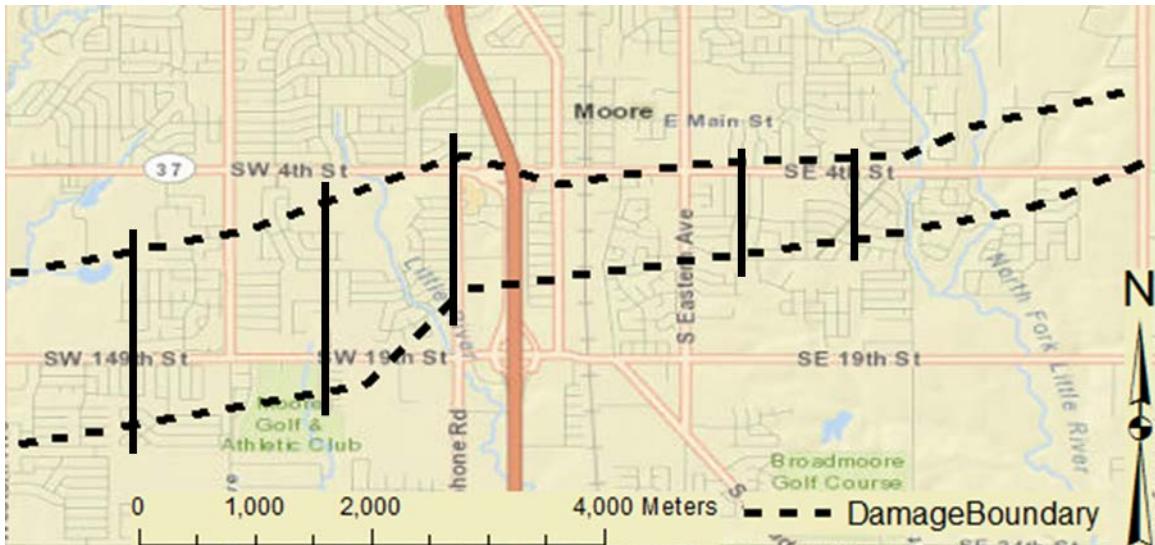
Figure 4.4. Transect locations inspected on May 25.

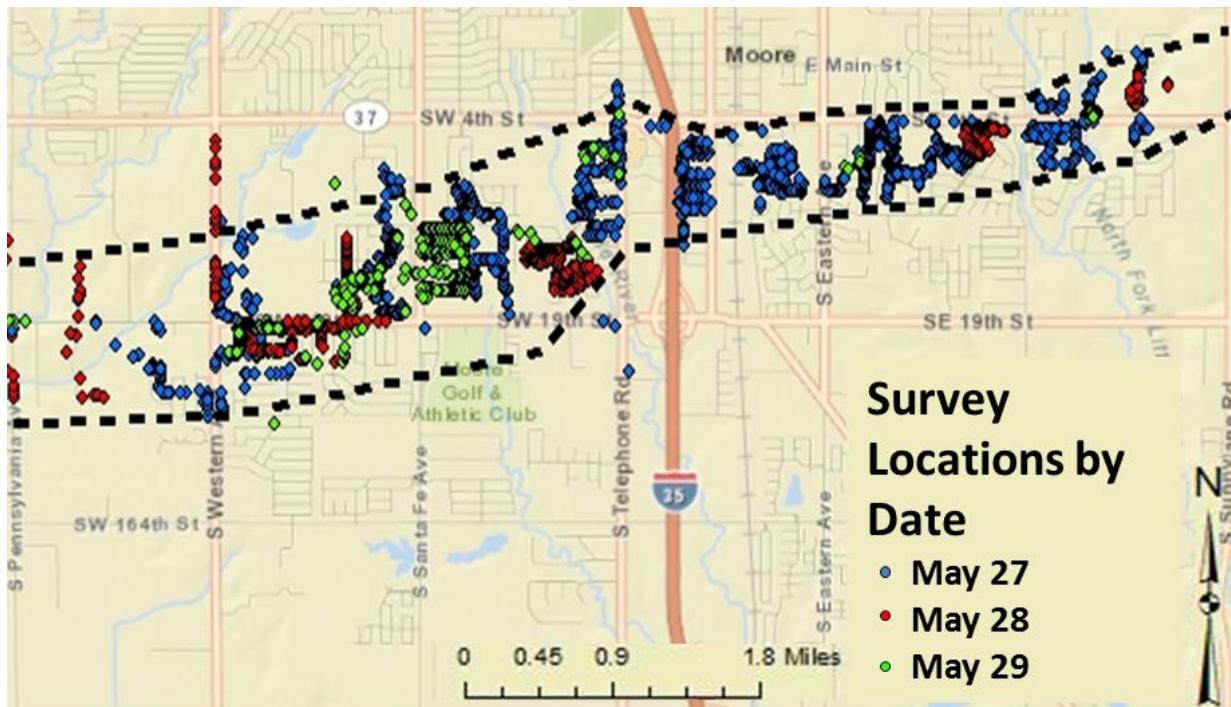
Figure 4.7. Geolocated photographs color coded by the day collected.

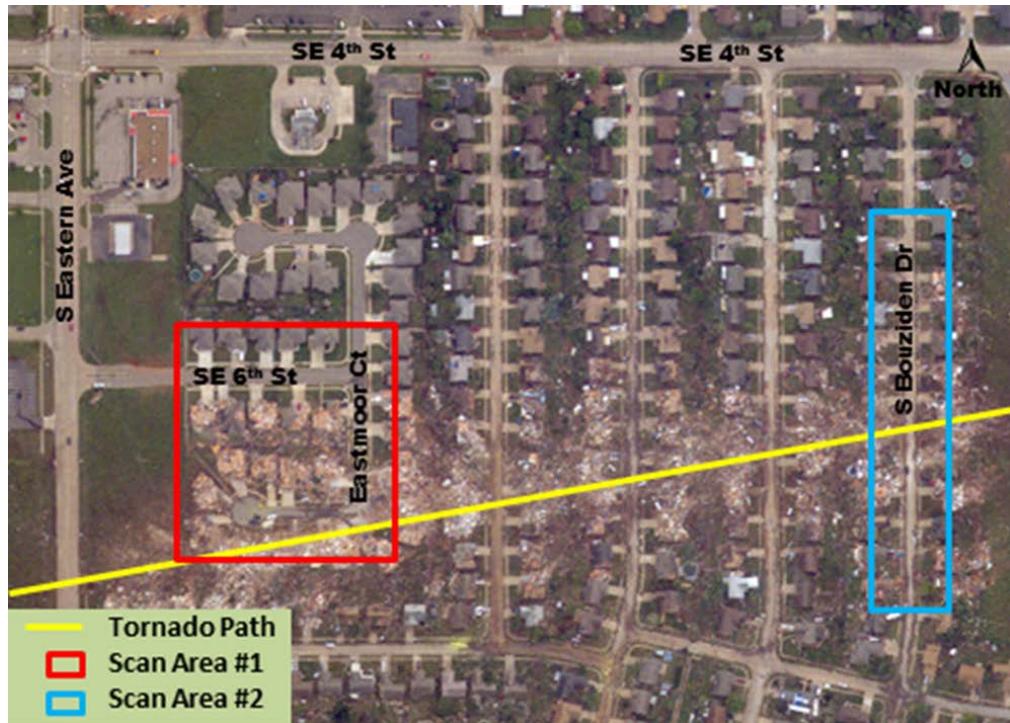
Figure 4.8. Areas where laserscans were captured in Moore.

Terrestrial LiDAR laserscans were captured for two sites in Moore. The point clouds created by the scans were used to virtually model damage to these areas. Figure 4.8 shows a map of the two areas. The first area includes a neighborhood that was in the direct path of the storm with damage ranging from completely destroyed buildings to buildings with very mild damage. The second scan area covers a street with a wide range of damage. From the centerline of the storm, damage decreases incrementally. Figure 4.9 shows a point cloud rendering of a damaged house in scan area #1, and Figure 4.10 shows the damage pattern in scan area #2. These virtual representations were used to study methods of automated damage assessment by combining terrestrial LiDAR data with GIS basemaps (Geranmayeh Kashani et al, 2014).

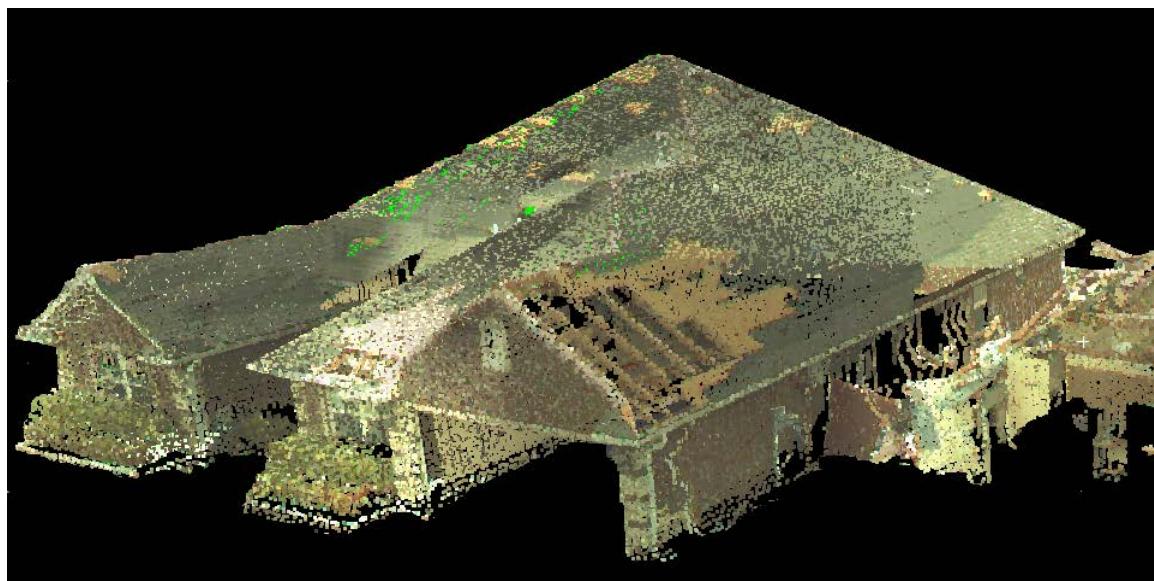
Figure 4.9. LiDAR point cloud of a damaged building from scan area #1.

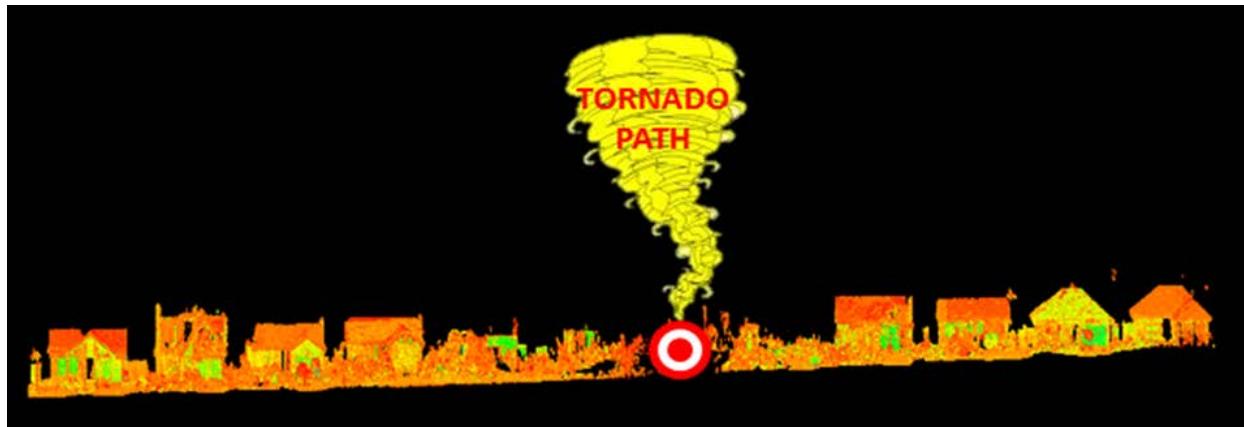
Figure 4.10. 3D representation of scan area #2 showing the gradual decrease in damage moving away from the path of the storm.

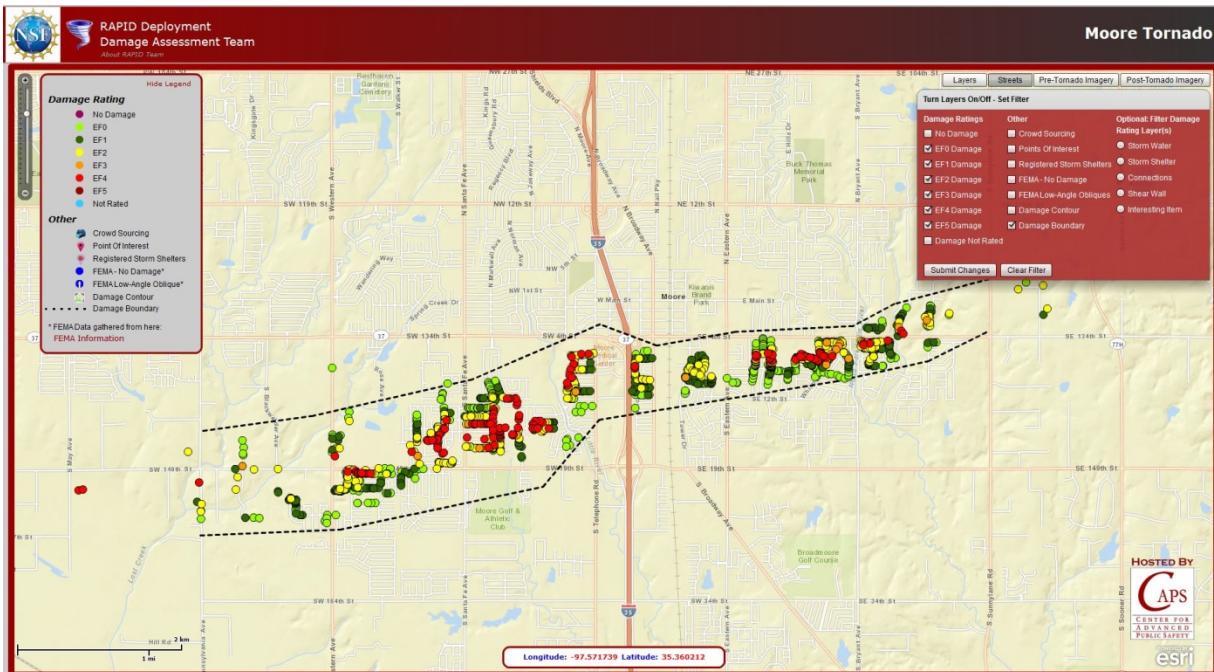
Figure 4.11. GIS-based web portal used for viewing the Moore damage assessment.

To create the GIS shapefiles, the Excel spreadsheet was loaded into ArcMap and the latitude and longitude coordinates of the photographs were used to display the points. The basemaps and aerial imagery collected in the predeployment phase were also loaded into ArcMap. The shapefile of photo locations was loaded into the web portal as well as all collected photographs. Figure 4.11 shows the startup screen of the web portal that includes a legend in the upper left showing the colors corresponding to each EF rating, and a window in the upper right allowing the user to toggle layers and filters on and off. Functionality was programmed into the portal that color-coded inspection points based on the EF rating given to each photograph. Layers were created in the web portal allowing the user to filter desired data on or off. The items

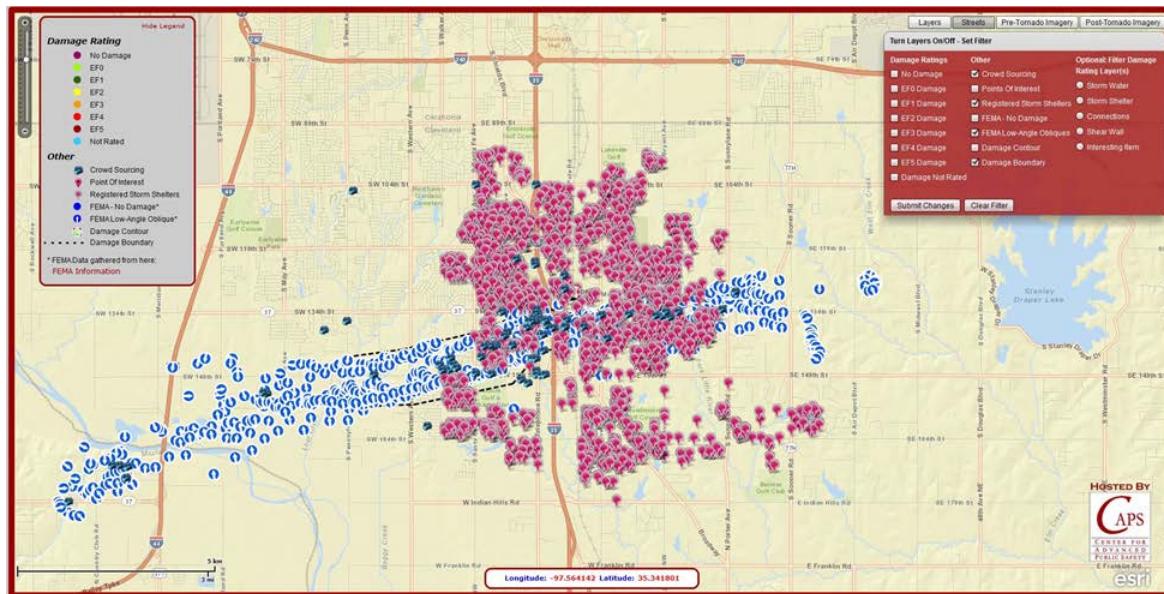
Figure 4.12. The layer data obtained in the post processing phase of the damage assessment. table of contents of the map, layers are drawn from the bottom up. For this reason, the damage boundary is almost unrecognizable because the other three layers are overlaid on top of it on the map. Similarly, the FEMA low angle obliques are displayed under the registered storm shelters,

Crowd sourced photographs were obtained from the social media website Twitter. A fifty five square mile box was created around Moore and every photograph with latitude and longitude data within the box posted to the website from May 21 to May 29 was collected by the Social Media Tracking and Analysis System (SMTAS) at Mississippi State University. Figure 4.12 includes the storm boundary indicated by dashed black lines, registered storm shelter locations indicated by red markers, crowd sourced photographs indicated by camera markers, and FEMA low aerial oblique photographs indicated by blue markers with white arrows. In the

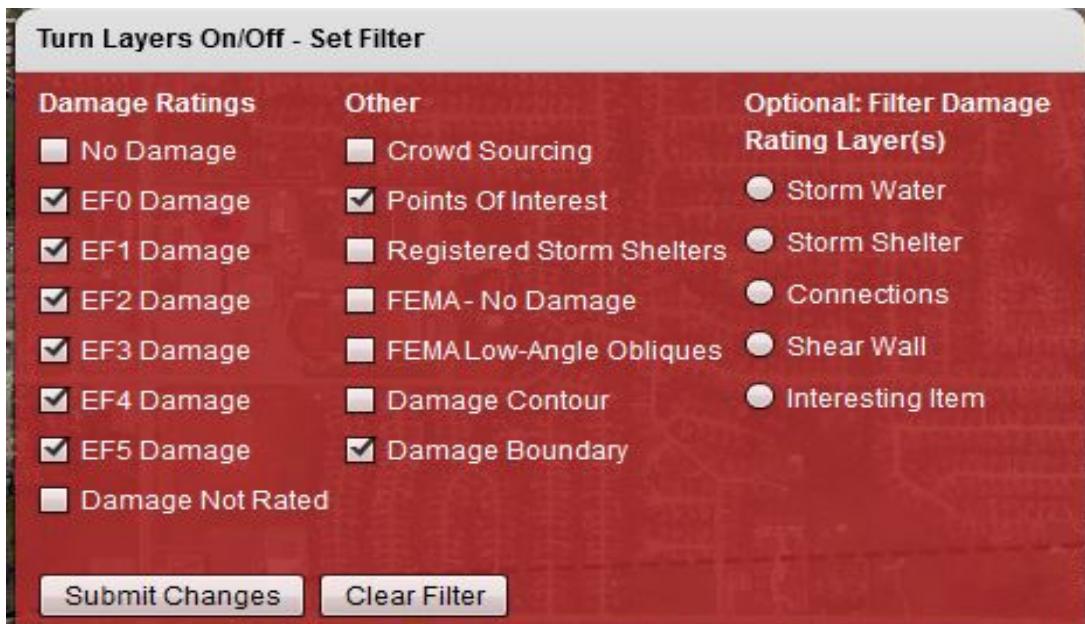
Figure 4.13. Menu of the layers and filters available in the web portal.

which are under the crowd sourced photographs. Figure 4.13 shows the layer and filter menu available on the website. The web portal for the Moore damage assessment is available to the public at [esridev.caps.ua.edu/MooreTornado/MooreTornado.html](http://esridev.caps.ua.edu/MooreTornado/MooreTornado.html).

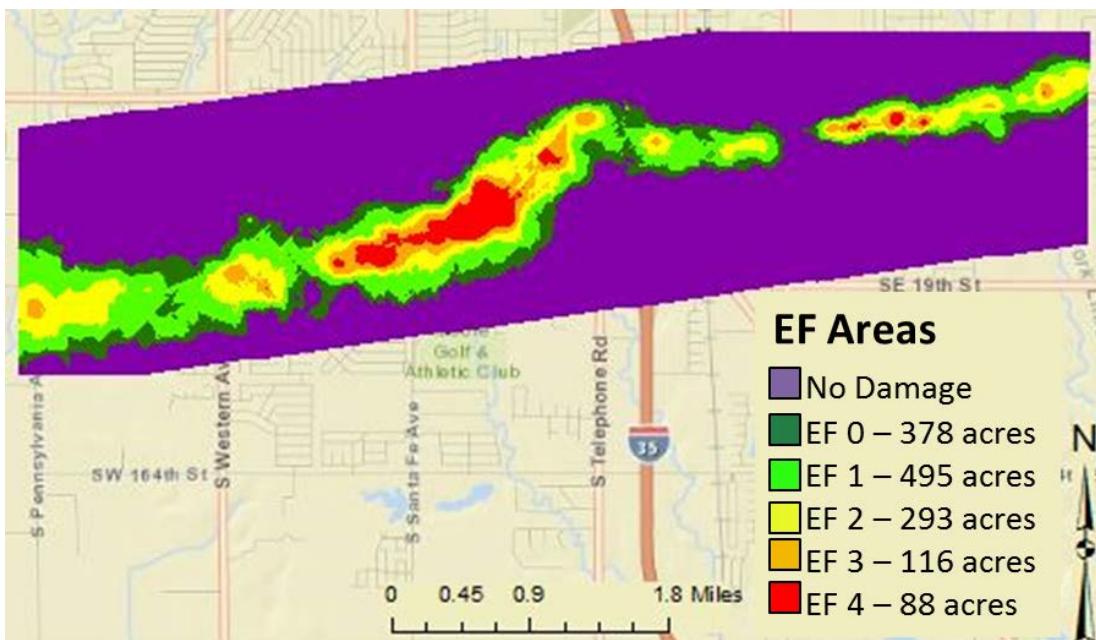
Figure 4.14. Damage contour created for the Moore Tornado.

was computed. Using the geostatistical wizard in ArcMap 10.0, a prediction modeling method called kriging was used to create this damage contour. Appendix B provides a methodology for creating a data contour using GIS tools. Figure 4.14 shows the damage contour for Moore, color coded based on EF rating area. Table 4.2 includes the area of each EF rating and the percentage of the storm each EF rating represents.

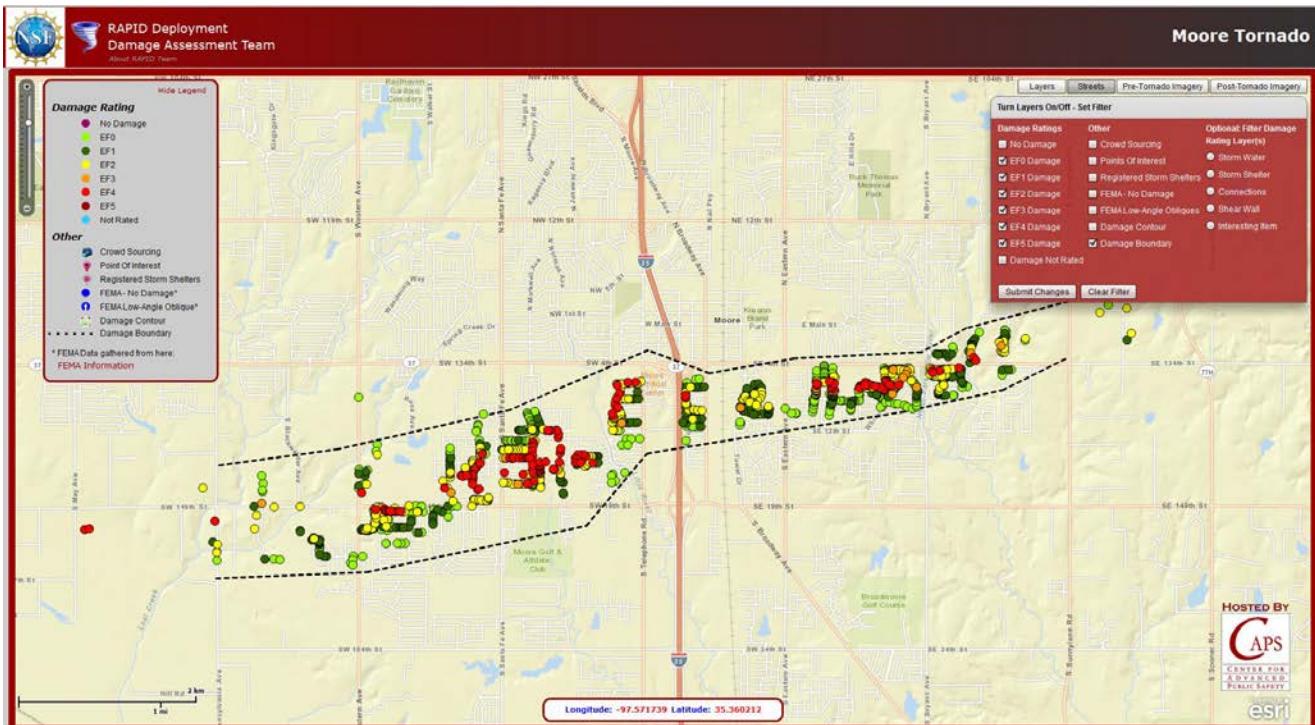
Figure 5.1. Web portal for the Moore, Oklahoma damage assessment.

The results from the damage assessment are contained in the web portal created for Moore, which allows users to toggle basemaps, datasets, and data filters. Figure 5.1 contains the web portal startup screen for the Moore, OK damage assessment. The map legend is located in the top left corner and explains the labels of each point on the map. Figure 5.2 shows the legend of the map. This legend contains the symbology for each data layer in the webmap and a link to the website where the FEMA datasets were collected. The layers and filters dialog box is located in the top right corner and lists all layers and data filters located on the map. This dialog box is shown in Figure 5.3. Boxes next to each layer label allow the user to toggle the layer on or off. Data filters can be toggled on to show the filter data contained only in the layers which are turned on. To show all points associated with a filter, the user can turn all of the layers on and select the filter. Above the layers and filters dialog box are the basemap layer buttons. This contains the streets basemap, pre-tornado aerial imagery basemap, and post-tornado aerial imagery basemap. Only one basemap can be turned on at a time. The zoom bar is located next to the map legend, and allows the user to zoom in or out of the map.

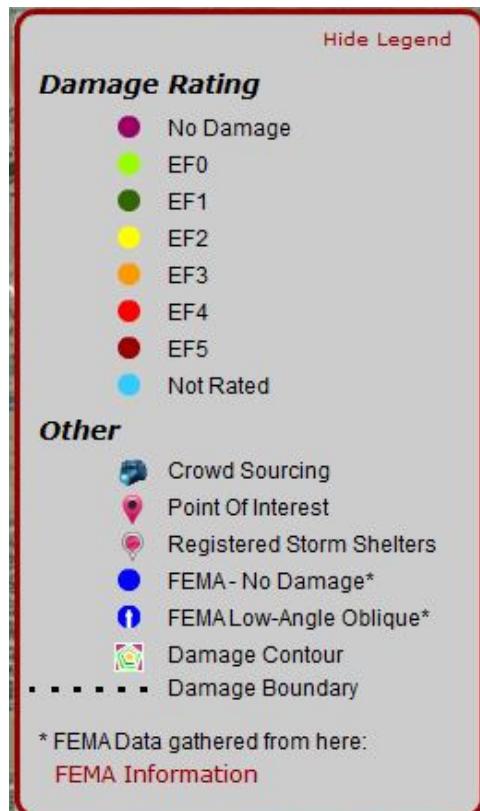
Figure 5.2. Damage assessment map legend containing labels for each layer contained in the map.

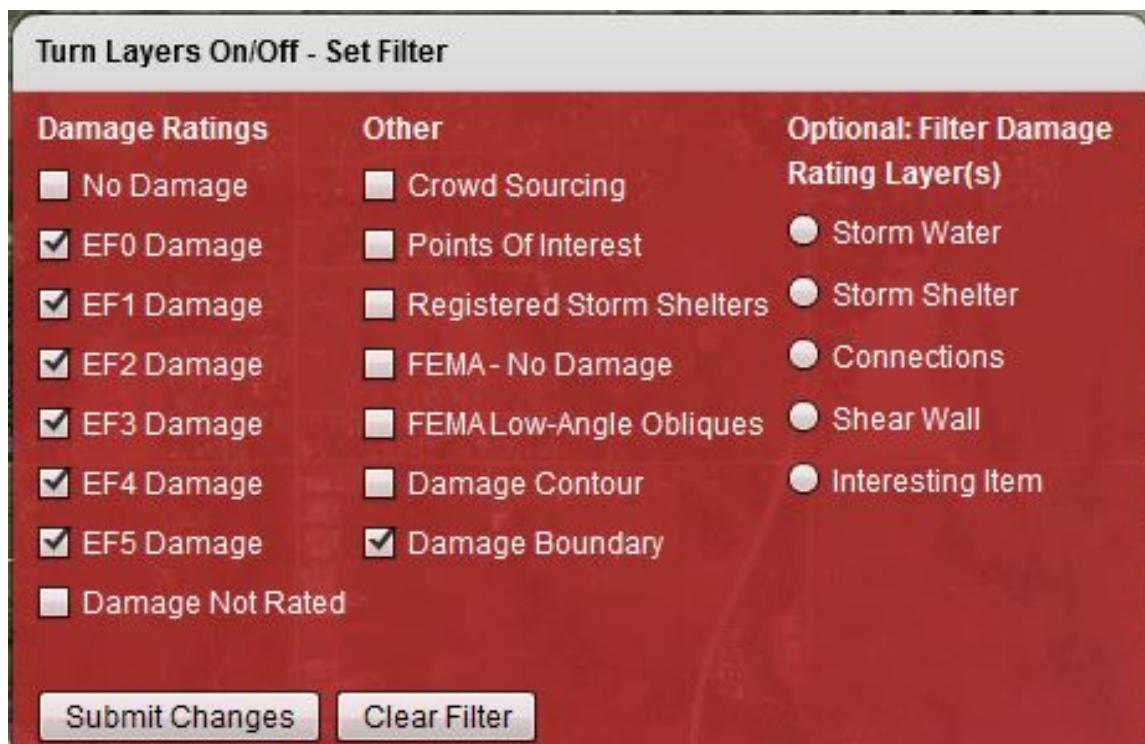
Figure 5.3. Layers and filters available in the damage assessment web portal.

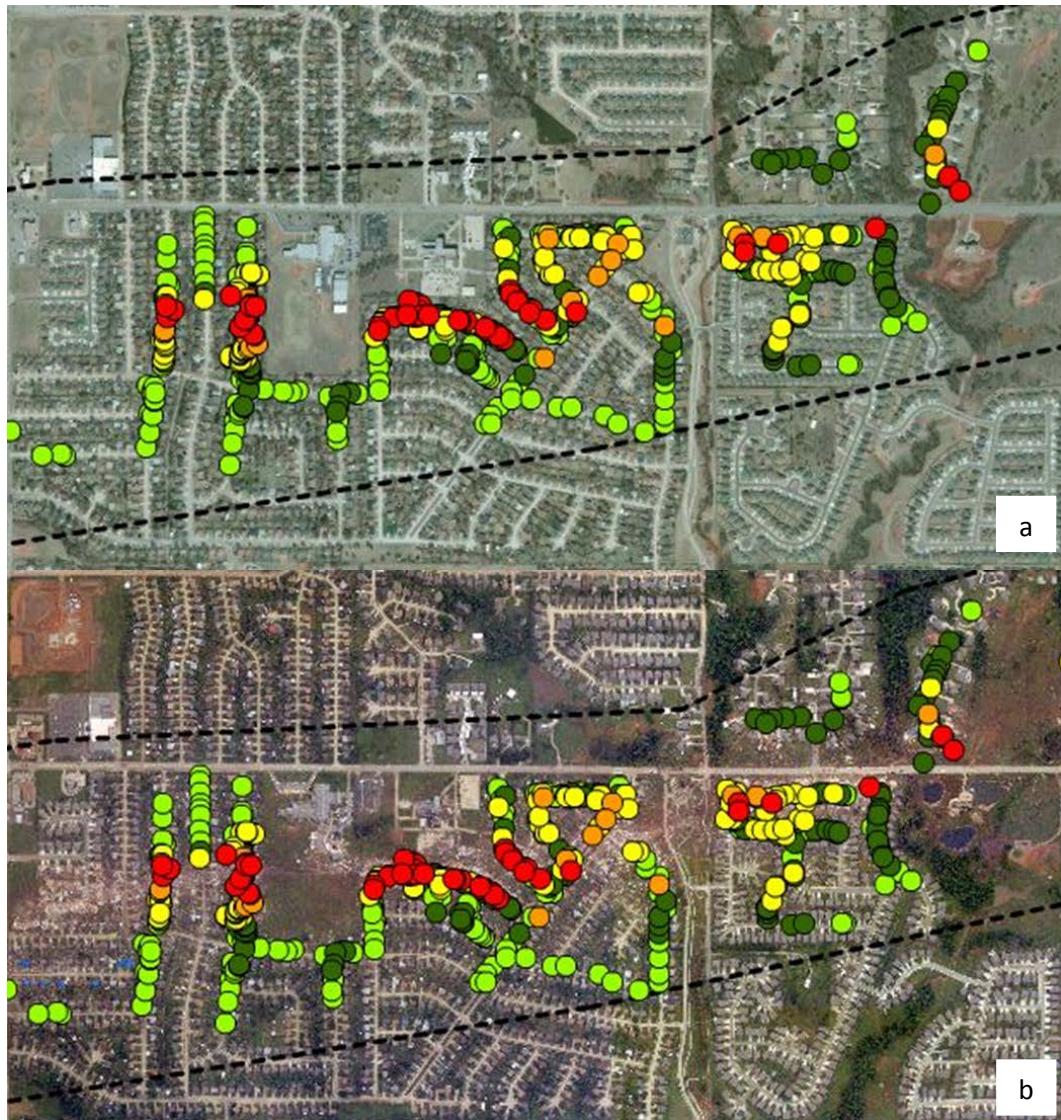
Figure 5.4 basemaps of the city of Moore (a) before the tornado and (b) after the tornado. View shown is zoomed in for resolution.

The pre- and post-tornado basemaps are useful for comparing damage from an aerial view. The pre- and post-event basemaps of the damaged area with the startup layers displayed on top of the basemaps are shown in Figure 5.4 (a) and (b) respectively. Aerial imagery datasets are limited in showing vertical surfaces of damaged buildings and street-level photography datasets are limited in showing many roofs. The combination of basemaps and collected photography offers simultaneous views of aerial and street-level damage caused by the storm which is important for researchers studying the damage.

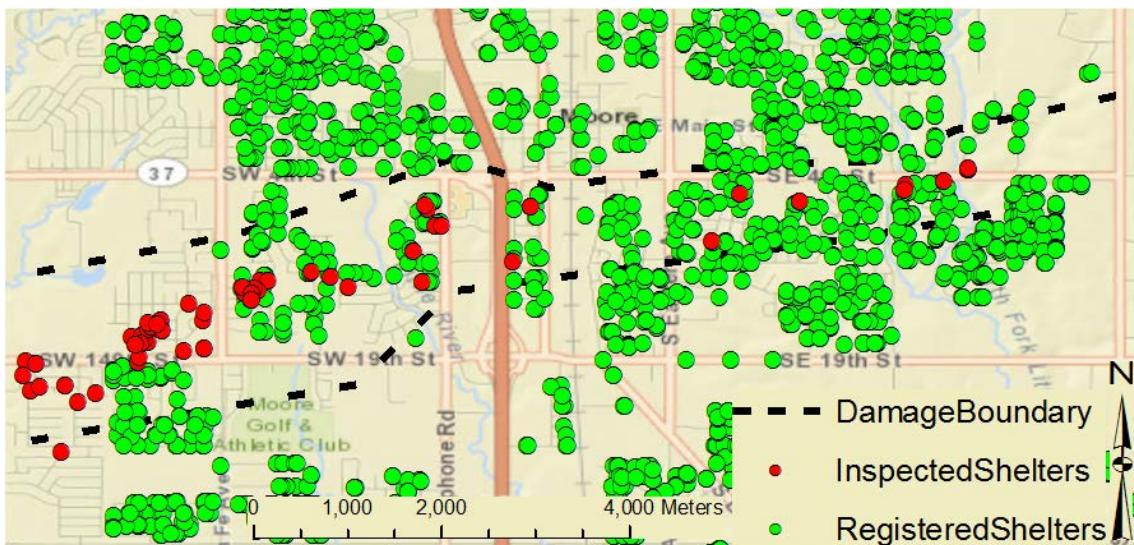
Figure 5.5. GIS map of storm shelters in Moore containing both the layer of inspection photographs taken of storm shelters as well as the layer of registered storm shelters.

Figure 5.5 shows this view of the web map. The research team found that storm shelters saved

lives in many areas of Moore. Many shelters were found in the EF-5 level areas where the damage was most severe. Houses were completely leveled in this area, but the shelters were left intact. One shelter was found in Moore that failed. The shelter was built above ground and was perforated by flying debris. Figure 5.6 shows the photograph of the inside of this storm shelter and the debris that caused the perforation. Research determined that the shelter was not built to FEMA standards and was also located on the outer wall of the house, which is not an ideal location for an above-ground shelter. The result of this research topic suggests that storm shelters have been shown to save lives in these powerful tornadoes.

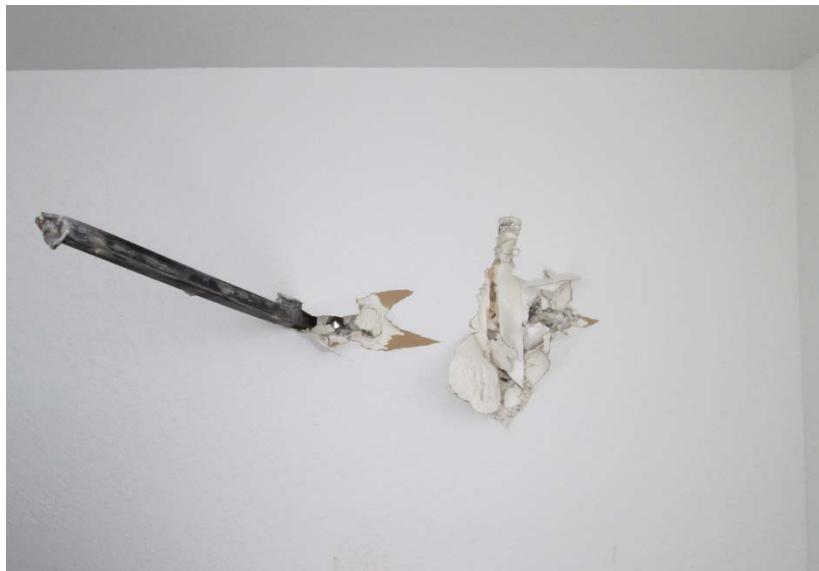
Figure 5.6. Above ground storm shelter in Moore that was perforated by flying debris.

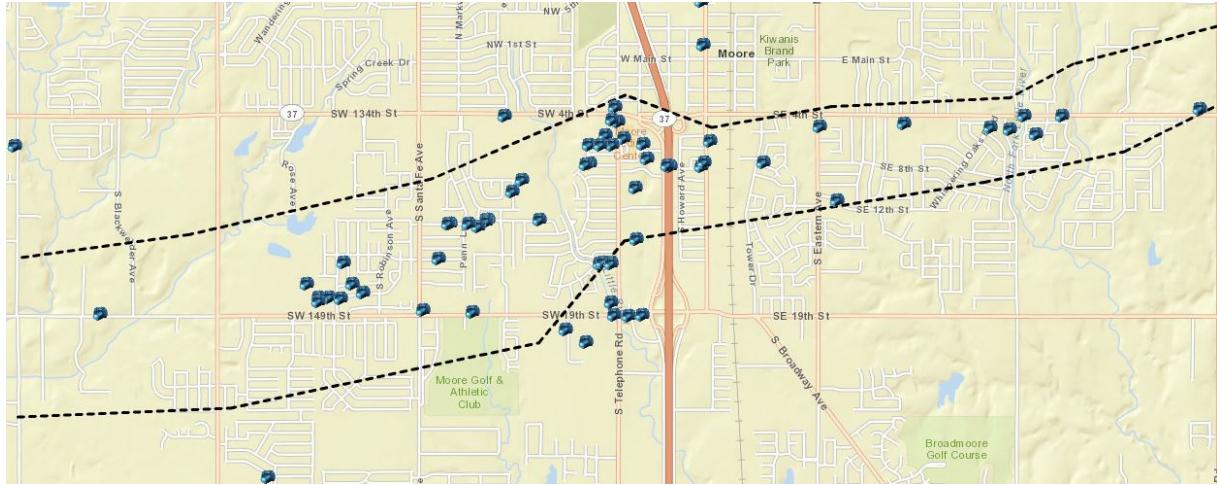
Figure 5.7. Crowdsourcing locations for photographs obtained from Twitter following the Moore damage assessment.

Crowdsourcing photography was a research topic for the Moore damage assessment and research on this topic included how inspectors can leverage these sensors in the damage area which provide temporal damage photography to automatically collect data before researchers can access the affected area. The research suggests that contacting social media websites, such as Twitter in the case of the Moore damage assessment, can allow researchers to collect photographs from a specified area surrounding the disaster. Processing the data to filter out photographs which are not useful for research, it was found that this data can be acquired and added as a layer to the web portal. This offers preliminary views of damage which can guide planning and offer research topics before the team enters the damaged area. Figure 5.7 shows the photographs collected from Twitter in the web portal.

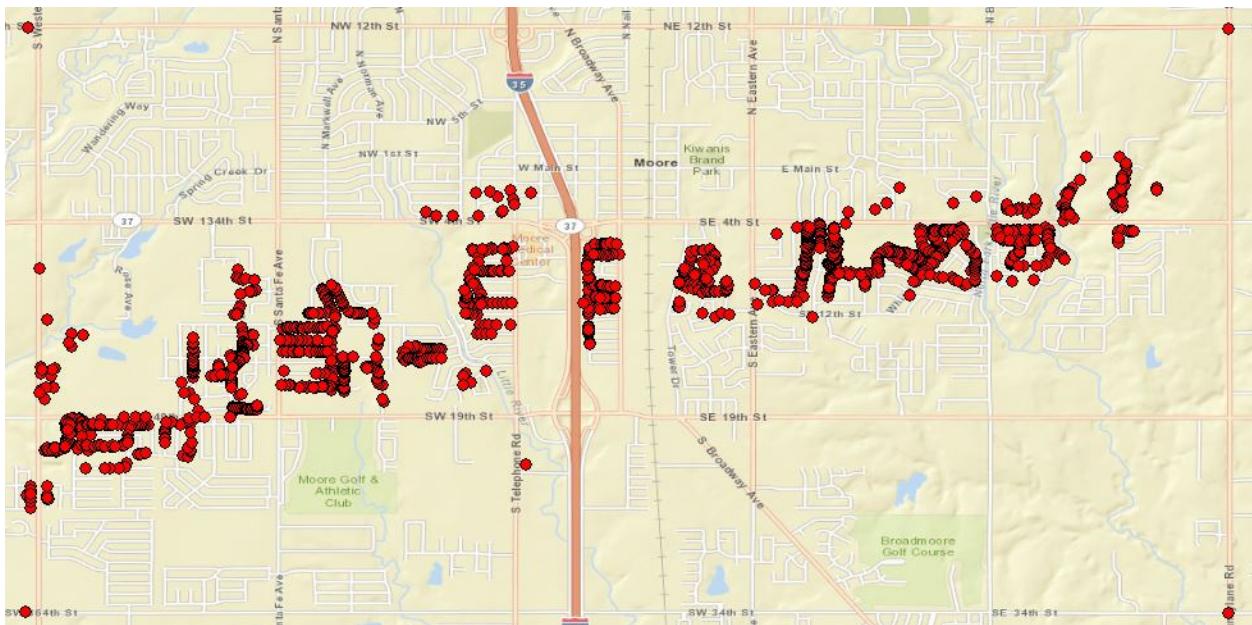
Figure B.1 Collected photographs from the Moore, OK damage assessment. Points labeled “No Damage” have been added at the desired extents of the damage contour.

1. Load the layer of inspection data into GIS and display the location. Remove any points in this layer that were not rated based on the scale desired for the contour. Add points where the extents of the contour are desired. These points should be labeled as “No Data”. When this step is completed, the map should look like Figure B.1.

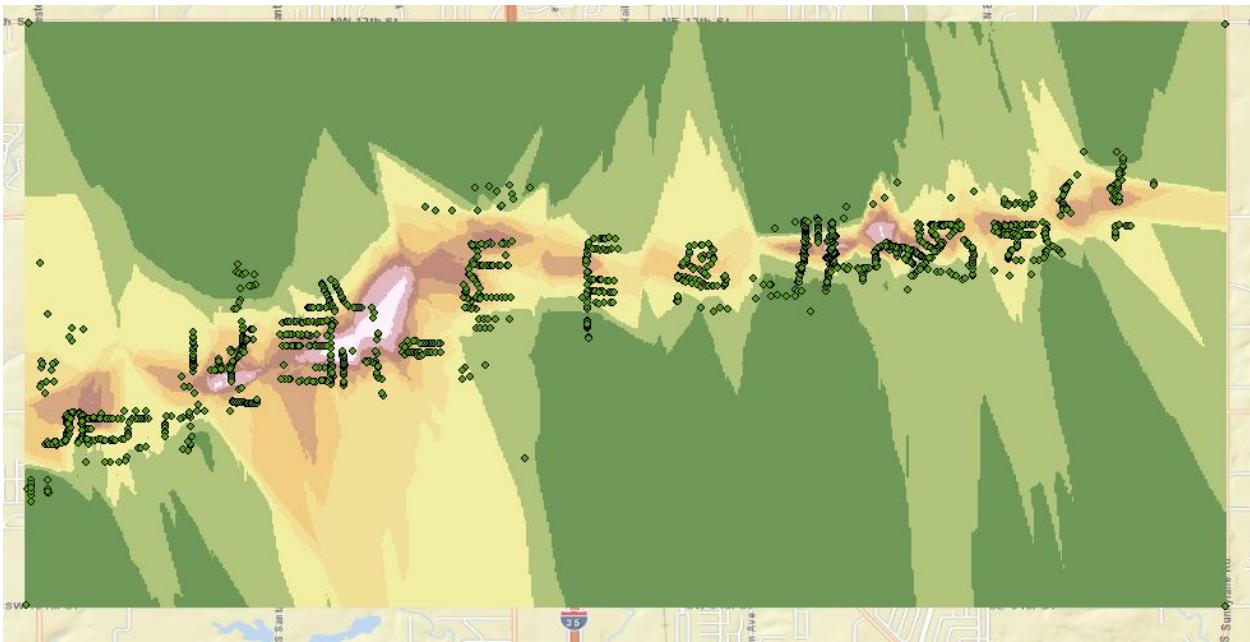
Figure B.2. The raster interpolation created by the Kriging tool. The raster data will need to be processed in order to get an accurate contour.

3. In the output cell size field, select the size that each cell in the raster should be. This sets the resolution of the raster, and allows the user to easily calculate the area of each damage rating. For the Moore damage assessment, a cell size of 15 ft was specified. The cell value is measured in the units specified on the map. If the map units do not match the desired units, the map data frame can be set in the correct units.
4. There are options to hone the semivariogram as well as the search radius. For this methodology, the preset values are acceptable. Click OK.
5. A raster will appear on the map, but will look very inaccurate. Figure B.2 illustrates what the raster looks like after the kriging tool has been used.
