METHODOLOGY FOR A GIS-BASED DAMAGE ASSESSMENT  
FOR RESEARCHERS FOLLOWING  
LARGE SCALE DISASTERS

A THESIS

Submitted in partial fulfillment of the requirements  
for the degree of Master of Science  
in the Department of Civil, Construction, and Environmental Engineering  
in the Graduate School of  
The University of Alabama

2014

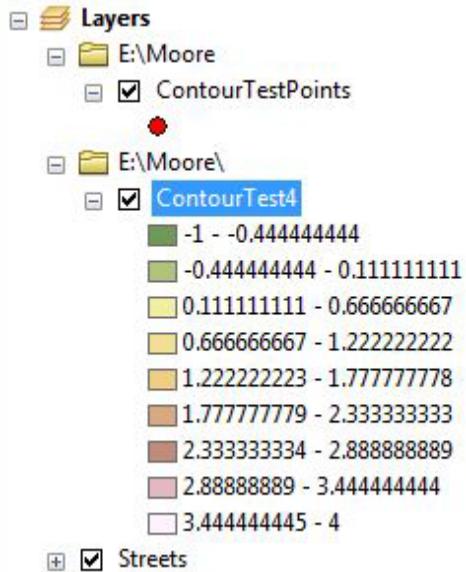
Figure B.3. Table of Contents containing the streets basemap, the collected points, and the raster output from the Kriging tool.

6. In the Table of Contents, the raster is shown along with the classifications and ranges within each classification. By manipulating these classes and ranges, the contour can be corrected. Figure B.3 shows the output classes and ranges from the Kriging tool.

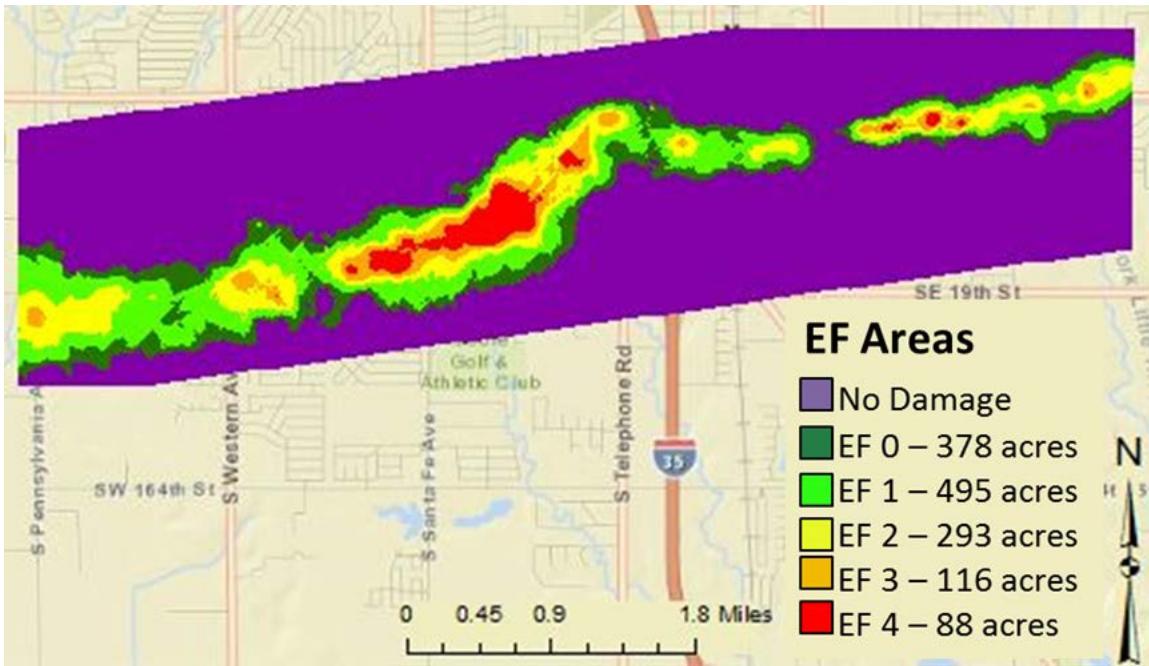
Figure B.4. Final damage contour for the Moore, Ok damage assessment.

12. The clip tool requires an Input Raster to be selected. Select the damage contour raster. In the Output Extent box, select the polygon shapefile created in Step 11. Select the Use Input Features for Clipping Geometry button. This button creates a new raster bounded inside the polygon. Name the new raster in the Output Raster Dataset field. Select OK. The new raster is created. Steps 7-10 will need to be repeated in order to correct the new raster. Figure B.4 shows the final Moore, OK damage contour with area values corresponding to each EF value and clipped to a desirable size.
