END ZONE DESIGN FOR ALABAMA
DEEP PRESTRESSED GIRDERS

A THESIS

Submitted in partial fulfillment of the requirements
for the degree of Master of Science
in the Department of Civil, Construction, and Environmental Engineering
in the Graduate School of
The University of Alabama

2016

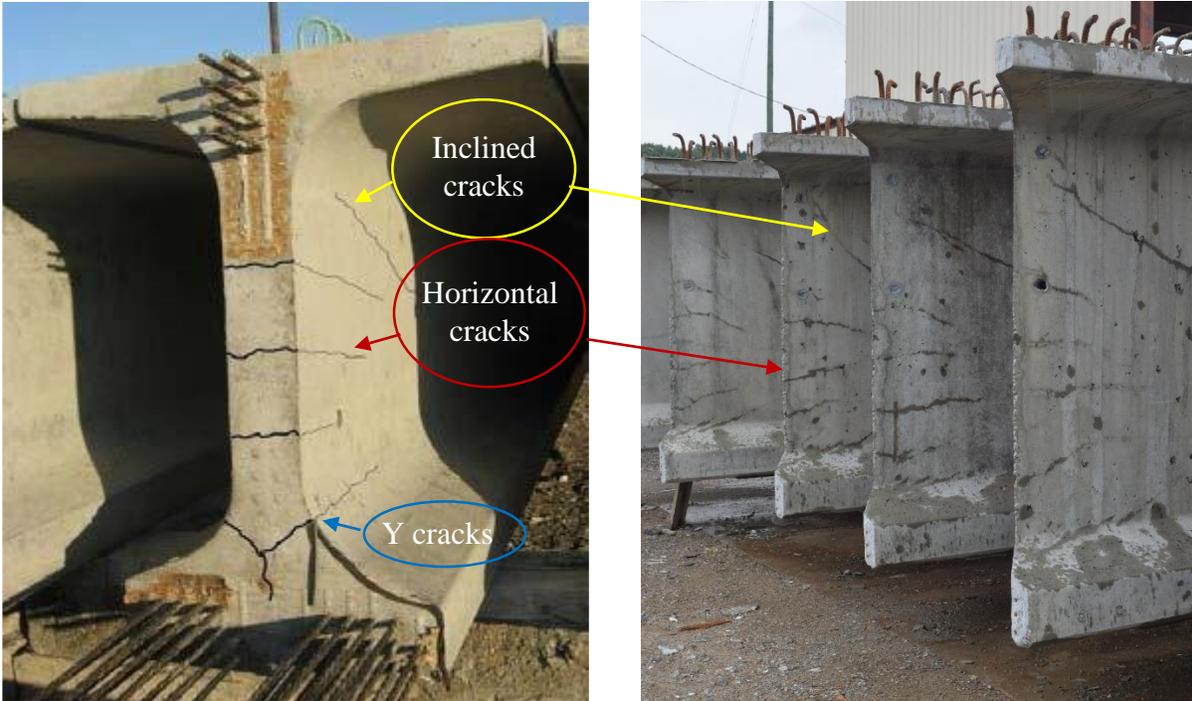
a) WisDOT 54W girder in storage yard (Oliva & Okumus, 2011)

Figure 1-1 Typical end zone cracks in pretensioned girders

As shown in Figure 1-1, three characteristic crack types have been identified in girder end zones: horizontal cracks over the web depth, splitting “Y” shaped cracks at the bottom flange-web interface, and inclined cracks that run parallel to draped strands in the top of the web. The consequences of these cracks are concerning. Since the cracks naturally form near the location of prestressing strands, they open up a direct path for moisture and corrosives to reach the strands. This results in strand corrosion, concrete spalling, and eventually a reduction in the flexural and shear load resisting capacity of the member by interrupting the bond between the strands and the concrete. Excessive cracking in the end zones require the fabricators to epoxy inject the cracks or, in some severe cases, even reject the girder.

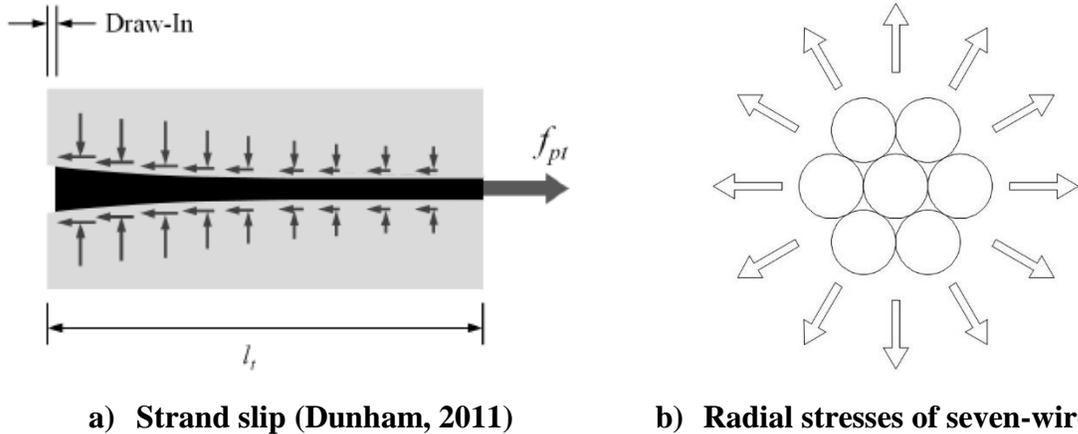
a) Strand slip (Dunham, 2011)

Friction, the second mechanism, plays a large role in creating transfer bond stress at the strand-concrete interface. This mechanism is a product of the Hoyer Effect. As a prestressing strand is pulled in tension the strand elongates, causing the diameter of that strand to simultaneously decrease. This principle, known as the Poisson Effect, helps explain what occurs after the strands are released from the abutments of the prestressing bed. Through the curing process, concrete hardens around the pretensioned strand. When the concrete has reached a desirable release strength, the strand is cut and tends to naturally shrink back to its original length, causing the diameter to increase. The hardened concrete inhibits the strand from returning to its original size, thus the transfer of mechanical stress from the strand to the concrete is manifested in a radial fashion around the strand. The Hoyer Effect is a key contributor to transfer bond stress as it creates frictional resistance between the concrete and the strand. The Hoyer Effect can be visualized in Figure 2-1.

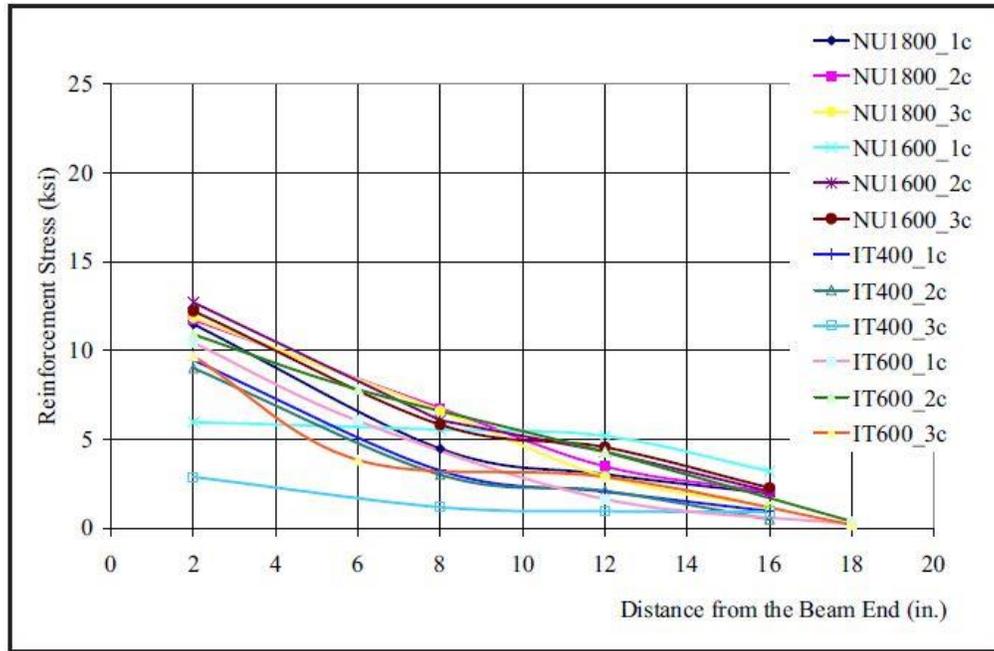
Figure 2-2 Variation of Maximum Steel Stress in the End Zone, (Tuan et al., 2004)

Phase II involved the design of new end zone details based on information learned in Phase I. Three criteria were followed in the new design: 1) the end zone reinforcement was concentrated as close as possible to the girder end since this was the location susceptible to the highest splitting forces, 2) a working design stress of 20 ksi in vertical reinforcement was used, and 3) special vertical reinforcement was implemented within a distance of $h/8$ from the girder end, while the remainder of the vertical reinforcement was distributed as required for the critical shear section. The results of Phase II demonstrated that the new end zone reinforcement design improved the efficiency of the steel placement while reducing the quantity of steel used. The Phase II experiment confirms that in order to reduce the strain in steel and the concrete cracking it is necessary to use a large area of steel as close to the girder end as possible. The strain in the vertical bars within the Phase II I-girders followed the same trends as in Phase I. While the maximum stresses in these bars varied between 0.4 and 25.8 ksi, the strain was highest towards the girder end and decreased rapidly as the distance from the girder end increased. The variation of the maximum vertical reinforcement stress in the end zone can be seen in Figure 2-2. The measured crack widths and lengths in Phase II of the study were smaller than those in Phase I. The Gergely-Sozen (1967) method of analysis was used to predict crack locations after Phase II testing. This method proved to be an effective predictor of crack locations.

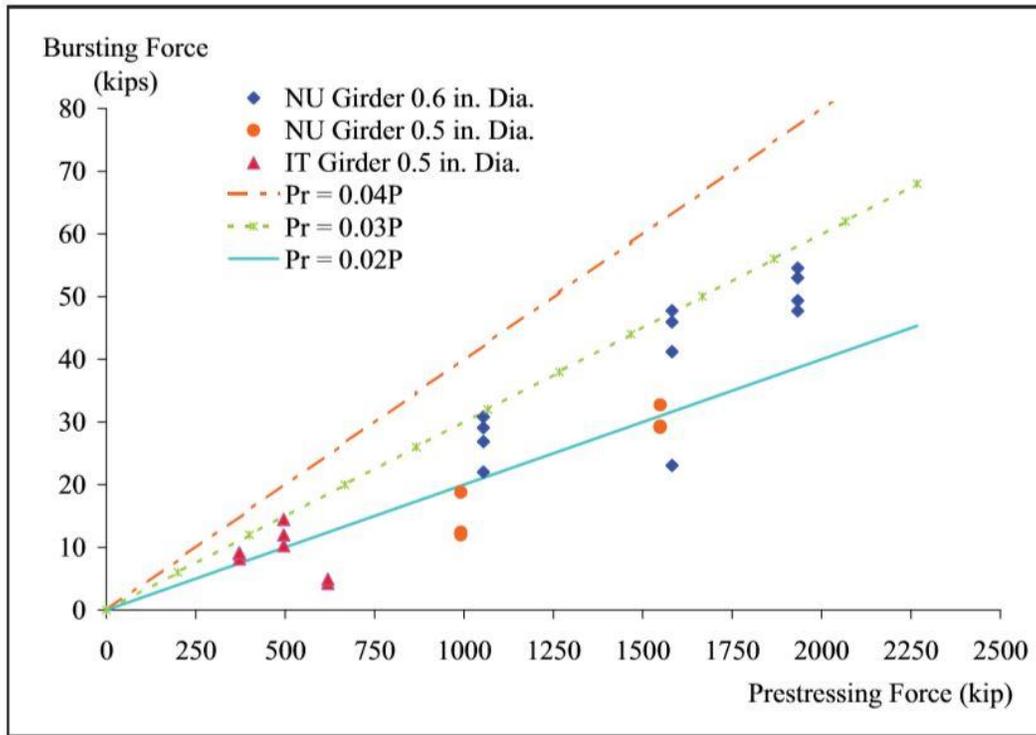
Figure 2-3 Relationship between splitting force and prestressing force, (Tuan et al., 2004)

The ratio of the splitting force to the prestress force in Phase II testing ranged from 0.69 to 3.02 percent. The maximum measured splitting force of 3.02 was significantly under the required AASHTO standard which mandates that the splitting force be designed for 4 percent of the total prestress force. The relationships between the splitting force and the prestressing force for the girders studied in this project can be seen in Figure 2-3. Considering the data gained from the Phase II testing, the authors suggest that the current AASHTO recommendations of 4 percent splitting force could be an overly conservative estimation when the steel is concentrated very near the end of the member. Instead, the authors suggest that a pair of very large bars, designed for 2 percent of the prestress at a stress level of 20 ksi, be placed near the end of the girder to control the splitting cracks. The remaining balance of the prestressing force is recommended to be distributed across the critical shear section. The authors also proposed an alternative design of

distributing the splitting force of 4 percent along a distance of $h/2$ from the girder end with 50 percent of that force placed within a distance of $h/8$ of the girder end.

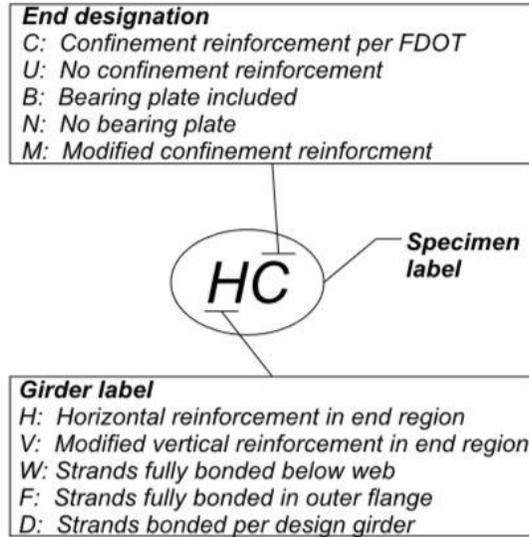
Figure 2-4 FIB-54 labeling scheme (Hamilton et al. 2013)

FDOT: Detailed per FDOT design standards
Mod: Detailed with modifications to FDOT design standards
Web: Fully bonded strands placed below web (24 fully bonded strands)
Flange: Fully bonded strands placed in outer portion of flange (24 fully bonded strands)
Design: Strand pattern based on prototype design (45 fully bonded strands)

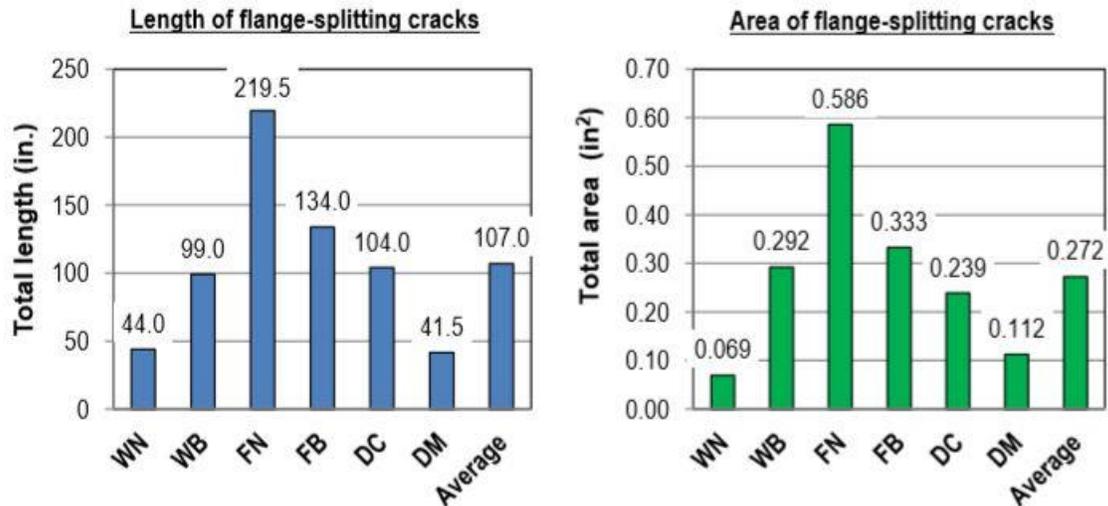
Figure 2-5 Flange splitting cracks in girders W, F, and D (Hamilton et al. 2013)

The length and area of the bottom flange cracks are represented in Figure 2-5. The most severe cracking occurred in specimens FB and FN. The severity of these cracks is likely due to the presence of fully bonded strands in the outer flange. The transverse tension created by these fully bonded outer strands is likely responsible for the large lengths and areas of these cracks.

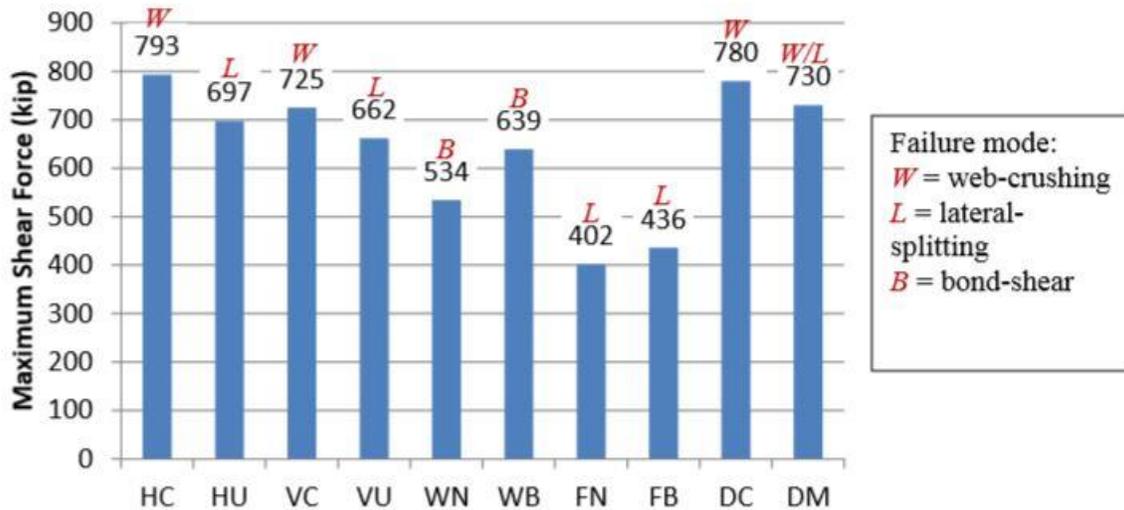
Figure 2-6 Peak shear forces and failure modes (Hamilton et al. 2013)

For the second portion of the FIB-54 test program, the girders were loaded to failure. Three distinct failure modes were reported during load testing: lateral splitting failure, bond-shear failure, and web-crushing failure. The highest peak shear force, at 793 kips, was observed in specimen HC, while specimen FN, at 402 kips, produced the lowest peak shear force. Bond-shear failure occurred only for the W girders which contained strands fully bonded below the web. Through the use of strain gauges during load testing, it was estimated that transverse forces of up to 100 kips were present in the bottom flange of specimens H and V. The peak shear forces and failure modes of each specimen can be seen in Figure 2-6.

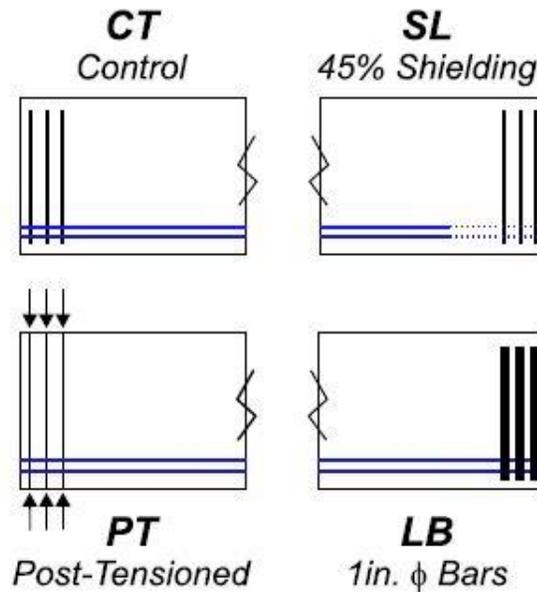
Figure 2-7 BT-63 end zone designs (Hamilton et al. 2013)

The girders were both fabricated at a length of 49.5 feet. The full span of girders with the same cross section are typically upwards of 125 feet. The specimens each included 52 0.6-inch diameter prestressing strands in the bottom flange and four 3/8-inch diameter tie strands in the top flange. Since the specimens would be tested to failure in a laboratory, they were fabricated without a top deck in order to reduce the load required in testing. The specimens were loaded in 3-point bending and instrumented to collect load, displacement, strain, and strand-slip data during testing.

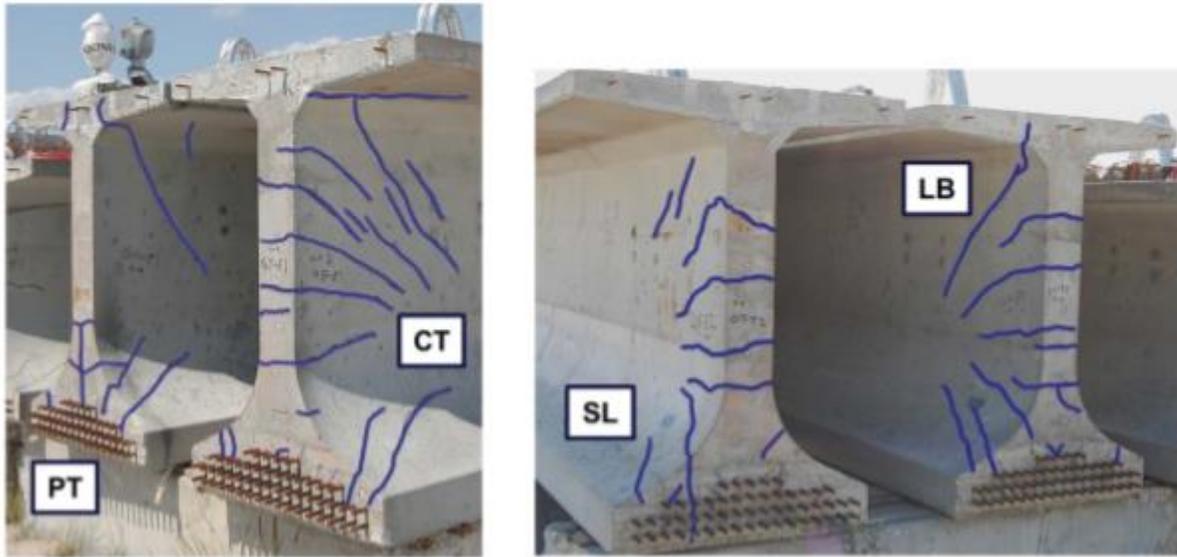
Figure 2-8 FIB-63 cracking after prestress transfer (Hamilton et al. 2013)

smaller average width than specimen CT. The success of specimen SL is attributed to the reduction of tensile stresses, caused by partial debonding. Specimen PT was the most effective specimen in controlling web splitting crack length with 50% less length than specimen CT. Cracking on the FIB-63 specimens after prestress transfer can be seen in Figure 2-8.

The high diagonal cracking in specimen PT, which can be seen in Figure 2-8, are believed by the authors to have been caused by forces introduced at the bearing plate of the vertical post-tensioning system. This crack was the greatest crack width and largest average web crack width, at 30% greater than that of specimen CT. The average and maximum crack lengths and areas were recorded for each specimen and can be seen in Figure 2-9 and Figure 2-10.

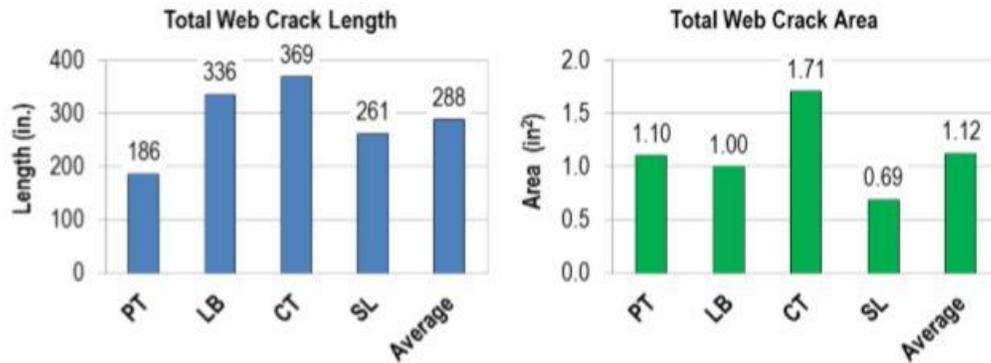
Figure 2-9 FIB 63 web splitting crack length and area (Hamilton et al. 2013)

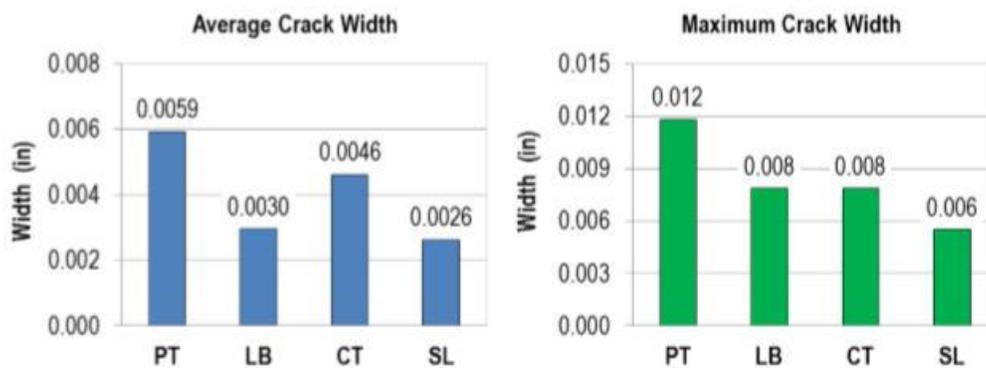
Figure 2-10 FIB 63 web splitting crack widths (Hamilton et al. 2013)

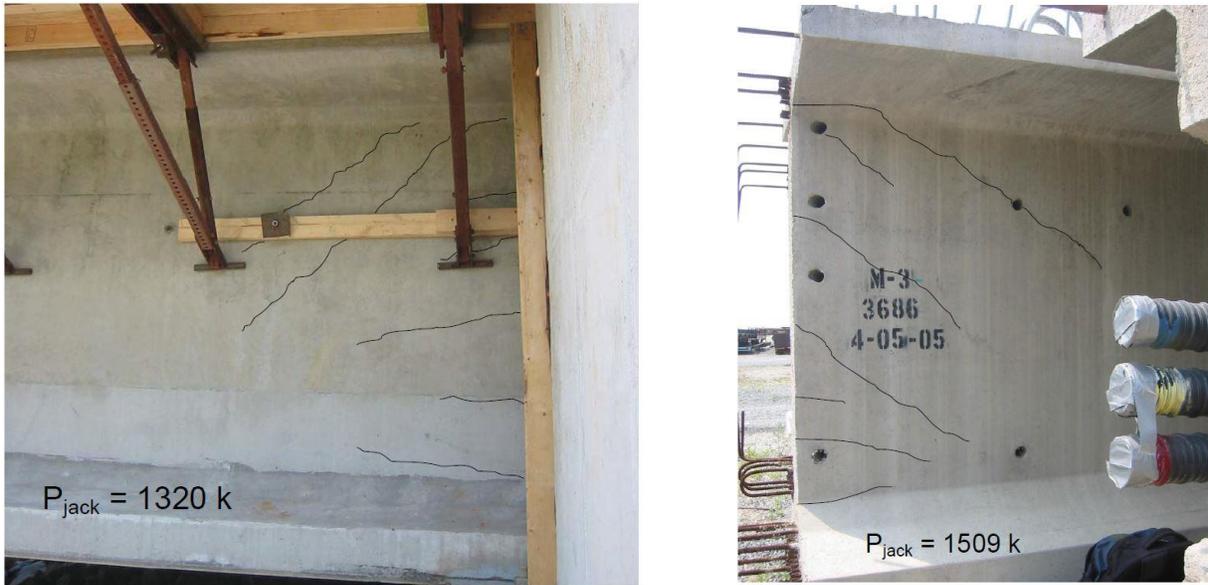
Figure 2-11 Examples of end zone cracking in PCBT-77 girders (Crispino, 2007)

Through the investigation of a variety of recently cast VDOT PCBT girders at a Virginia precast plant, the research team was able to notice trends in the end zone cracking of the girders. The girders ranged in depth from 37 in. to 93 in. Horizontal cracks in the girder ends typically developed at the bottom flange-web interface and extended up to 25 percent of the girder height. Examples of the investigated girders can be seen in Figure 2-11. Diagonal cracks typically developed inches from the beam end and extended up to 75 percent of the girder height. Cracking occurred most frequently in deeper beams while smaller beams usually performed better when designed to AASHTO LRFD standards. Girders with more reinforcement in the end zone usually contained less cracking, however, diagonal cracking in some of these girders was still observed.

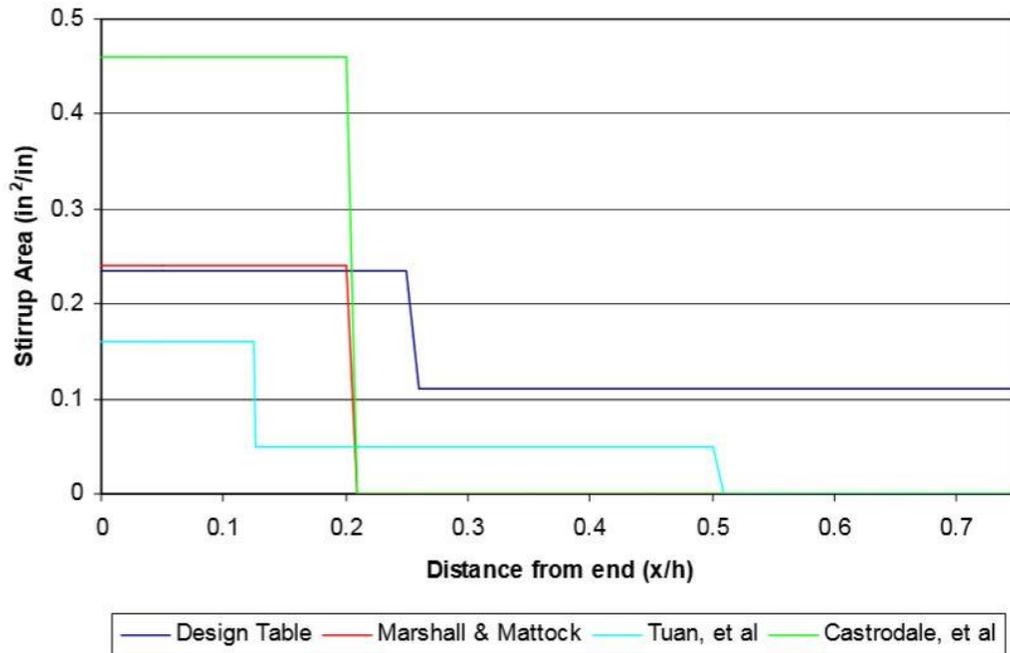
Figure 2-13 Design method comparison, PCBT-77, NWC, 34-0.6 in. strands (Crispino, 2007)

The research team used the strut-and-tie model to create design aids for VDOT girders based on cross-sectional size. The design aids were used to convert the results from the strut-and-tie models into area of reinforcement needed. The design model was then compared to other recommendations from Marshall & Mattock (1962), Tuan (2004), and Castrodale & White (2002). These comparisons can be seen in Figure 2-13.

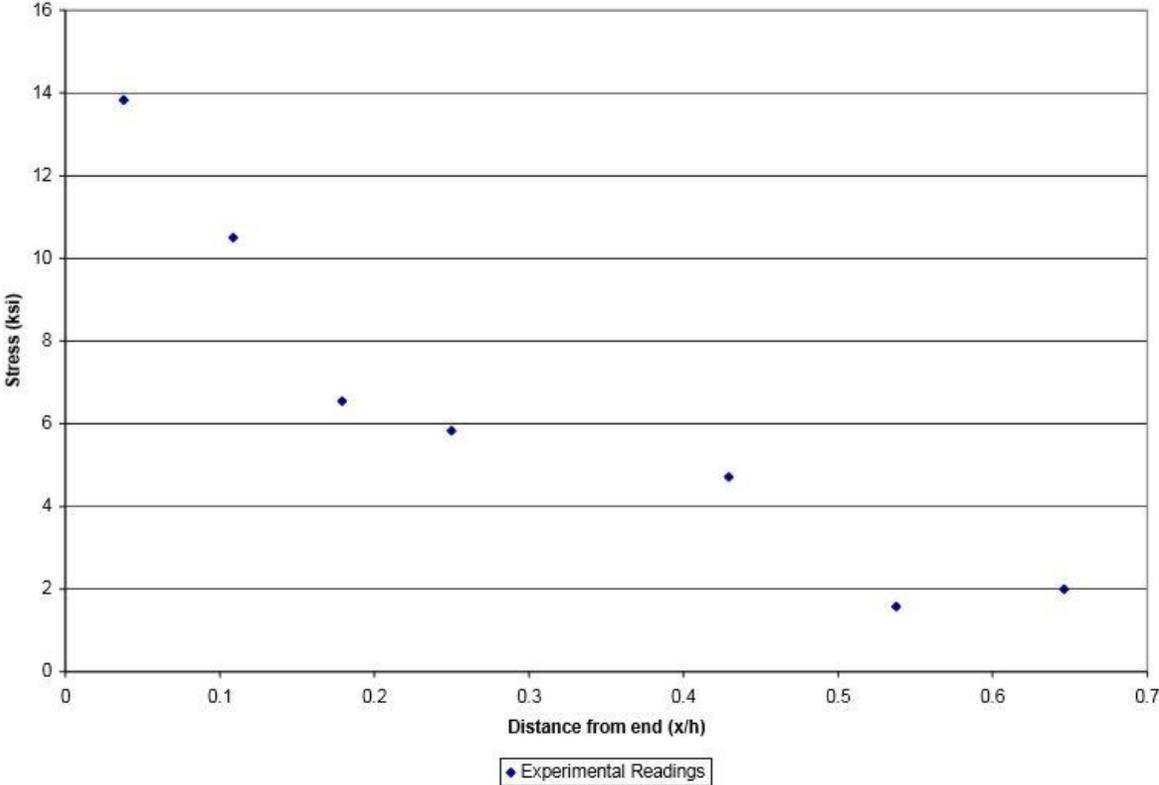
Figure 2-14 Distribution of tensile stress in 12 ksi end zone (Crispino, 2007)

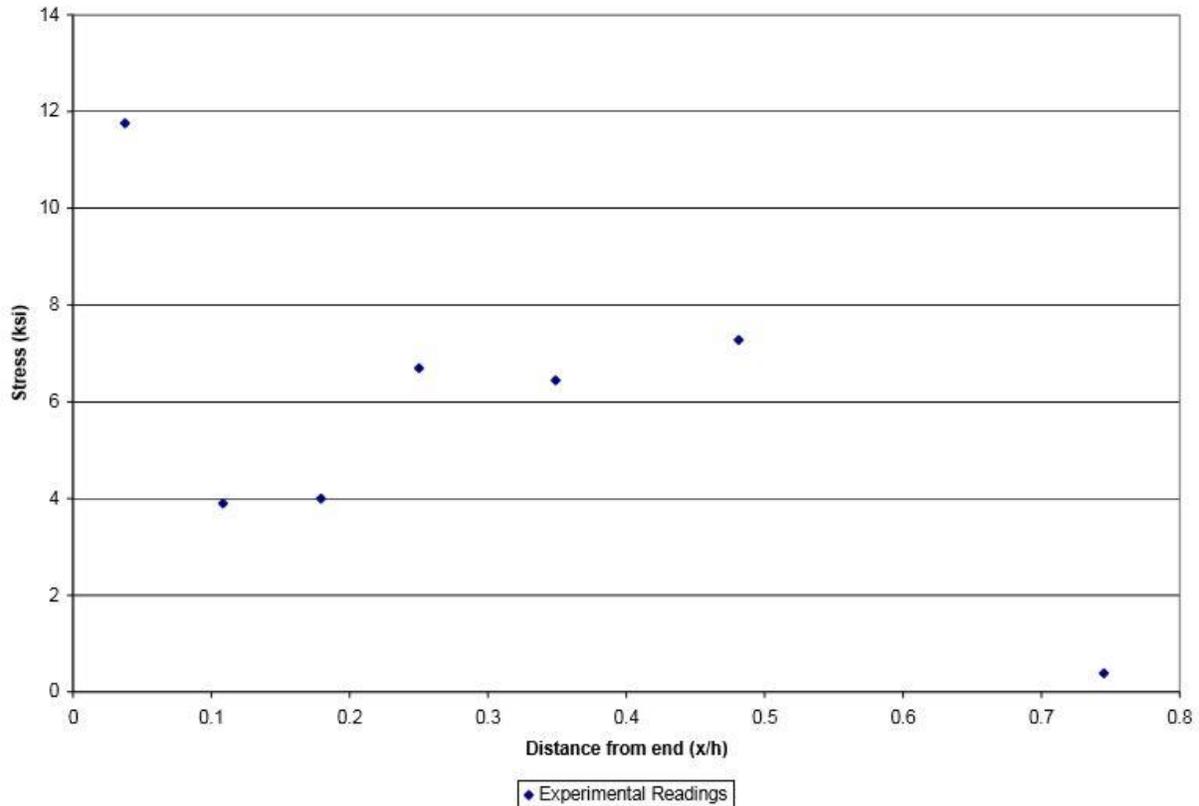
Figure 2-15 Distribution of tensile stress in 18 ksi end zone, (Crispino, 2007)

measured stress in the bars was approximately 12 ksi in the end zone designed for an 18 ksi working stress, as shown in Figure 2-15.

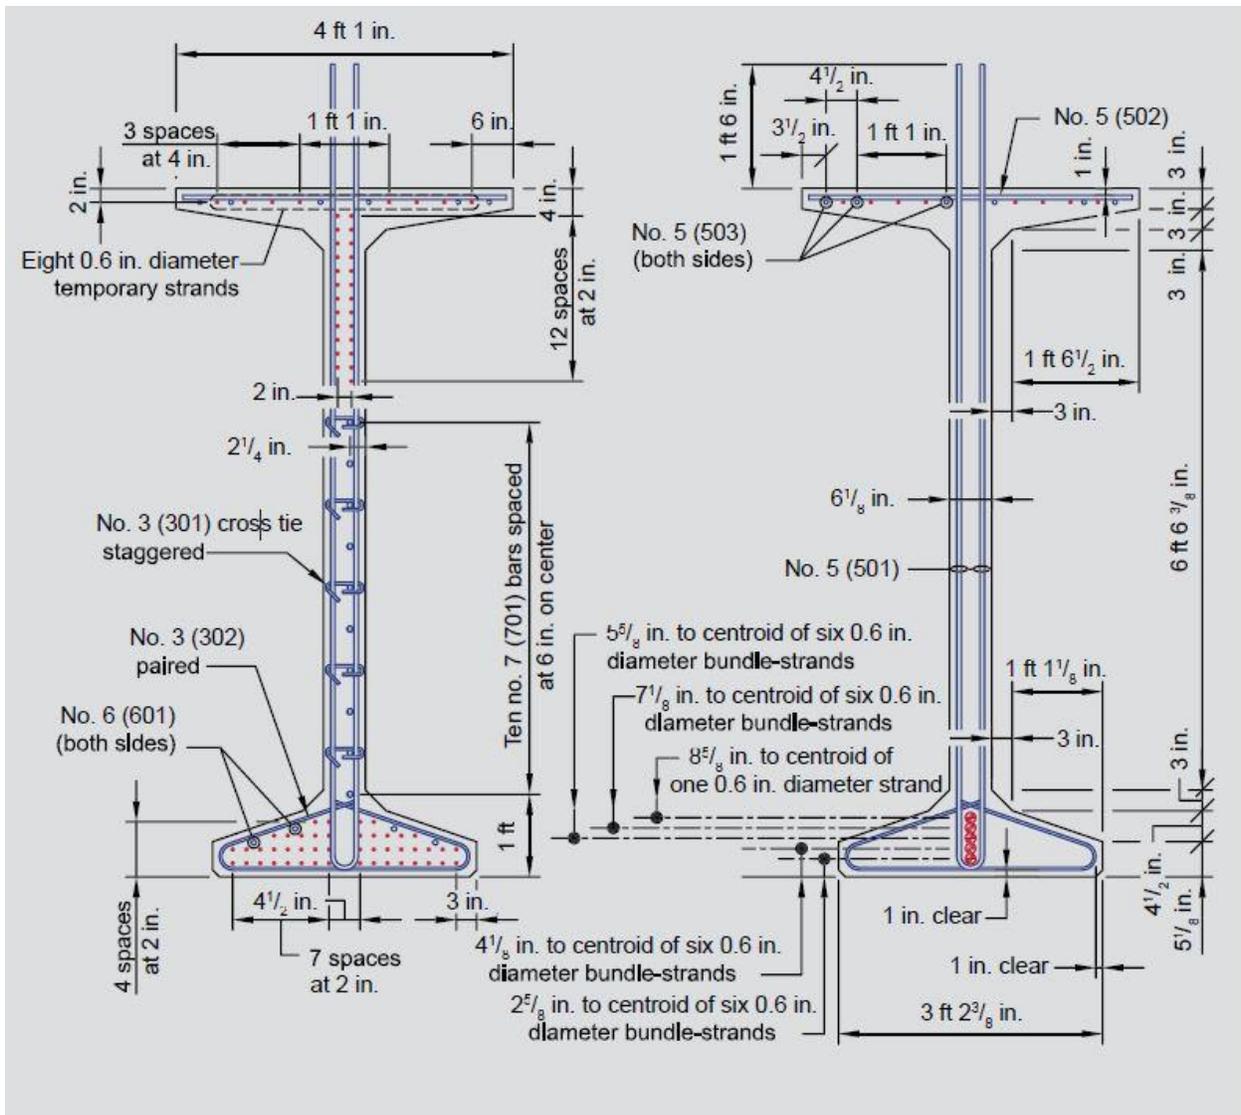
Figure 2-16 Typical cross section details of WF100G (Arab et al., 2014)

The WF100G girders, which each spanned 205 ft, were pretensioned with eighty 0.6 in diameter strands, 26 of which were harped. The pretensioning force was gradually released through the use of hydraulic movable abutments. The girders were lifted at points 8 ft from the ends during prestress release to remove friction forces between the girder and the casting bed. The typical cross-section details can be seen in Figure 2-16. The longitudinal profile including end zone details is shown in Figure 2-17.

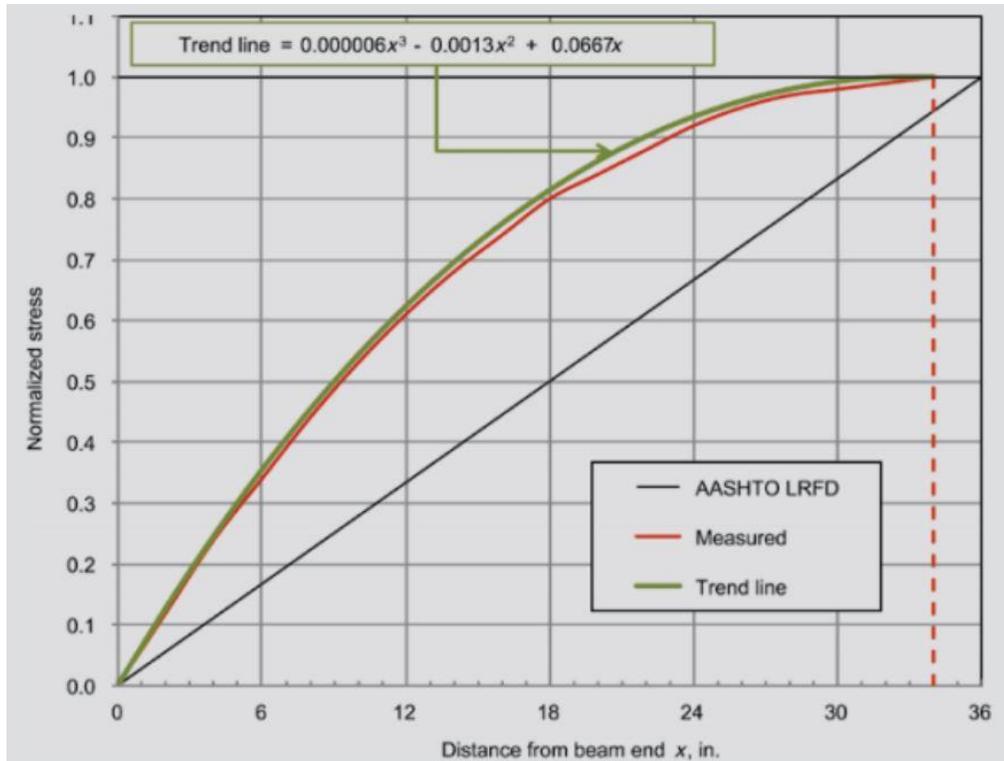
Figure 2-18 Measured strand stress in WF100G girders (Arab et al., 2014)

measured at approximately 34 in. from the girder end, indicating that the transfer length was smaller than the $60d_b$ length recommended by AASHTO LRFD specifications,

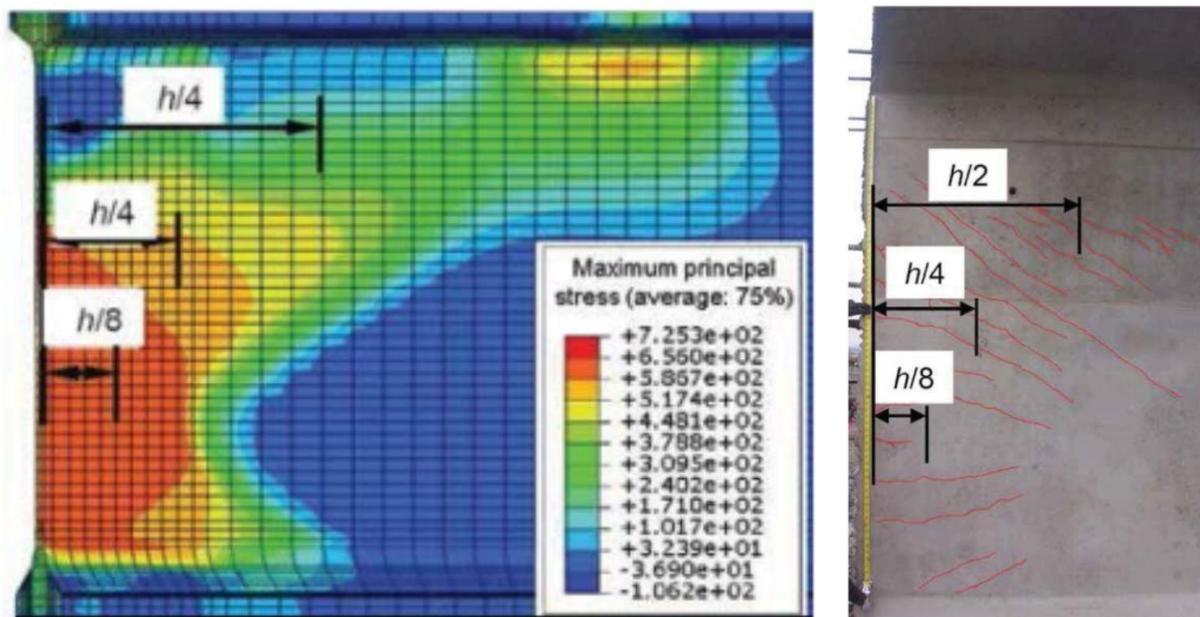
a) Principal stress distribution in numerical model

b) Girder end cracks

The results of the numerical analysis showed principle tensile stresses much higher than the modulus of rupture within $h/4$, and higher than the modulus of rupture within the $h/2$. The results are shown in Figure 2-19 alongside the actual cracks observed after prestress in a WF100G girder. The authors believe the reinforcement distribution recommended by (Tuan, Yehia, Jongpitaksseel, & Tadros, 2004) most appropriately matches the stress distribution from the finite element analysis. This distribution has 50 percent of the end zone reinforcement contained within $h/8$ of the girder end, and the remaining 50 percent between $h/8$ and $h/4$.

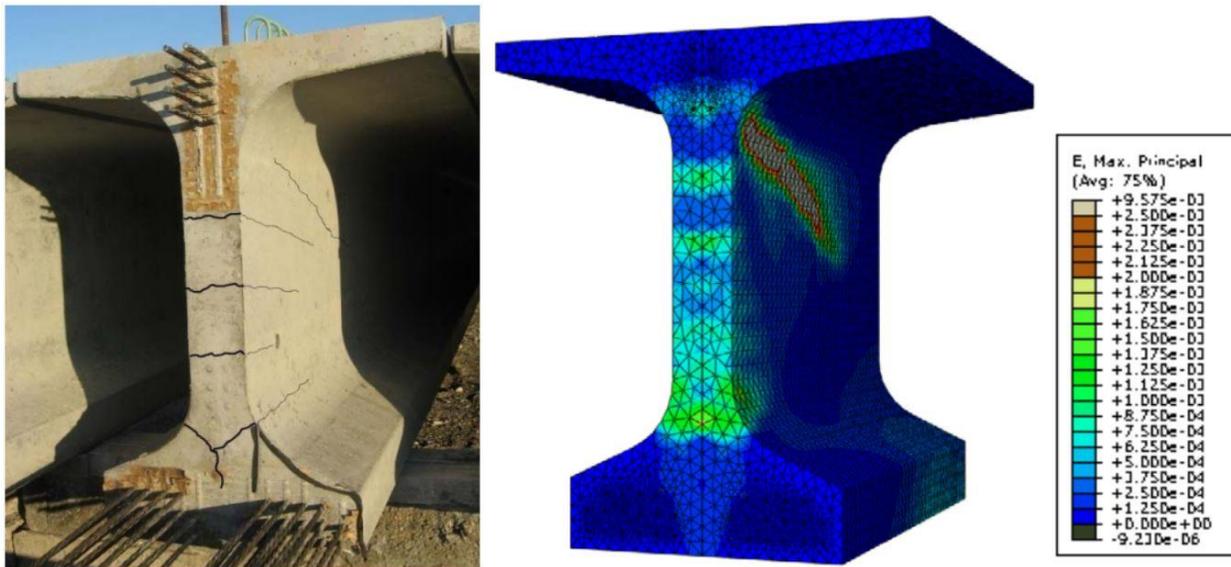
Figure 2-20 Cracks on the first 54W and maximum tensile strains from the FEM (Oliva & Okumus 2011)

The first 54W, a 129 ft long girder manufactured by Spancrete Inc., experienced horizontal and lateral cracking in the web as well as Y cracking at the bottom flange-web interface, as seen in the left side of Figure 2-20. The maximum principal strains from the finite element analysis are shown on the right side. The results in the finite element model are generally compatible with the cracks seen in the 54W. The dark blue areas in the figure correspond with tensile strains near zero, while the red and grey areas represent tension strains of over 2000 $\mu\epsilon$.

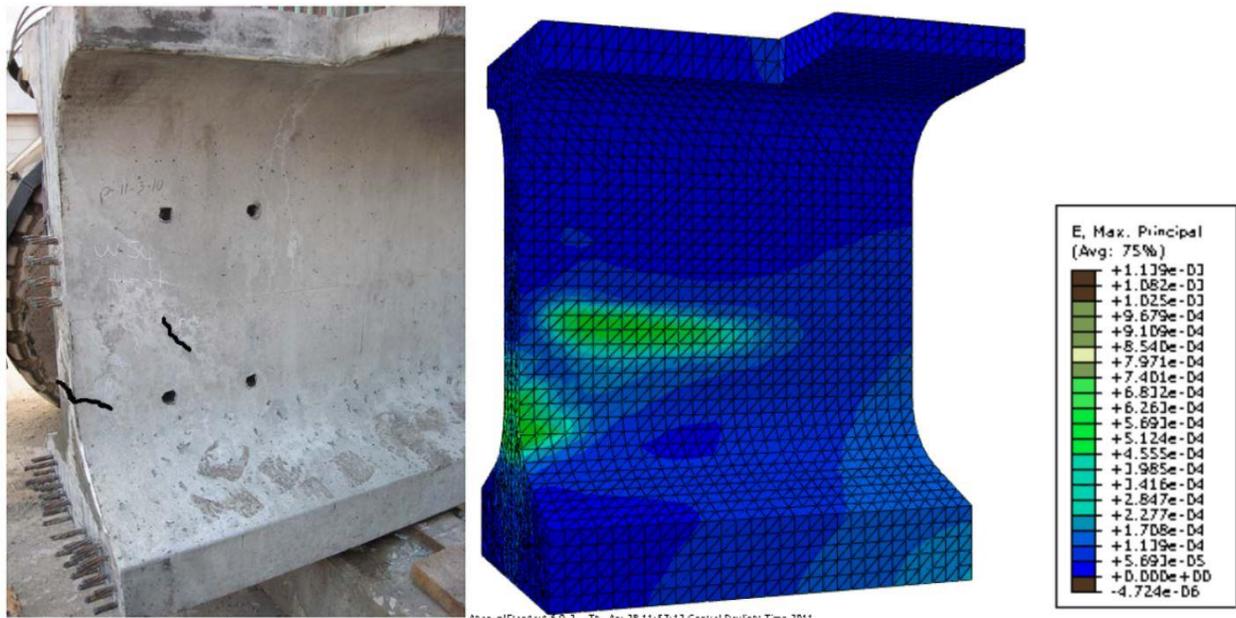
Figure 2-21 Comparison of cracks on the second 54W and maximum tensile strains predicted by the finite element model (Oliva & Okumus 2011)

distribution between the strands and the concrete. The average of the data produced by the strand strain gauges suggested a transfer length of 44 in., 22% longer than the AASHTO LRFD specification of 36 in. The cracks in the second 54W were also measured against the expected maximum principal strains from the finite element model. This comparison can be seen in Figure 2-21. Again, the results of the finite element model are generally verified by the observed end zone cracking of the girder.

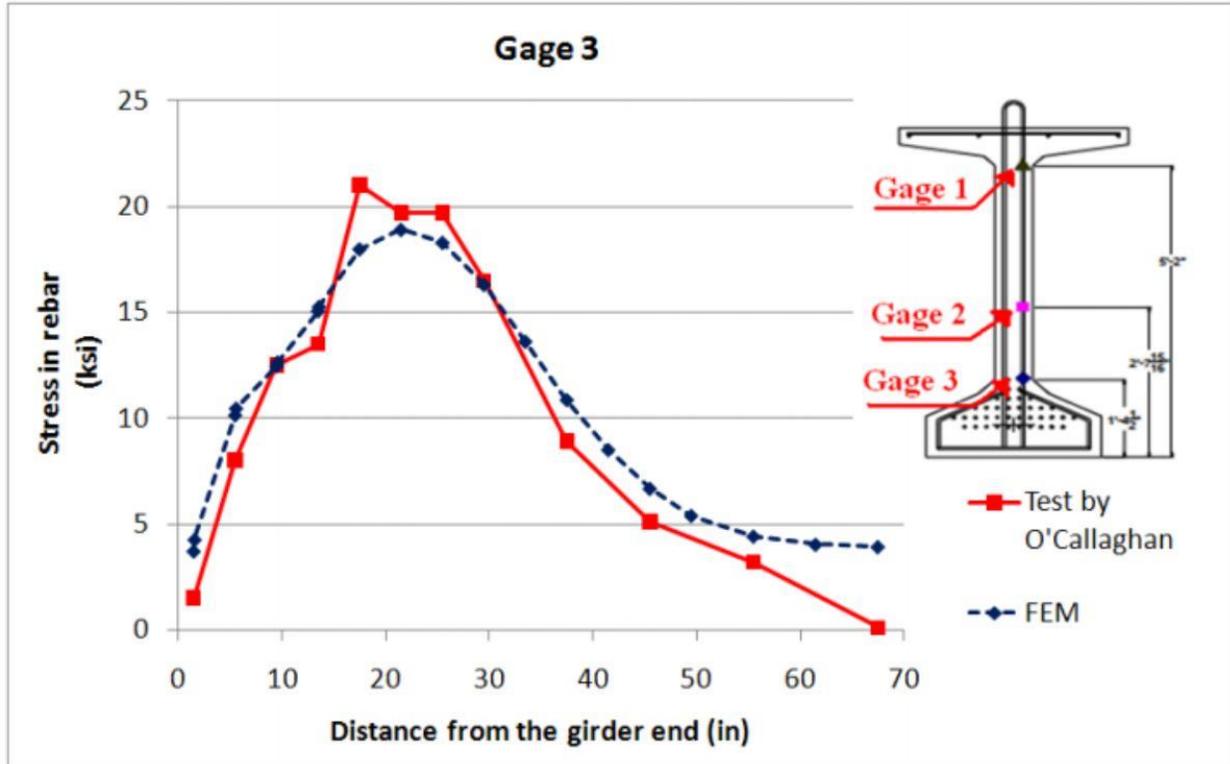
Figure 2-22 Distribution of reinforcement stress in Tx-70 model and strain gauges (Oliva & Okumus 2011)

A third, Tx-70 girder was used to verify the results of the finite element model. The authors verified their model with strain gauge data from the detensioning of a 70 in. deep girder cast for research at the University of Texas, Austin. A comprehensive instrumentation program was used to collect the strains from vertical reinforcement near the girder end. The comparison of the model with the strain gauge data showed very similar trends. One example of this comparison can be seen in Figure 2-22.

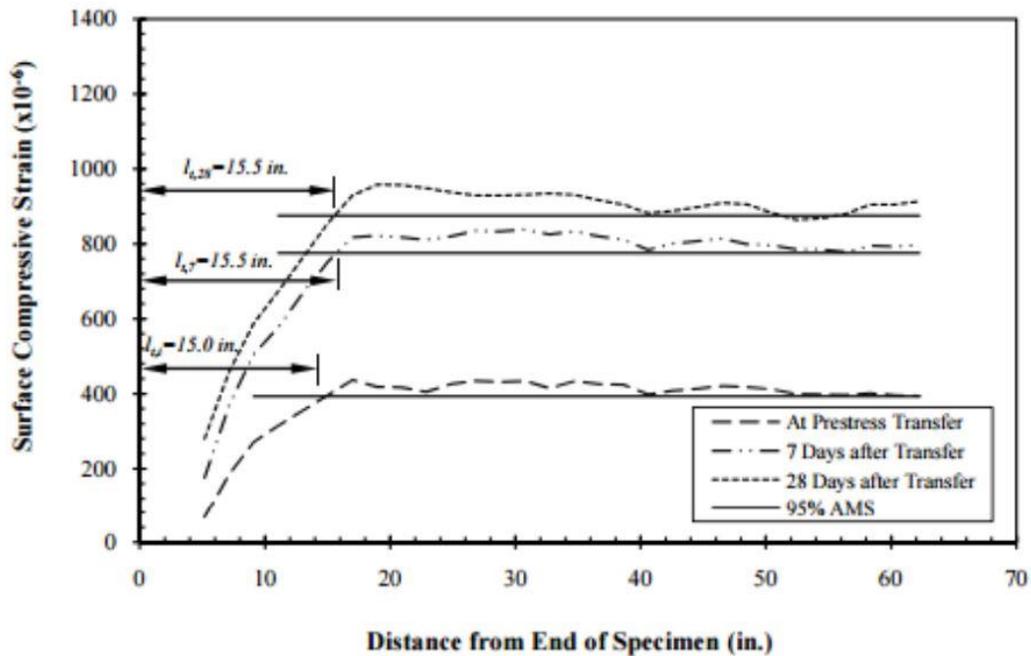
Figure 2-25 Determination of transfer length and 95%AMS (Dunham, 2011)

target screw was measured before prestress release, and the subsequent measurements were compared to the initial values to represent a change in distance between the points over time. The change in distance value between each point was converted into a change in strain. These values were then averaged with the values from the surrounding target screws to produce a smoother trend line. To eliminate the effect of the skew at the girder ends, the transfer length on both faces of the girder were measured and averaged together. Finally, the transfer lengths were reported by plotting the measured change in strain vs. the distance from the girder end of the central point between the target screws. The transfer lengths were determined by calculating the distance between the girder edge and the point along the girder length at which 95% of the average maximum strain (AMS) was measured. An example strain profile with the transfer lengths marked can be seen in Figure 2-25.

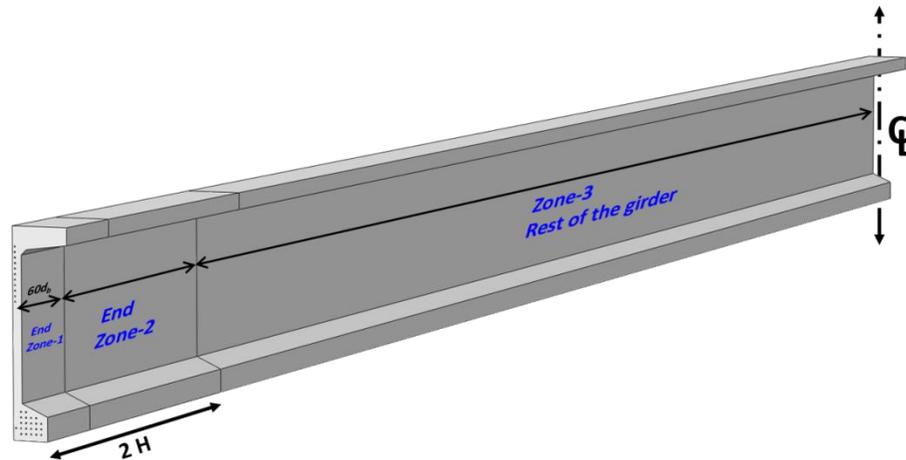
Figure 3-5 Abaqus model with mesh zones marked

mesh which produces a very accurate model. This zone extended a length equal to 60 times the diameter of the strand. An adjacent area, named “End Zone 2” in Figure 3-5, was modeled with a slightly coarser mesh, and extends the length of two time the girder height for the purpose of observing propagated cracks. The final zone, “Zone 3”, was modeled with a coarser mesh with material properties limited to the elastic range since cracks were not expected in this zone.

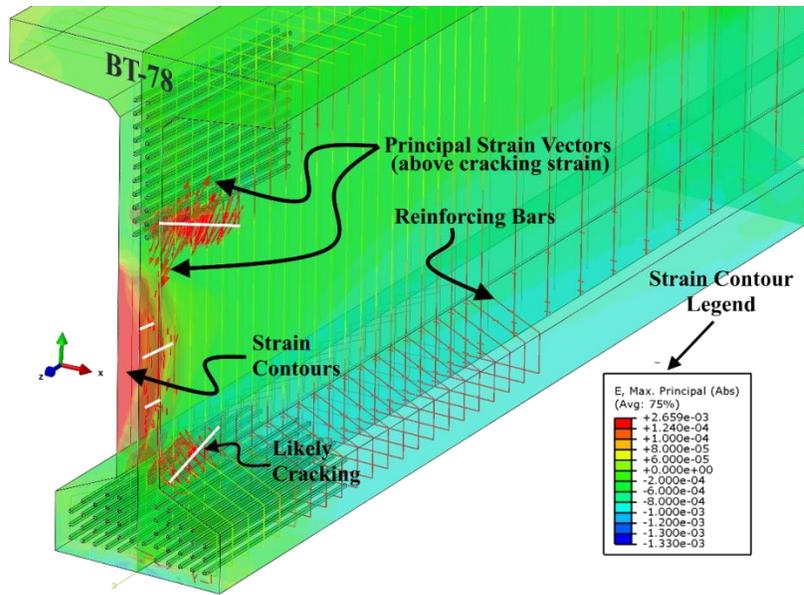
Figure 3-6 Typical girder model in the FEM

A typical girder model in the FEM contains two layers: a strain contour and principle strain vectors. The strain contours, shown on the model in Figure 3-6, represent strain intervals on the girder surface. Although the cracking within these contours is impossible to locate, the contours serve as a general area in which strains in the concrete are more likely to produce cracks. The principle strain vectors show the magnitude and direction in which the cracking is likely to occur. A series of parallel vectors represents the potential location and orientation of cracks. Cracks are predicted to form in a perpendicular orientation to the maximum principal strain vectors.

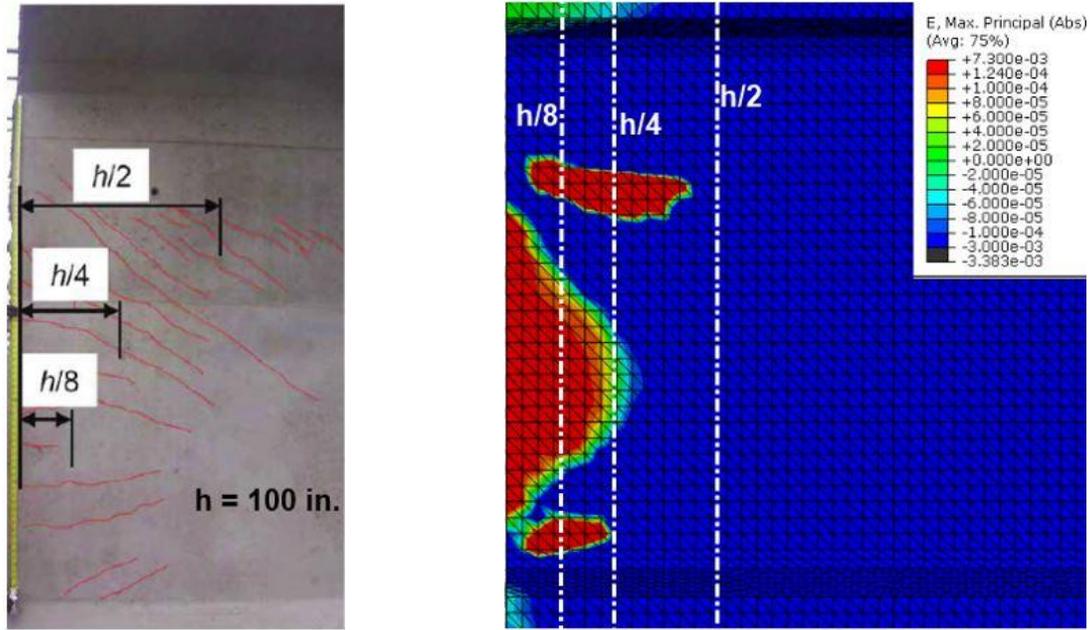
a) WF100G cracks

The Abaqus model was verified through the creation of models for several similar girder for which both the design specifications and the end zone crack locations after prestress were known. The Washington WF100G girder (Arab A. , et al., 2014) and the Virginia PCEF 95.5 girder were used for calibration. The results of the WF100G model and a photograph of the corresponding end zone cracks can be seen in Figure 3-7.

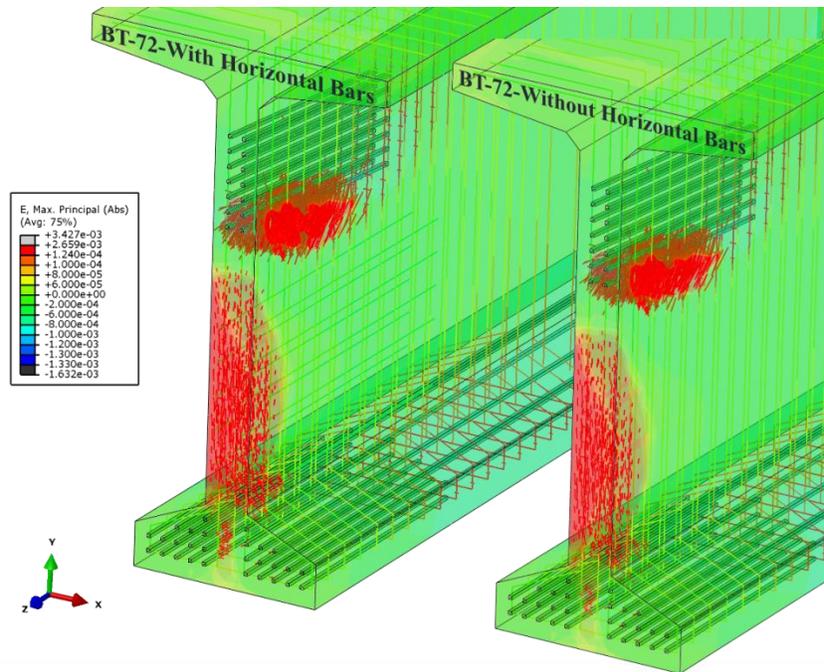
Figure 3-8 FEM comparison of BT-72 with and without horizontal reinforcement

The addition of horizontal reinforcement to the end zone is a prescribed method used by ALDOT to control the cracks in the end zones of BT-72 girders. The horizontal reinforcement in the BT-72 girders includes four pairs of #5 bars spaced at 4 in. vertically in the lower section of the web beginning one ft above the bottom of the girder. These reinforcement bars extend 5 ft from the girder end. The effect of these bars on controlling end zone cracking was investigated. The results of this investigation are presented in Figure 3-8. The resulting strain contours of the BT-72 show no clear reduction of principle strains in the model containing the horizontal reinforcement. As a result of this investigation, horizontal bars were not used to control cracking in any of the BT-78 models.
