END ZONE DESIGN FOR ALABAMA
DEEP PRESTRESSED GIRDERS

A THESIS

Submitted in partial fulfillment of the requirements
for the degree of Master of Science
in the Department of Civil, Construction, and Environmental Engineering
in the Graduate School of
The University of Alabama

2016

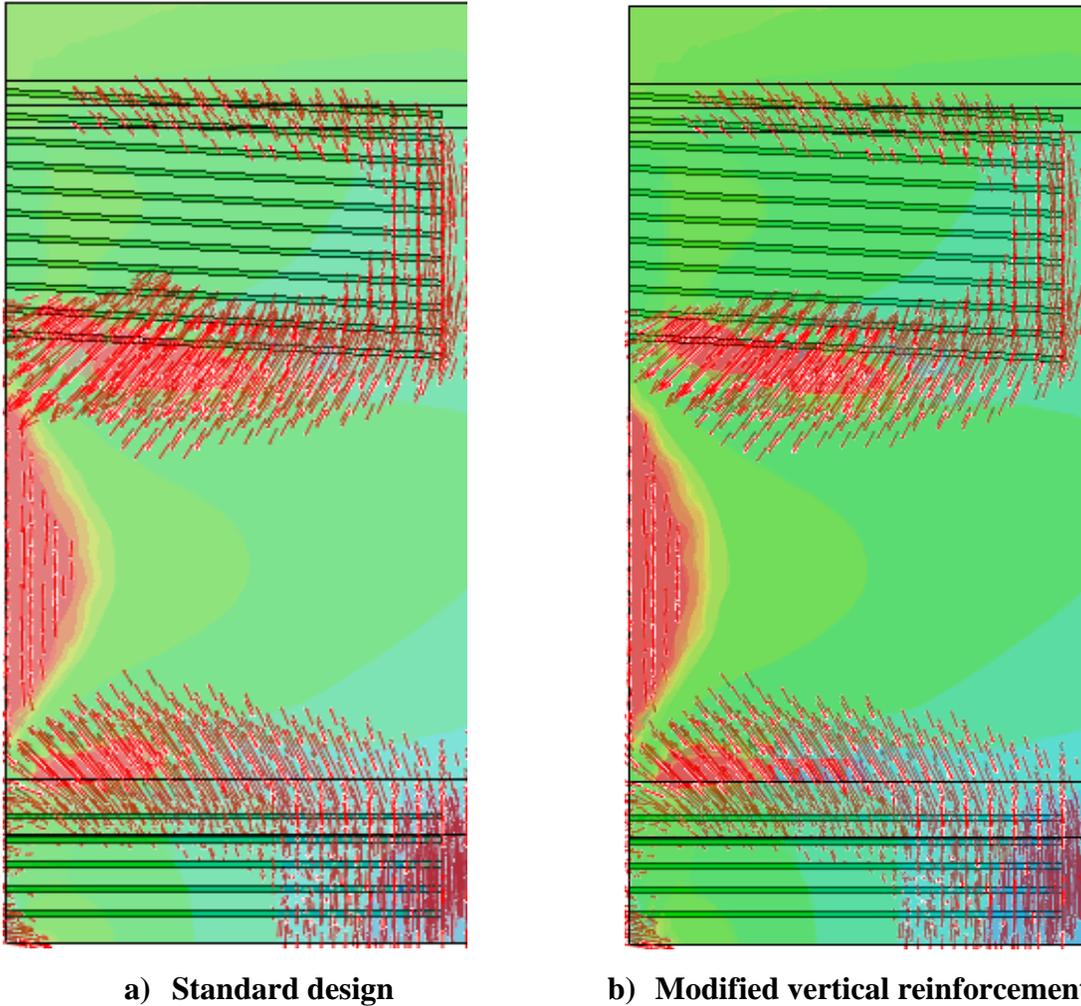
Figure 3-9 FEM comparison of standard design and modified vertical reinforcement

produced the results shown in Figure 3-9b. As can be seen in the figure, the addition of #8 bars to the end zone produced similar results to the standard design. Since the results suggest only a minimal reduction in principal strains in the end zone, the vertical reinforcement modification was abandoned and other alternatives were explored.

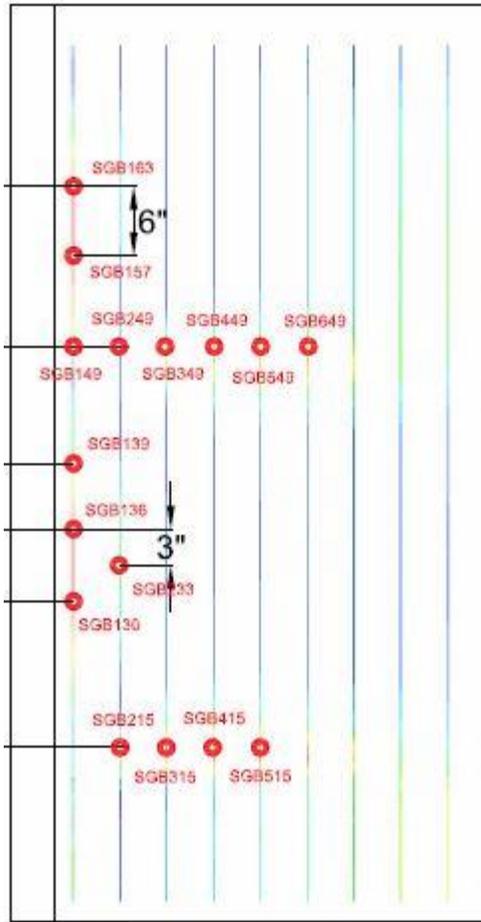
a) Steel strain gauge placement with bar stress contours

The models were also useful in determining locations for placement of the internal steel and concrete strain gauges. The research team used the strain contours to determine areas of likely cracking in both the steel and the concrete. Figure 3-11a shows the steel strain gauge placement on top of the local stress contours from the FEM in the end zone reinforcement of Specimen 1 at prestress release. The dark red color on the bars represents the highest levels of stress. Figure 3-11b shows the concrete gauge placement with the principle strain vectors from the FEM of Specimen 1 at prestress release. These locations were similar to locations chosen by Tuan et al (2004), Oliva and Okumus (2011) and Arab et al (2014). The final position of the strain gauges can be viewed in Chapter 4.

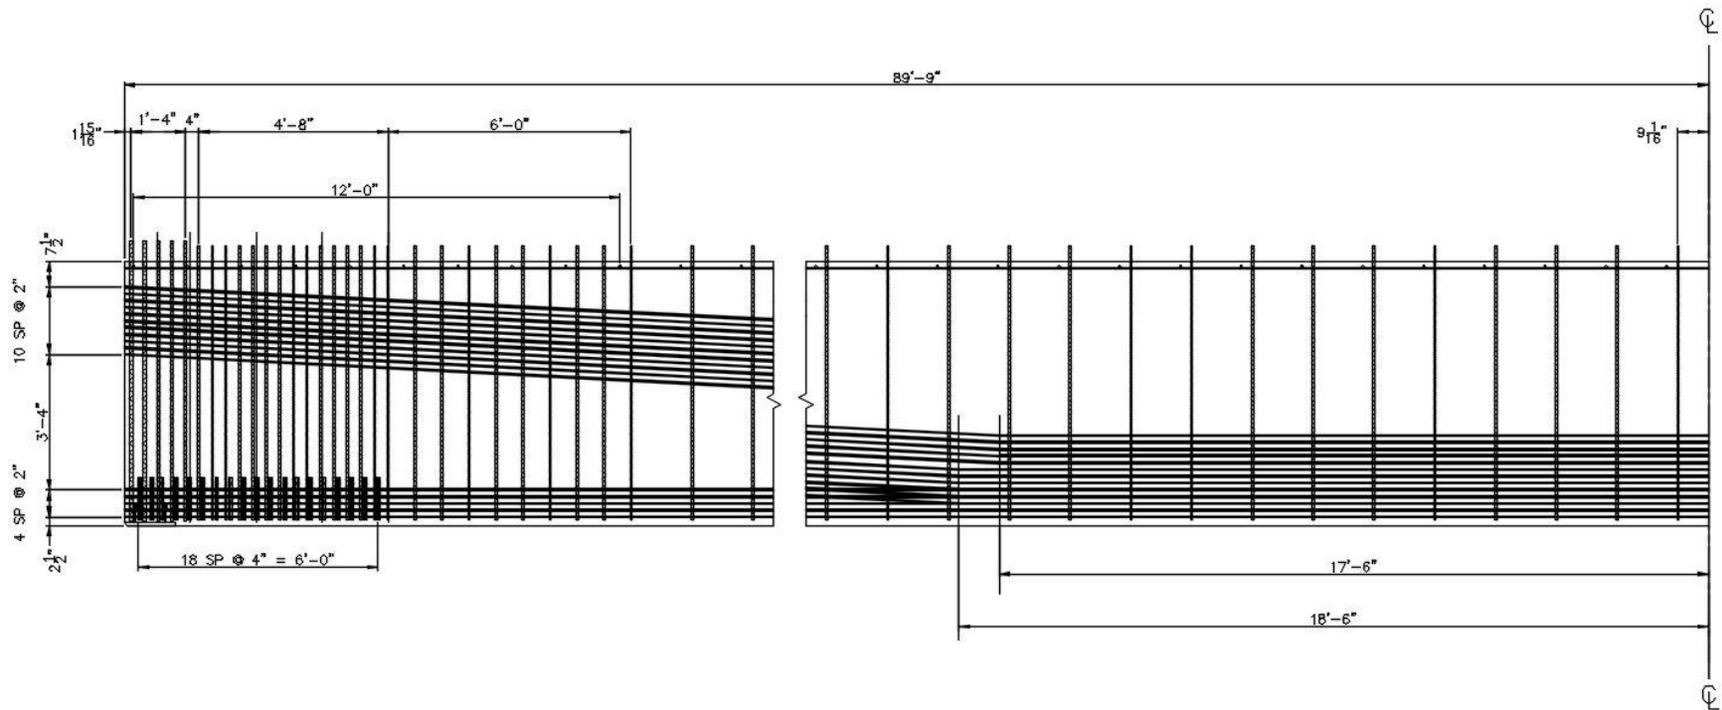
Figure 4-1 Standard design for full-scale BT-78 girder

Although the production span length for the BT-78 girder can reach up to 180 ft, the girder test specimens were limited to a span of 54 ft each, due to restrictions on the weight and length capacities for transportation and testing of the girder in the laboratory. Since the draped portion of the full-length girder was 72 ft-3 in. long, the hold down points were embedded within a central waste block that was cast between the two specimens on the same bed. The profile for the full 180 ft BT-78 girder can be seen in Figure 4-1.

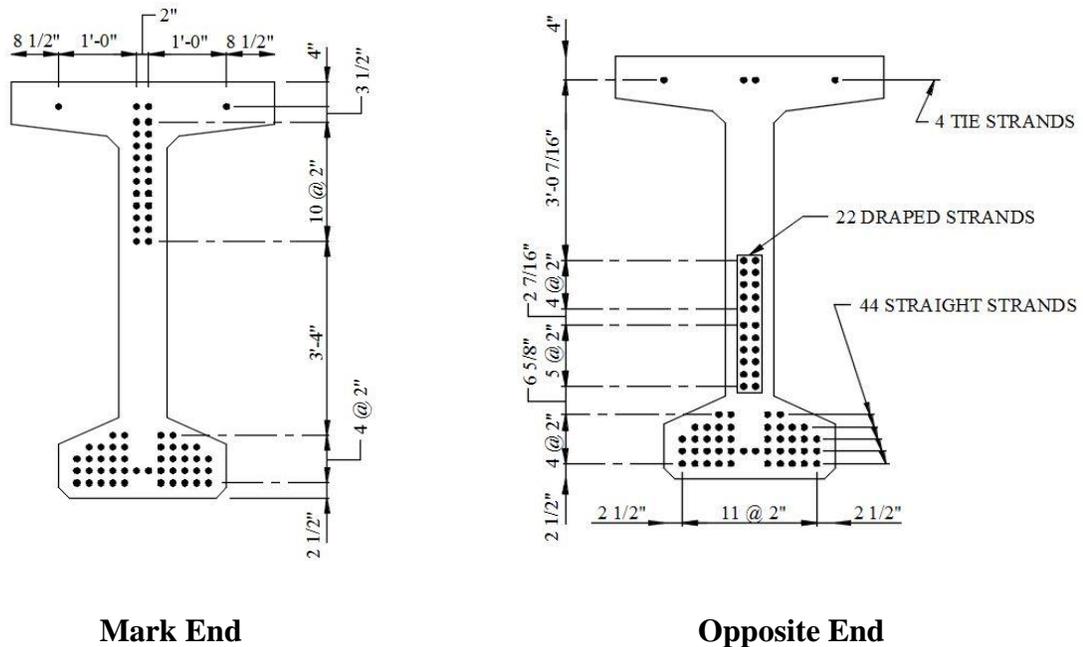
Figure 4-5 Specimen 1 Strand Pattern

Each girder contained 22 draped strands and 44 straight strands. The draping angle for Specimens 1 and 2 was 2.9 degrees while the draping angle for Specimens 3 and 4 was lowered to 1.67 degrees. For Specimens 2 and 4, 12 of the 66 strands, or 18%, were debonded in a typical “checkerboard” pattern with no more than 40% of the strands in any row being debonded. Furthermore, the debonding was discontinued at 5, 10, or 15 ft, depending on the row in which the debonding was contained. The design of the partial debonding satisfies the conditions presented in AASHTO LRFD Section 5.11.4.3. The total design prestressing force of the 66 strands was 2,977.8 kips. The strand pattern at the girder ends for all the test specimens are shown in Figure 4-5 through Figure 4-8.

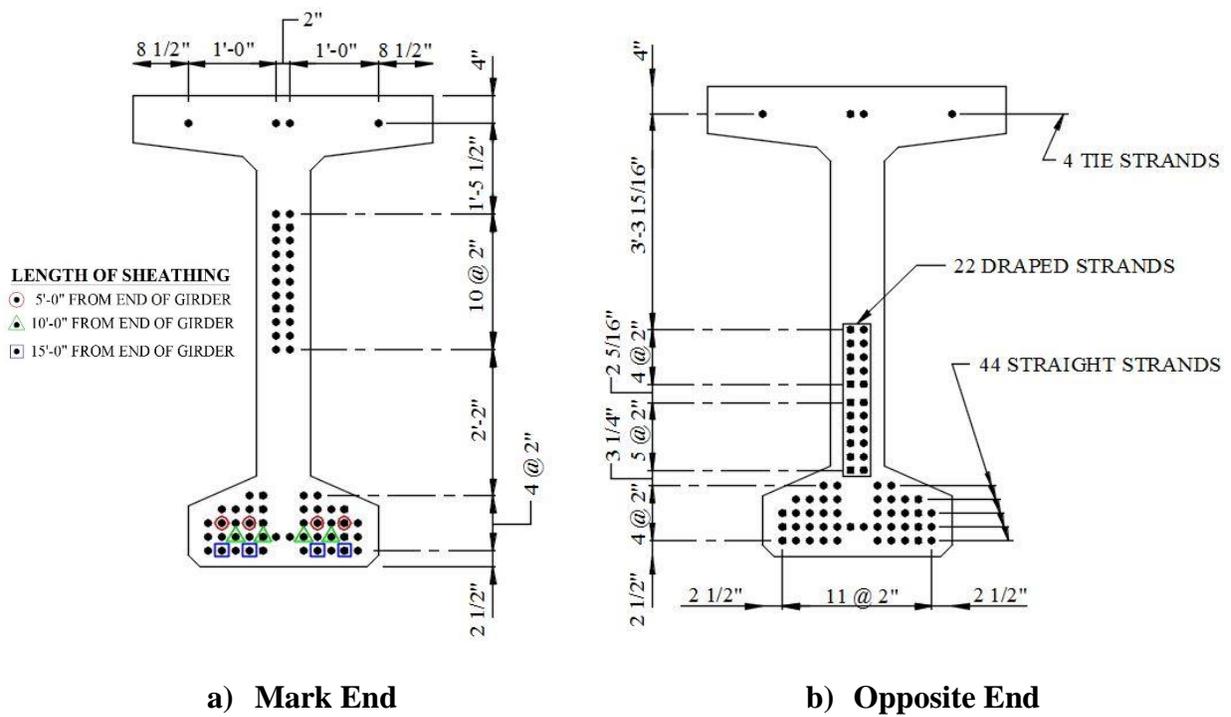
Figure 4-8 Specimen 4 Strand Pattern

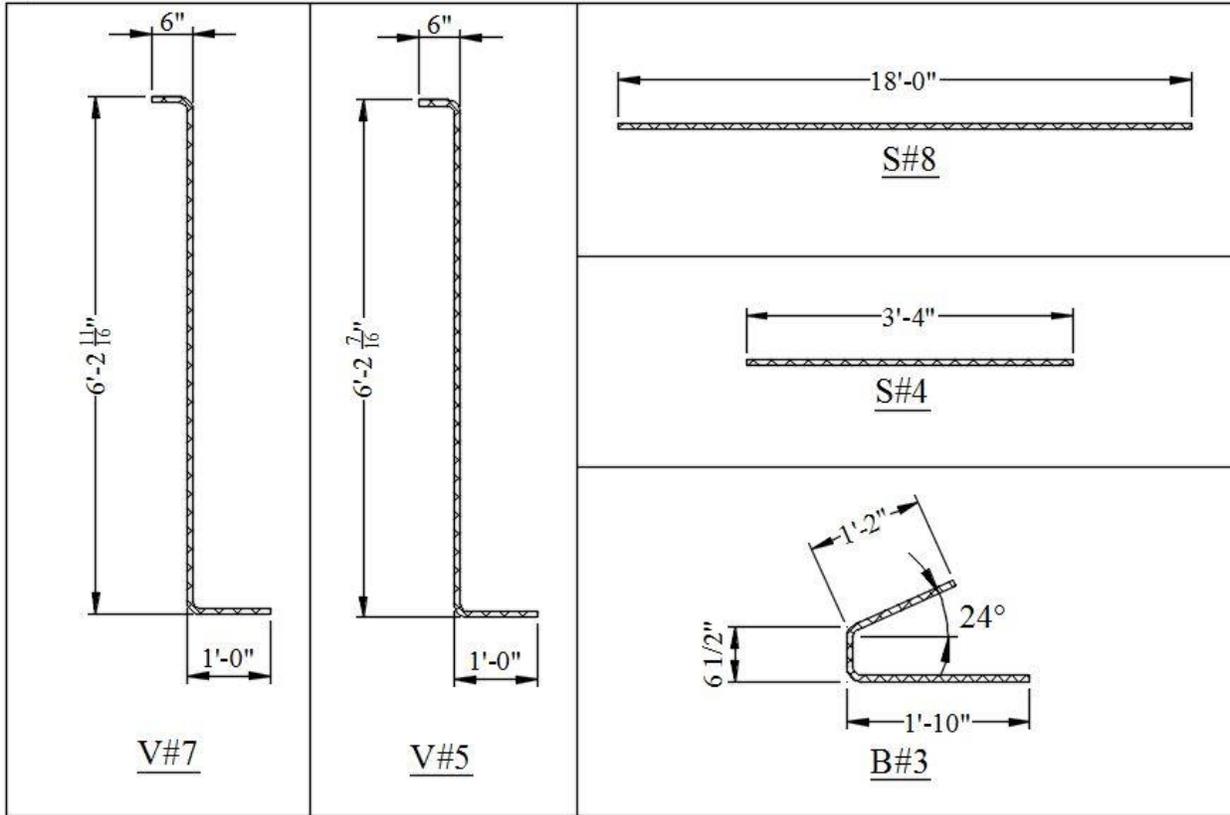
Figure 4-9 Typical reinforcement specifications

The steel reinforcement used was consistent for all four test specimens. There were five different types of steel reinforcement used in the specimens including: V#7, V#5, S#8, S#4, and B#3. All reinforcement used was uncoated, grade 60, mild steel. The size of the reinforcement bar is indicated within the label by the numeral following the “#” symbol. For example, V#7 represents a V-bar made from #7 rebar (diameter = 7/8 in.). The pattern of all bars, except the S#8 bars, was symmetric on either side of the mid-span. Each V bar and B bar was tied to a counterpart which faced the opposite direction. The bar shape specifications are shown in Figure 4-9. A 3D model of the prestressing strands and mild reinforcement is shown in Figure 4-10.

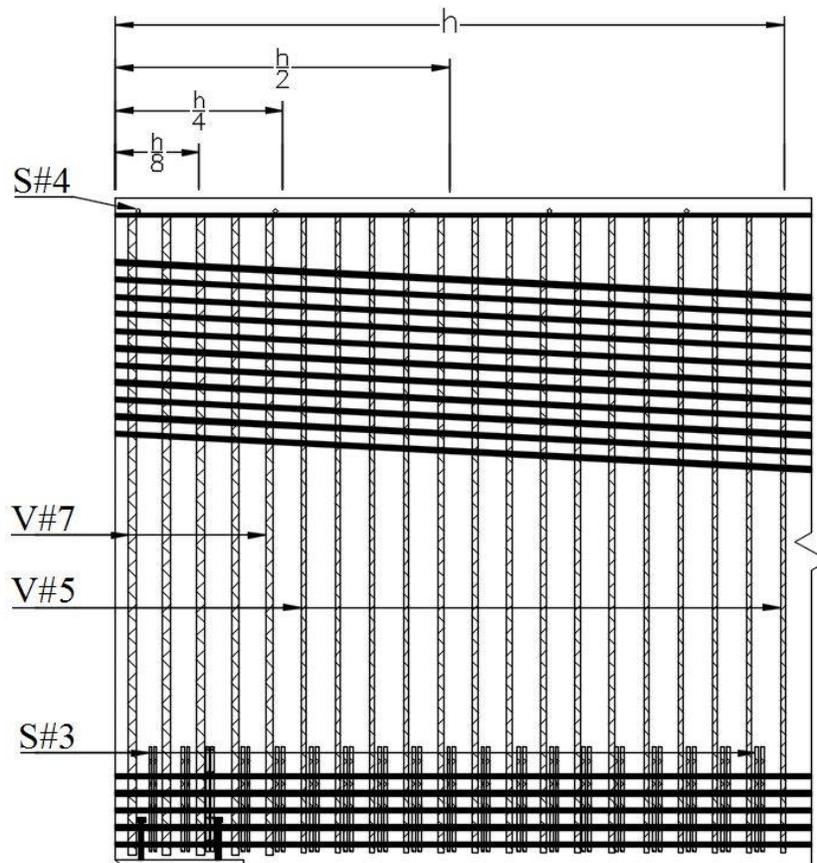
Figure 4-11 End zone reinforcement design

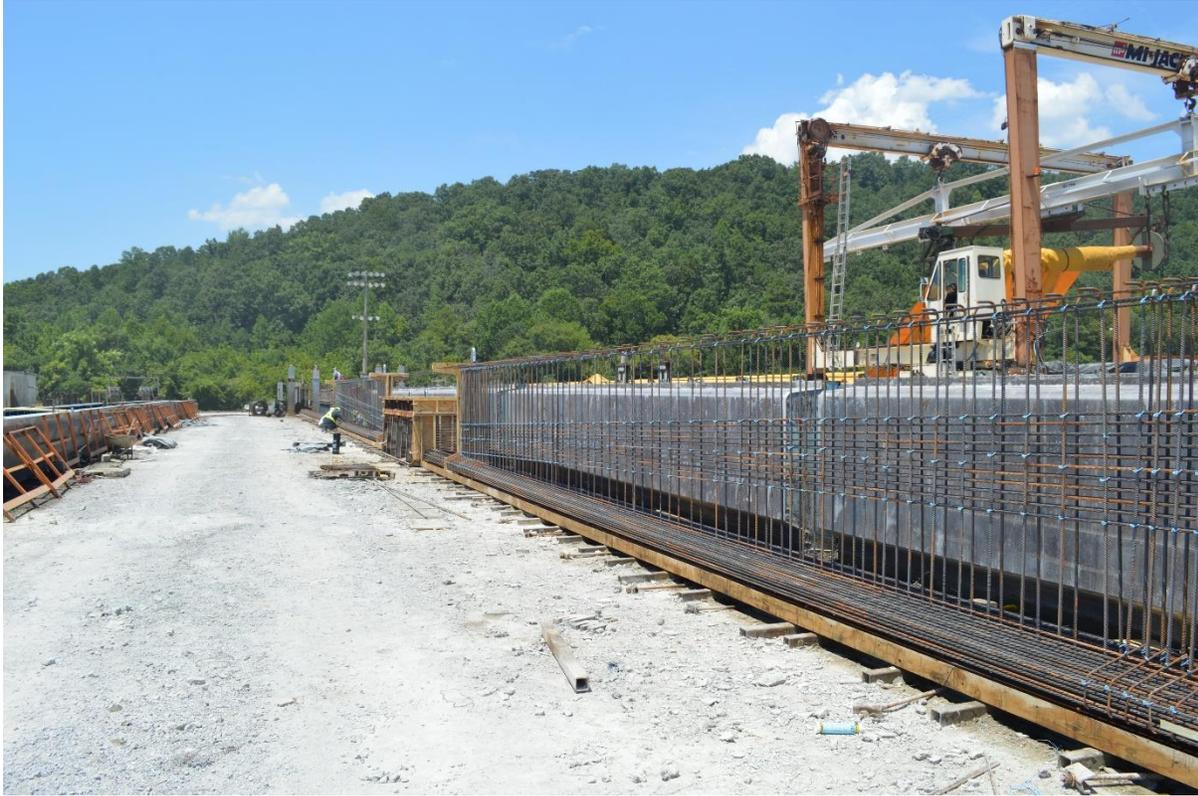
Figure 4-14 Placement of reinforcement bars

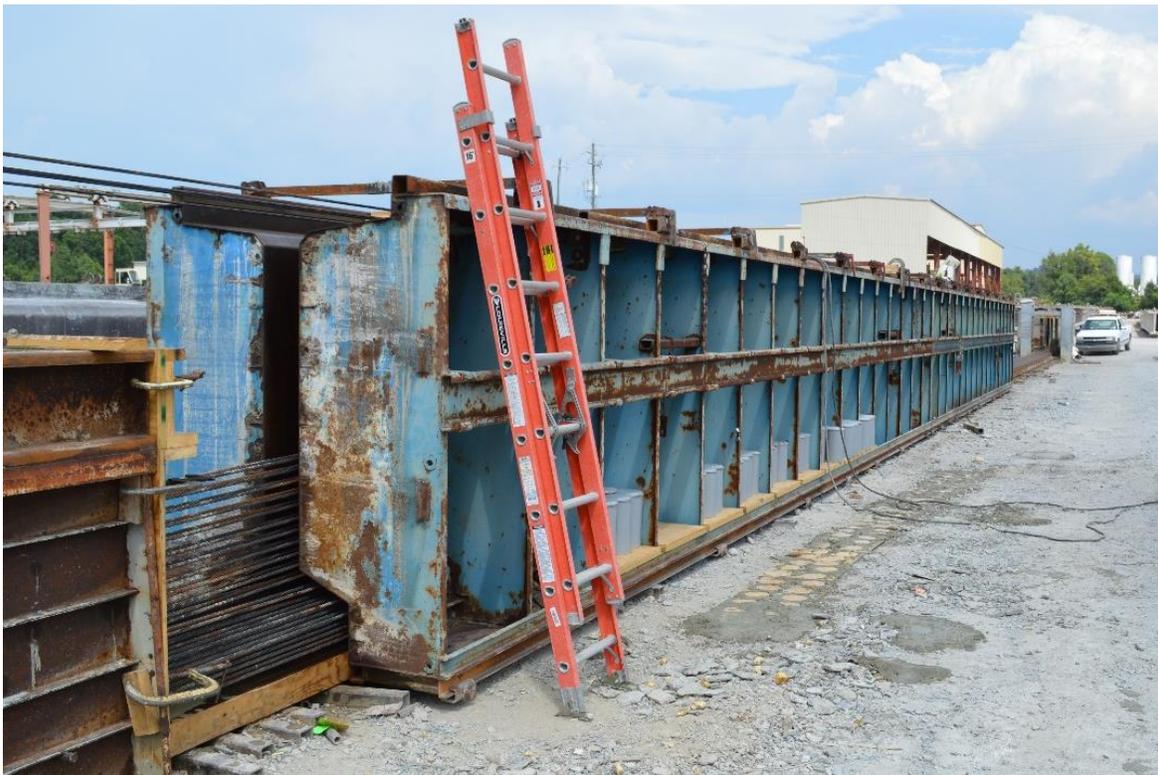
Figure 4-15 Placement of side forms

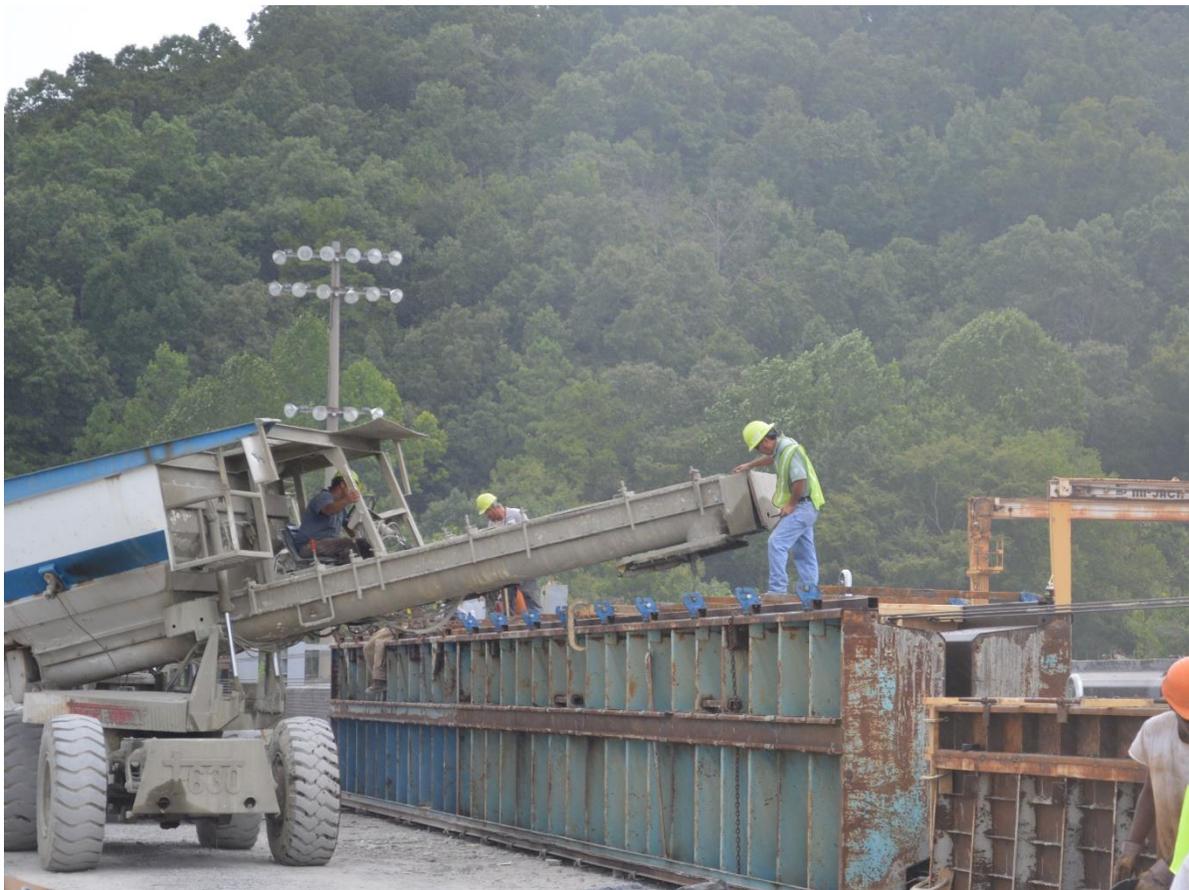
Figure 4-16 Pouring of concrete for Specimen 3

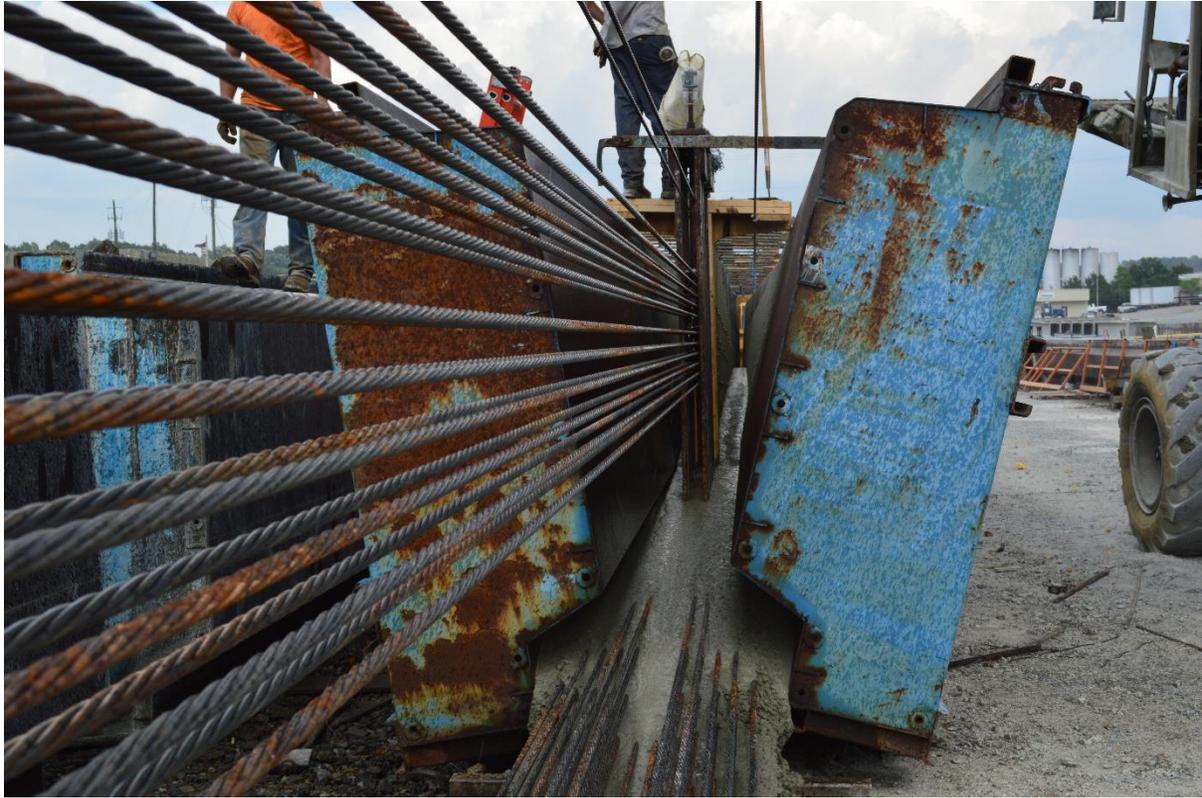
Figure 4-17 Specimen 4 side form failure

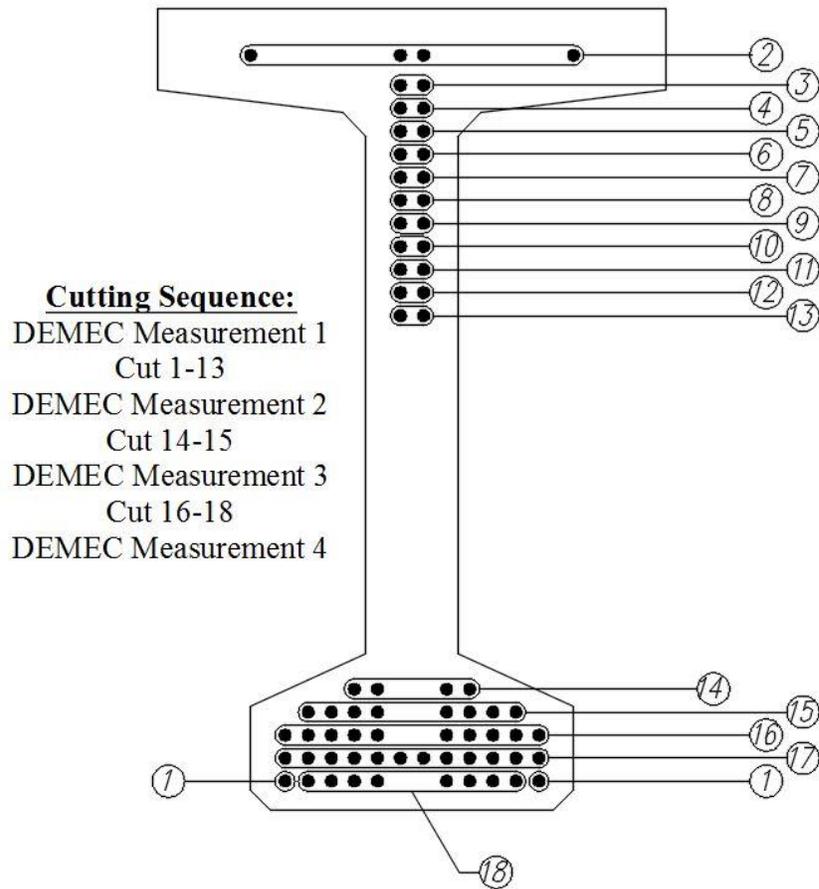
Figure 4-18 Strand cutting sequence

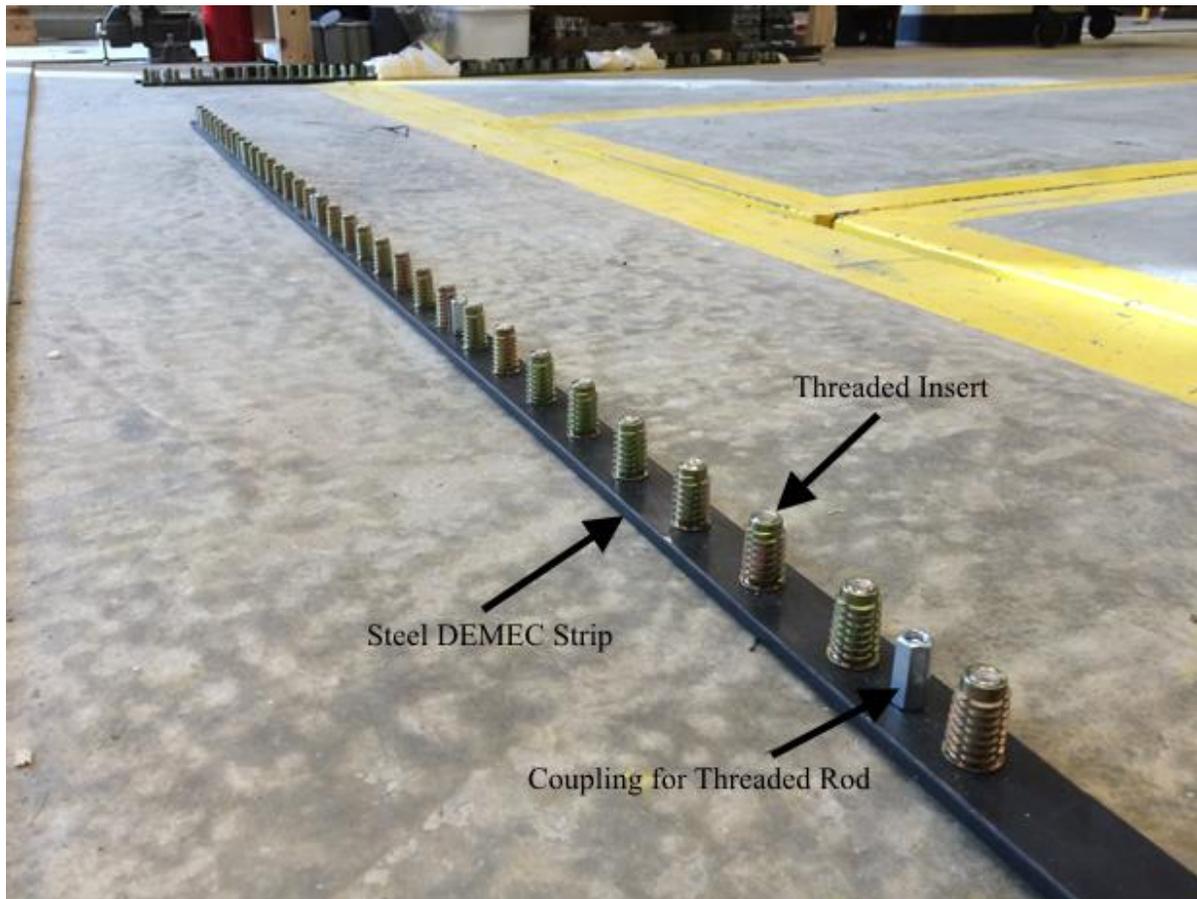
Figure 4-19 Initial setup of the DEMEC mounting system

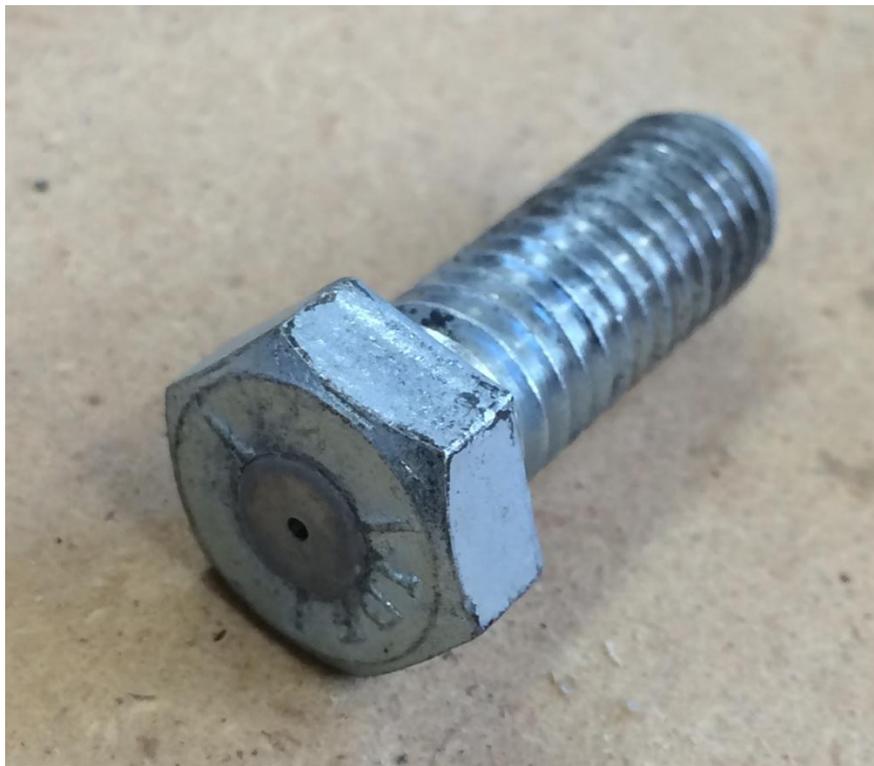
Figure 4-20 Assembled DEMEC Screw

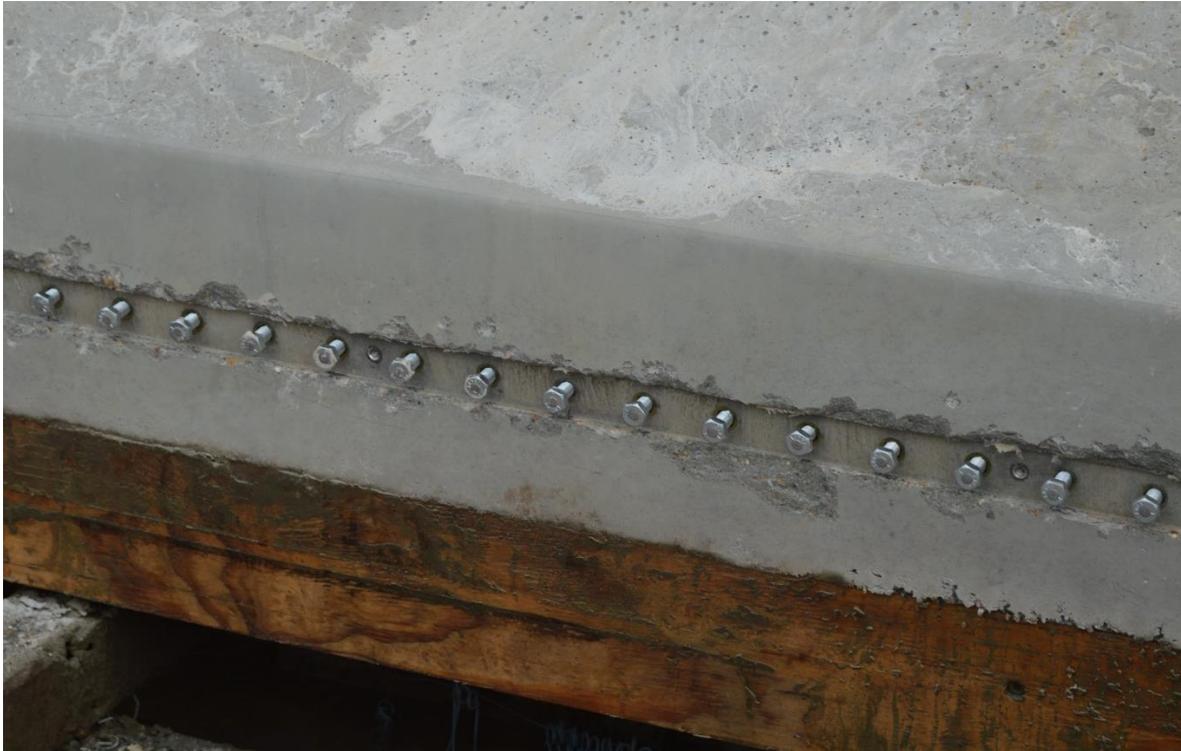
Figure 4-23 Application of DEMEC screws

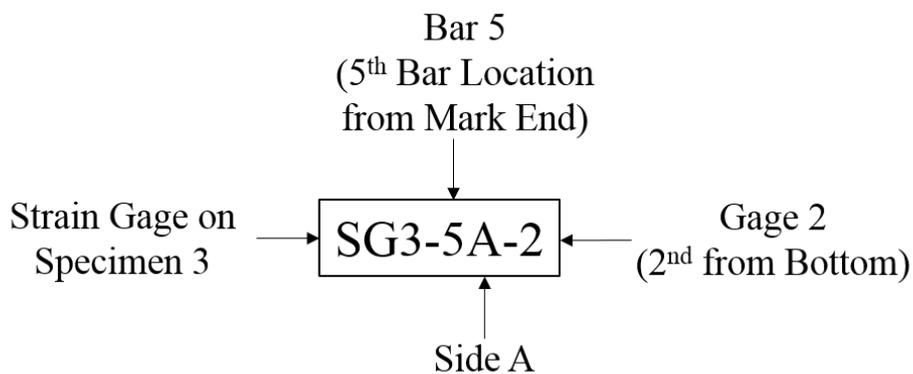
Figure 4-27 Identification system for the steel strain gauges

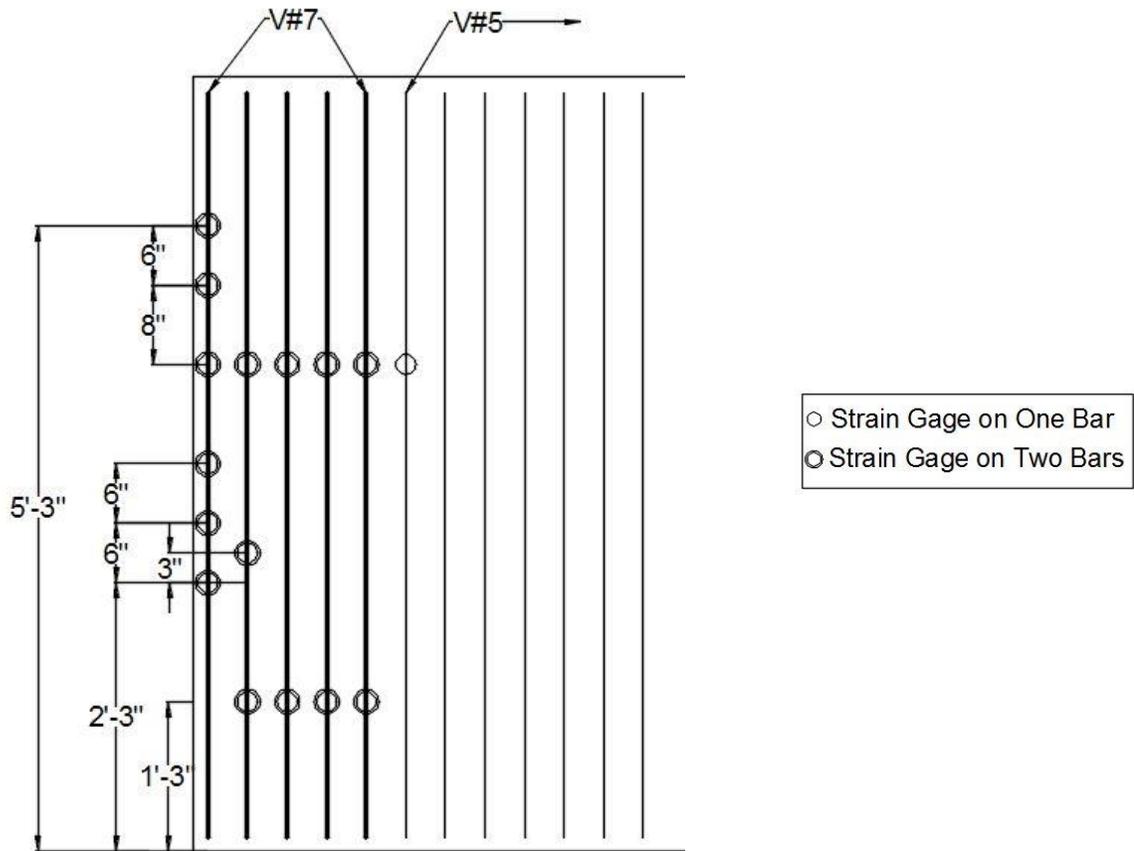
Figure 4-29 Location of the steel strain gauges

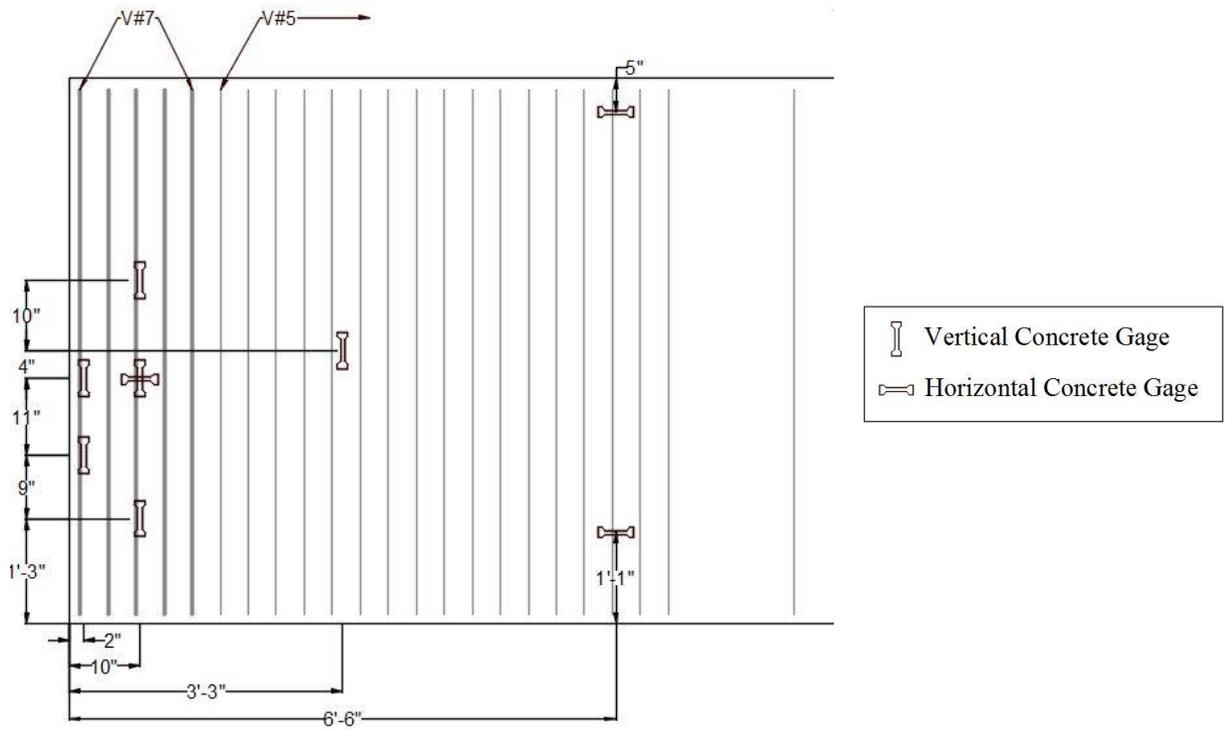
Figure 4-30 Location of the concrete strain gauges

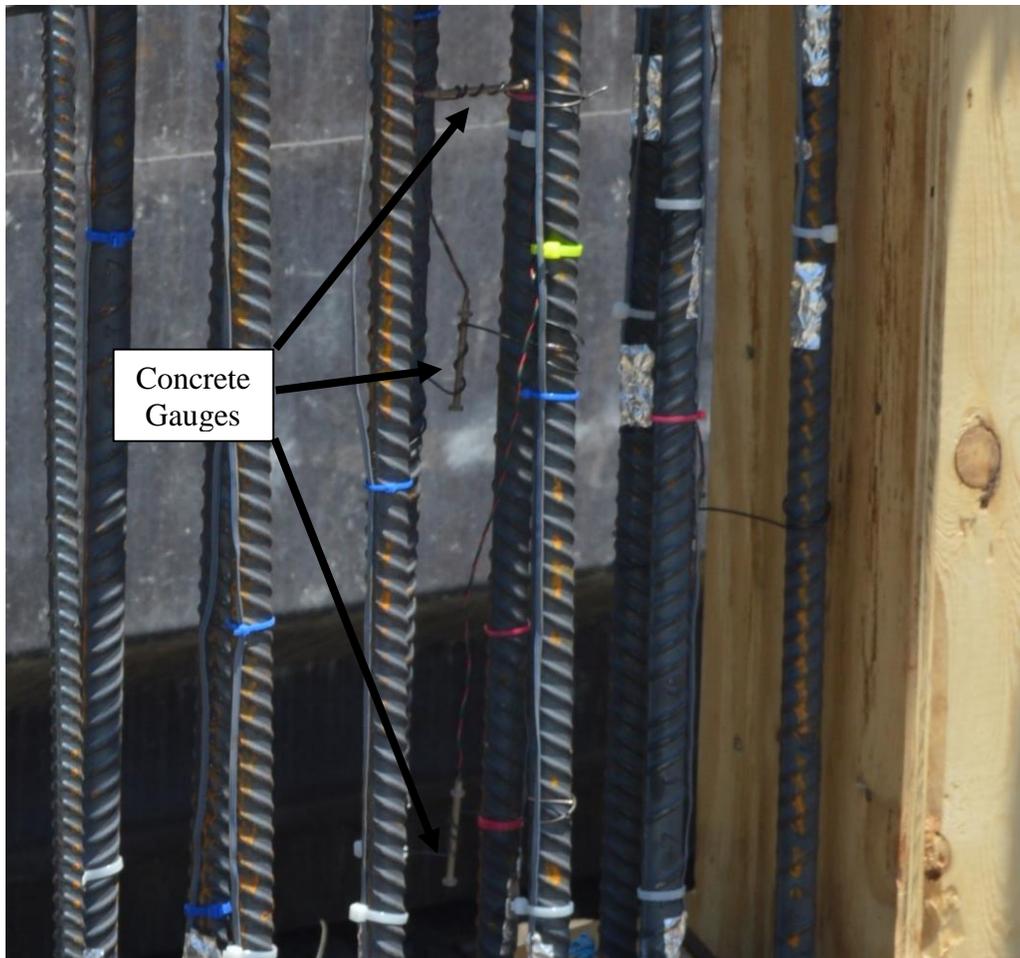
Figure 4-31 Configuration of concrete gauges during fabrication

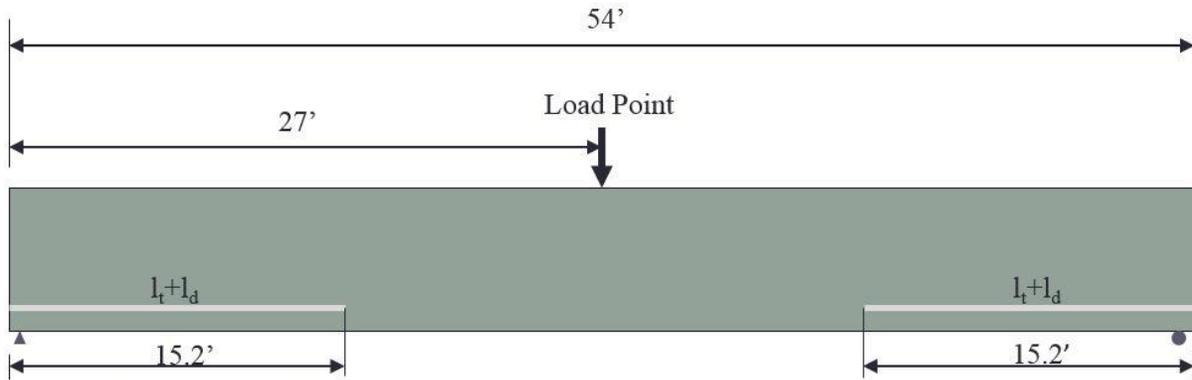
Figure 5-4 Load point for Specimen 1 and Specimen 3

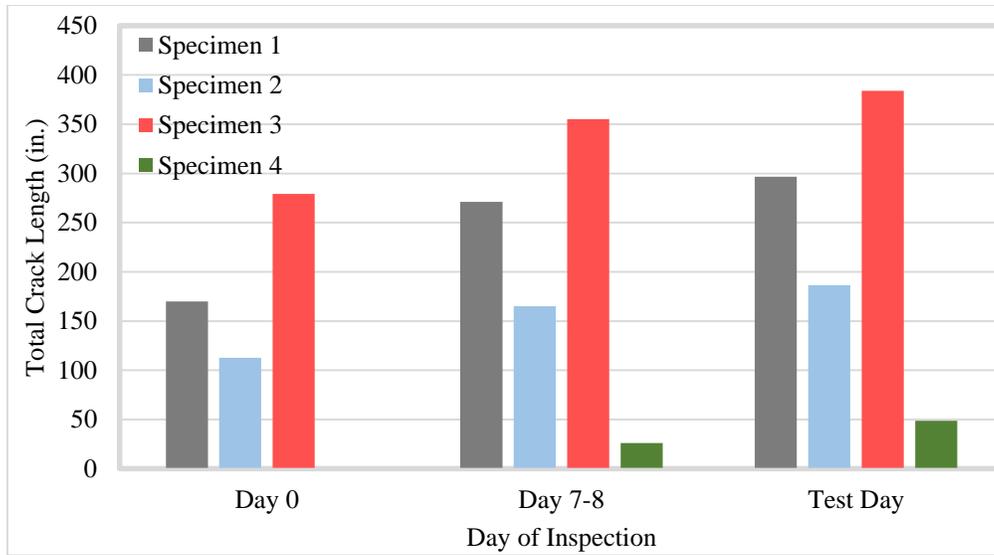
Figure 6-1 End zone crack lengths over time

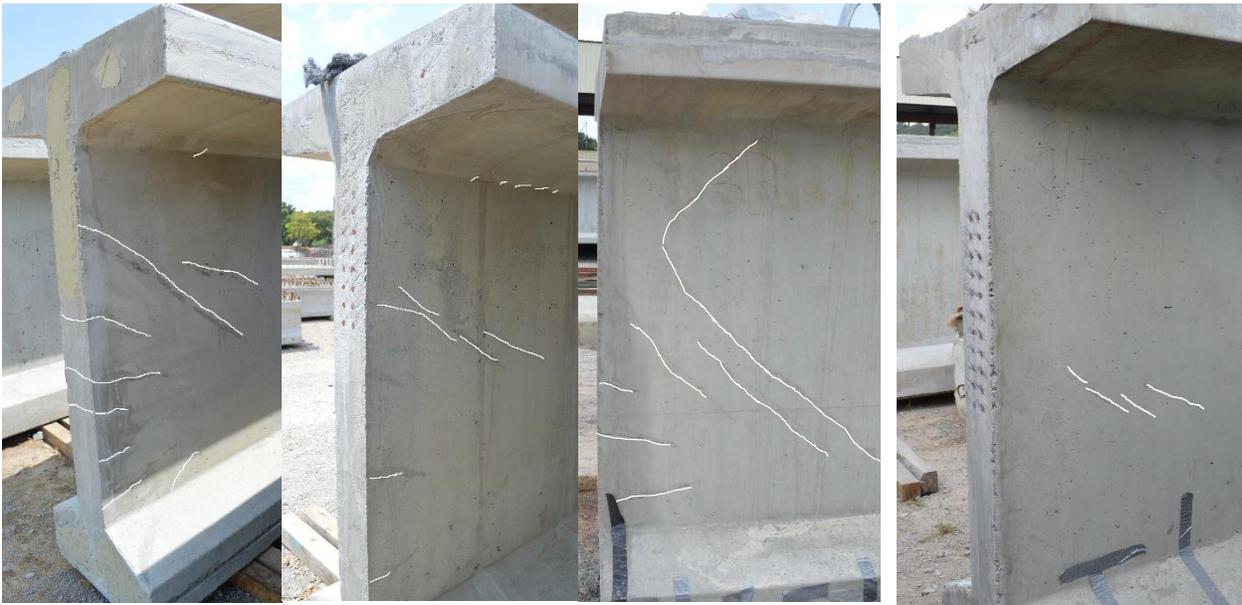
a) Specimen 1 b) Specimen 2 c) Specimen 3 d) Specimen 4

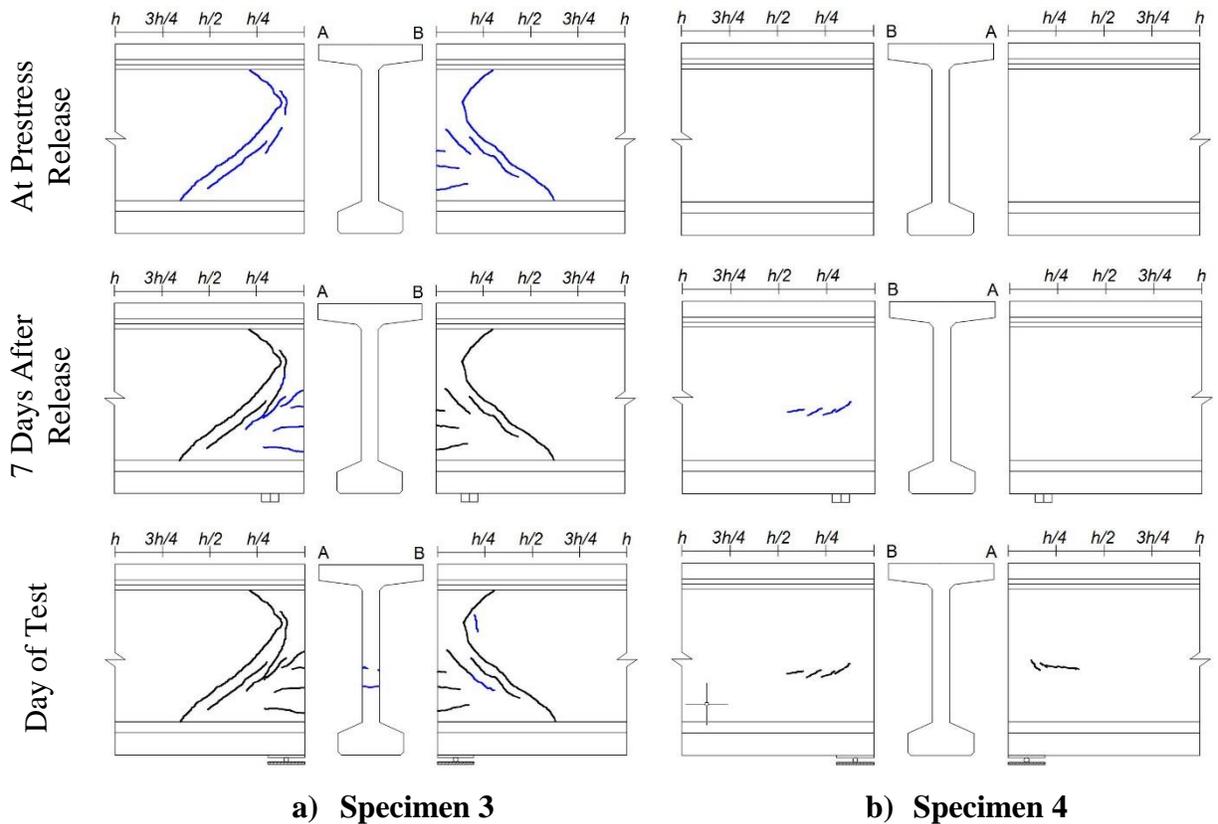
Figure 6-4 End Zone Cracking in Specimen 3 and Specimen 4

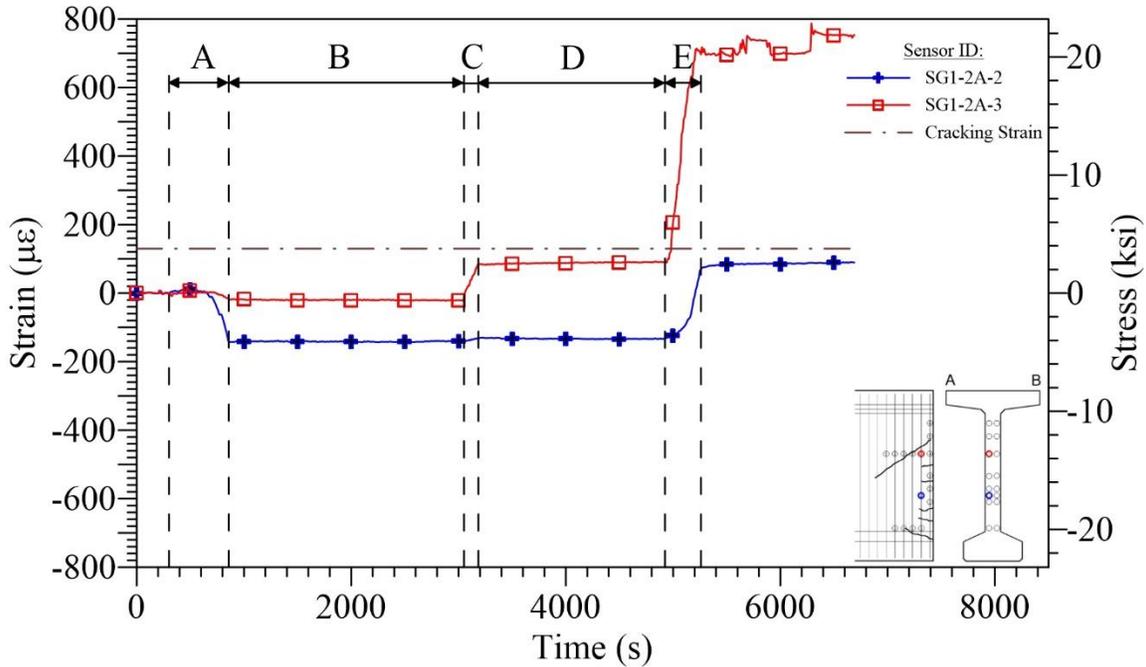
Figure 6-5 Specimen 1, Bar 2A, Steel strain gauges during detensioning

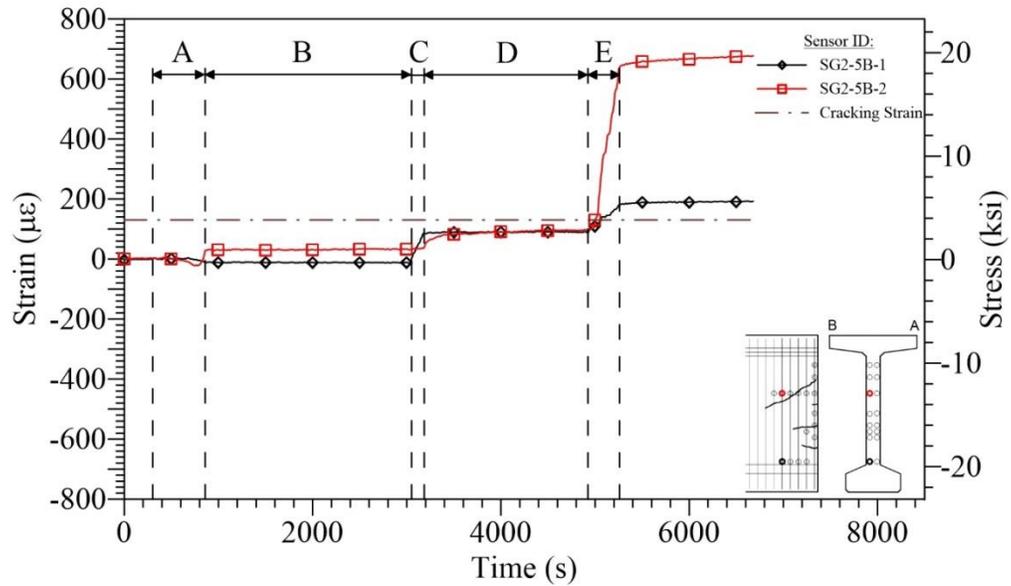
Figure 6-7 Specimen 2, Bar 5B, Steel strain gauges during detensioning

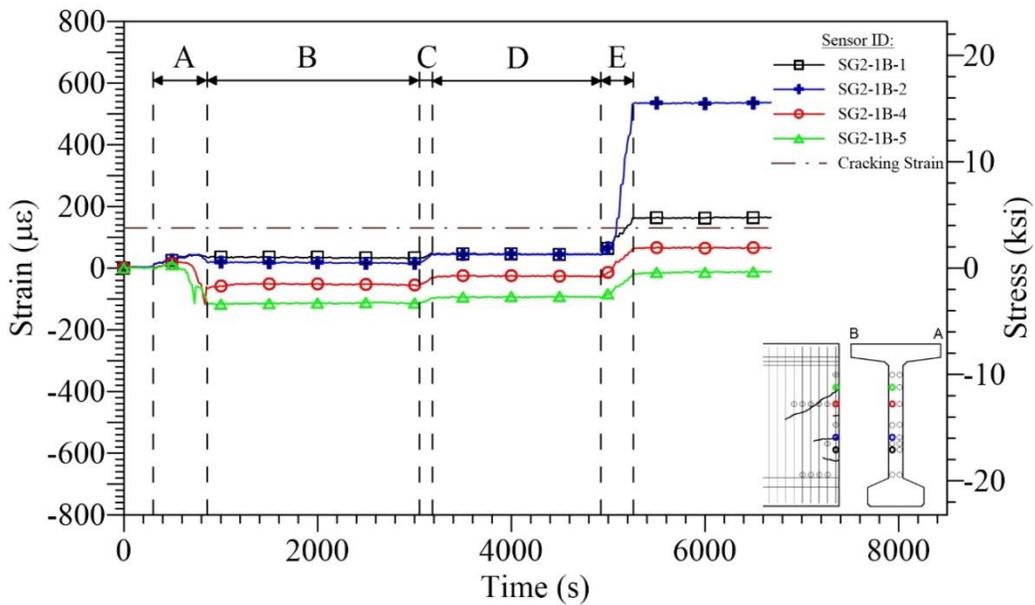
Figure 6-8 Specimen 2, Bar 1B, Steel strain gauges during detensioning

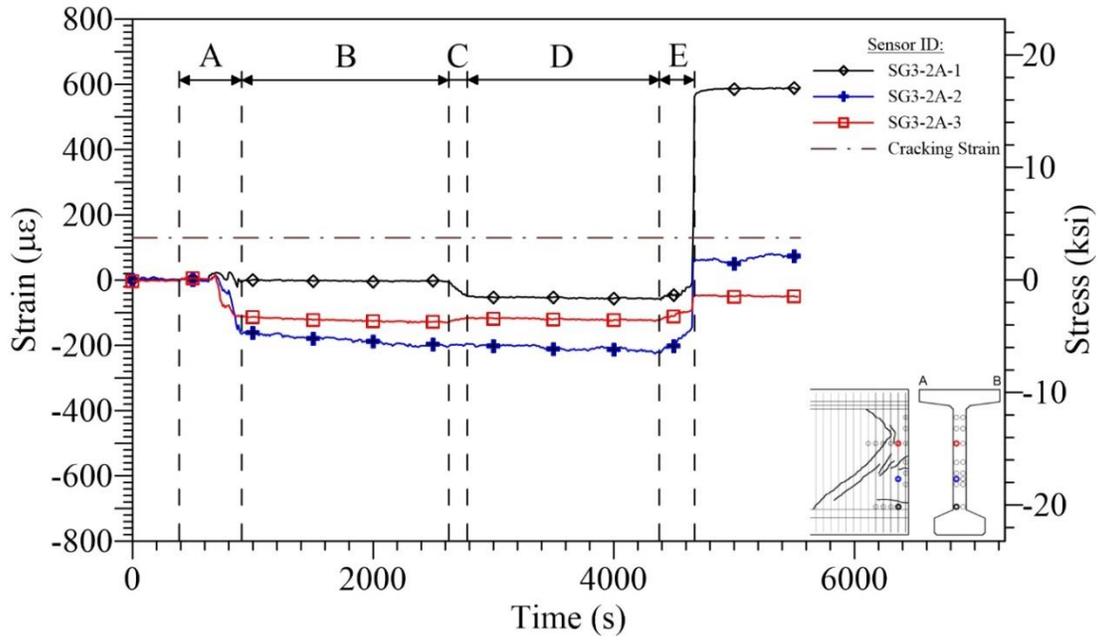
Figure 6-9 Specimen 3, Bar 2A, Steel strain gauges during detensioning
