END ZONE DESIGN FOR ALABAMA
DEEP PRESTRESSED GIRDERS

A THESIS

Submitted in partial fulfillment of the requirements
for the degree of Master of Science
in the Department of Civil, Construction, and Environmental Engineering
in the Graduate School of
The University of Alabama

2016

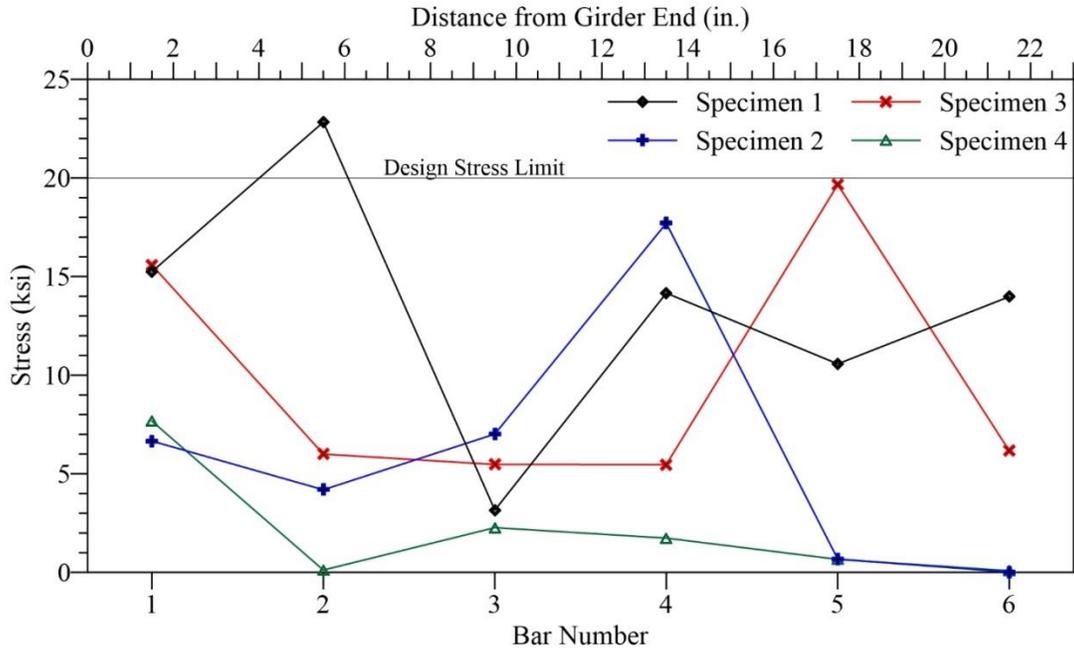
Figure 6-12 Vertical Stress in End Zone Reinforcement

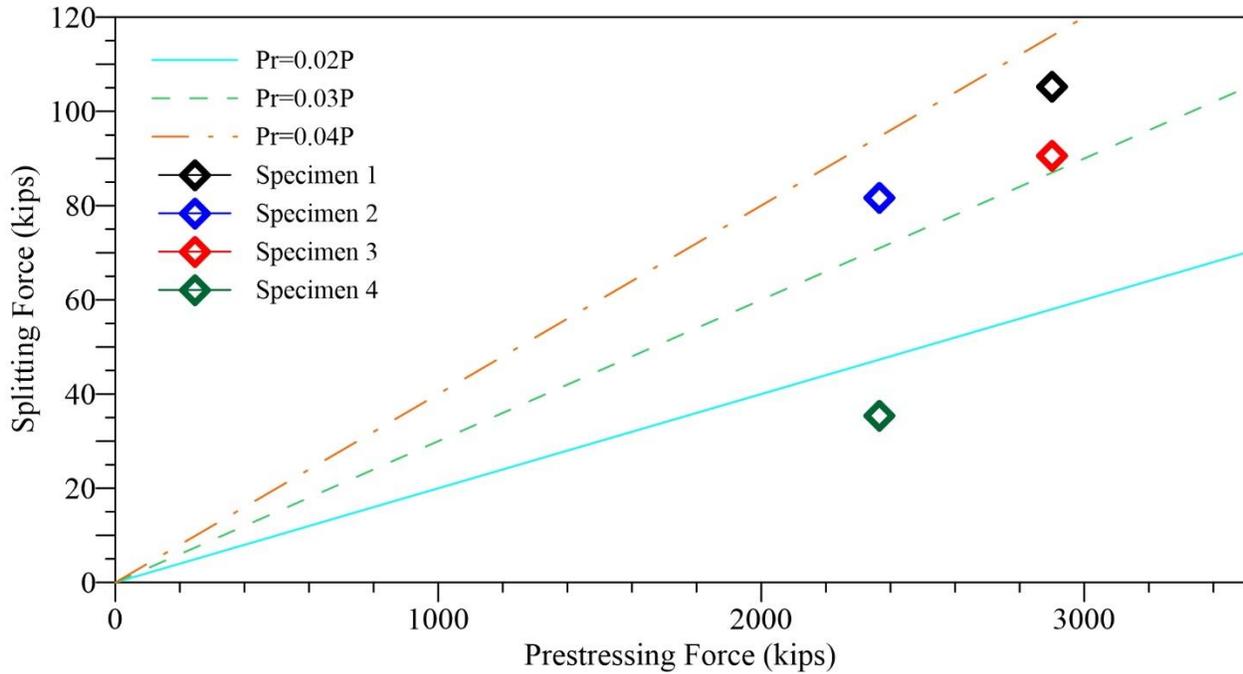
Figure 6-13 Splitting Force vs. Prestressing Force in Test Specimens

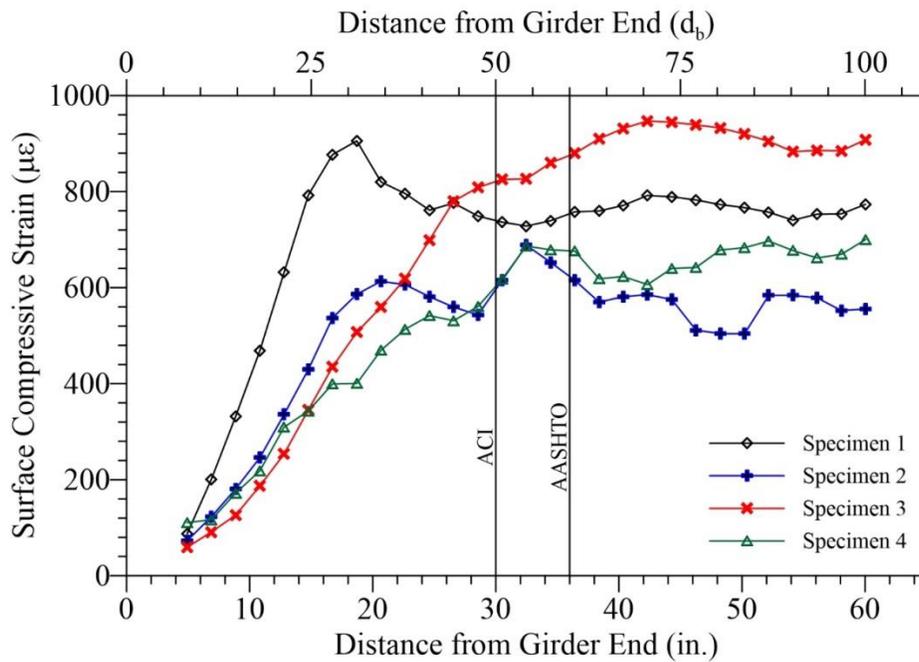
Figure 6-14 Average Surface Strain Comparison of all specimens

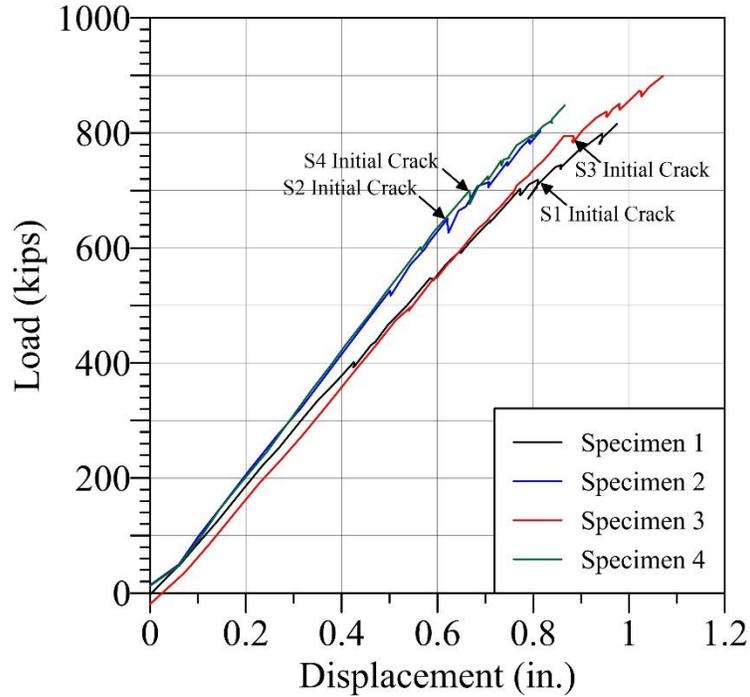
Figure 6-18 Load displacement curves

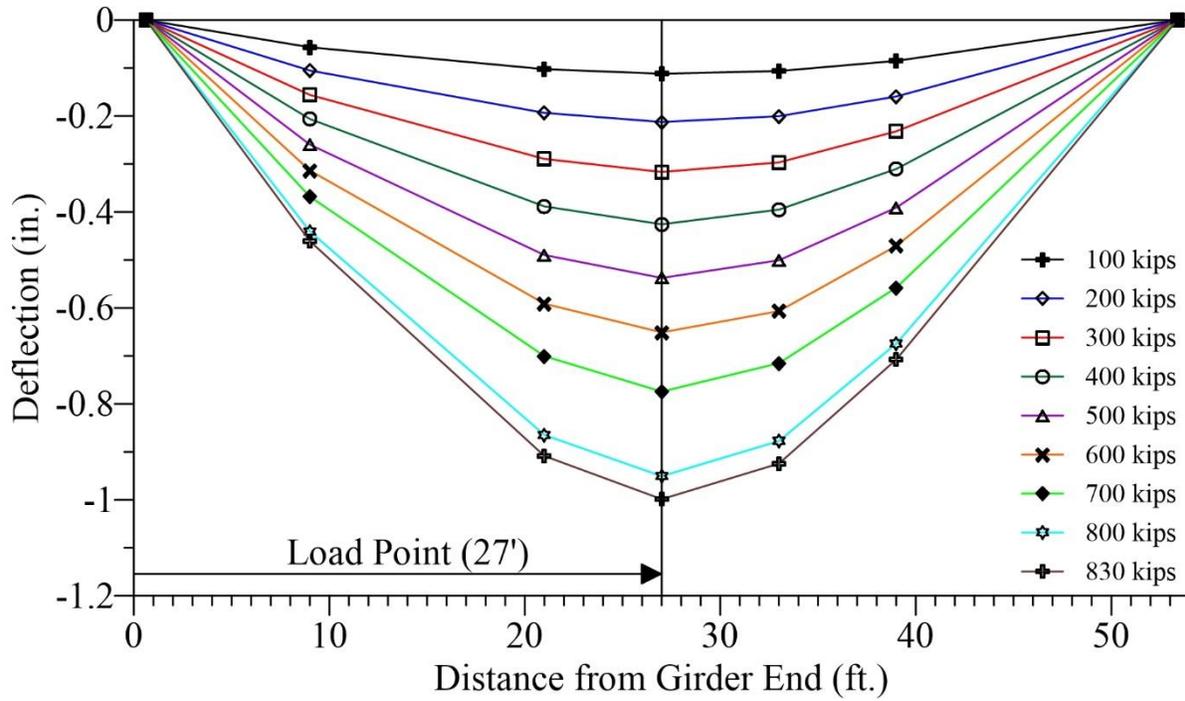
Figure 6-19 Specimen 1 deflection

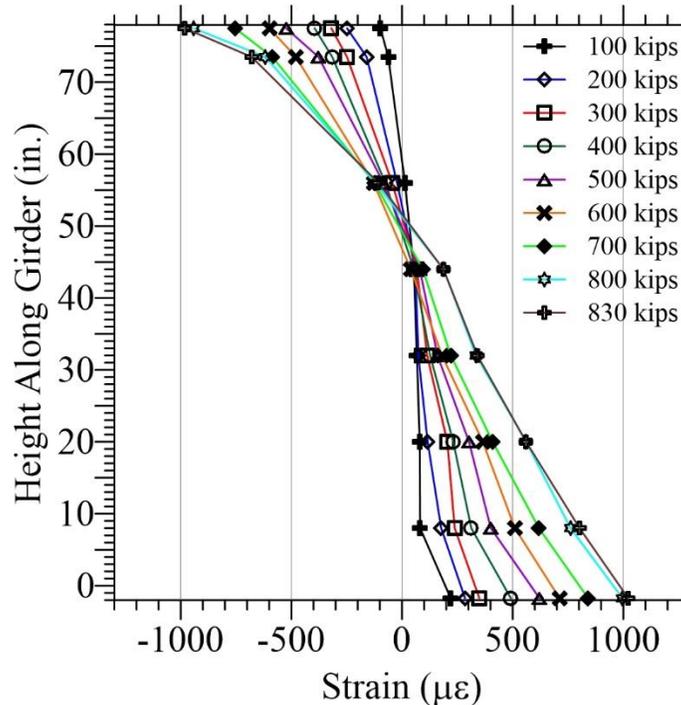
Figure 6-23 Specimen 1 strain profile

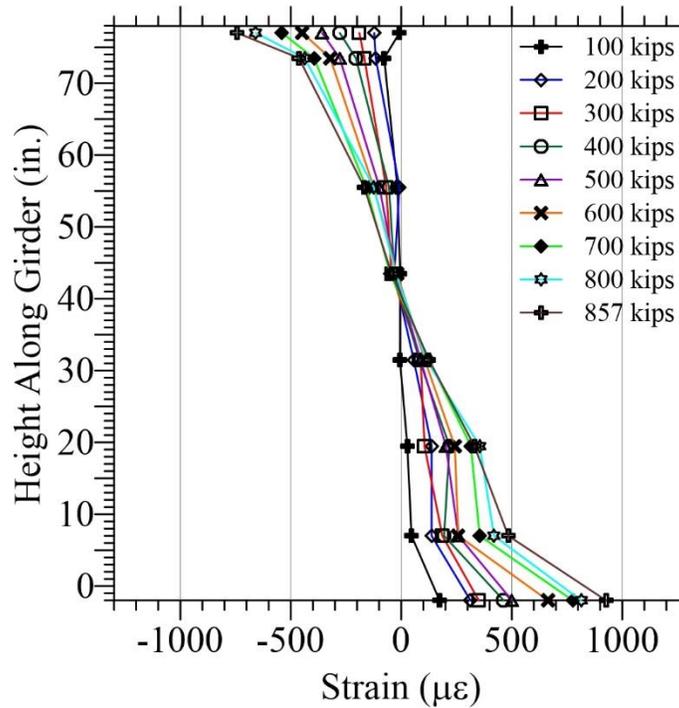
Figure 6-26 Specimen 4 strain profile

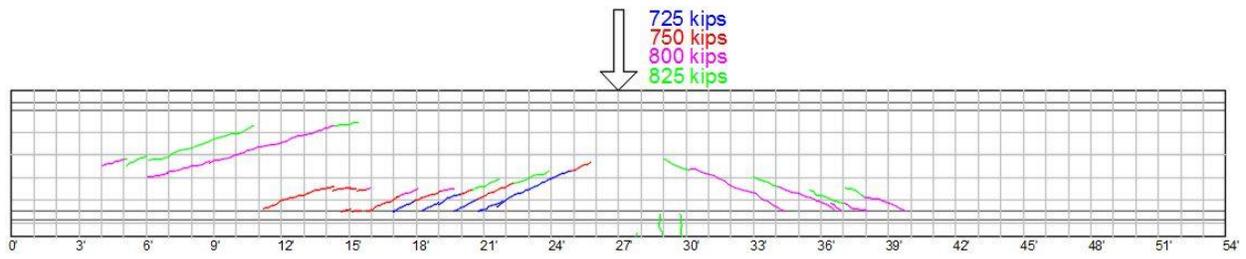
Figure 6-27 Specimen 1 load test cracks, Side A

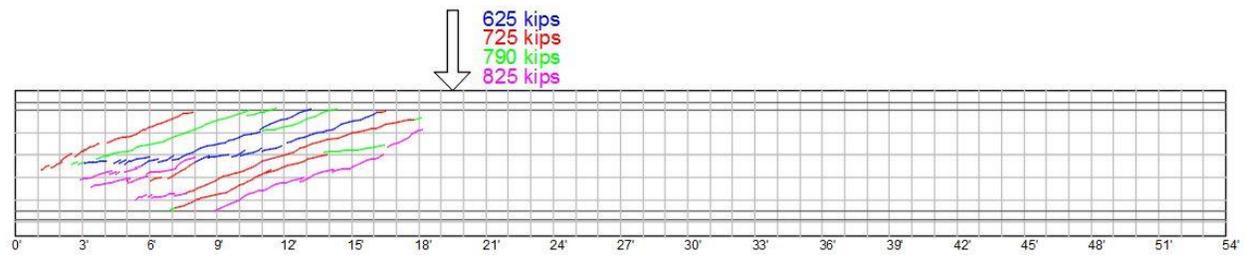
Figure 6-28 Specimen 2 load test cracks, Side B

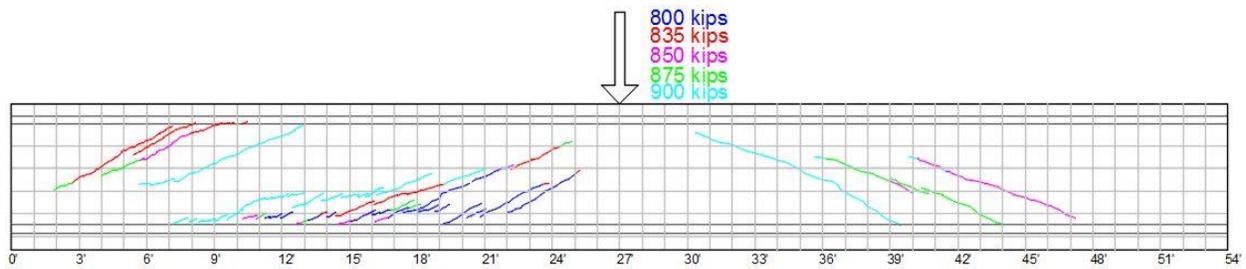
Figure 6-29 Specimen 3 load test cracks, Side A

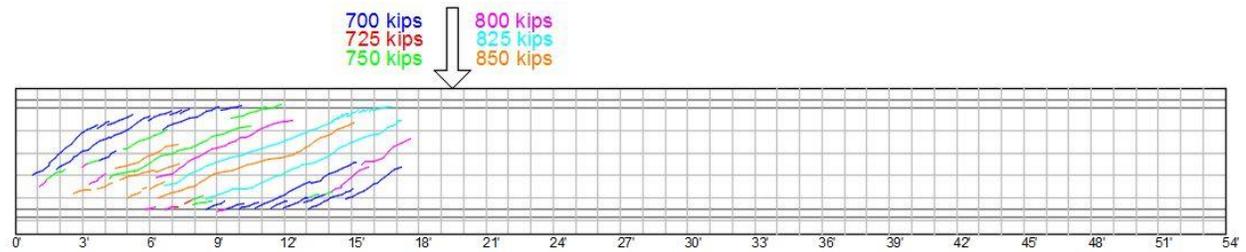
Figure 6-30 Specimen 4 load test cracks, Side B

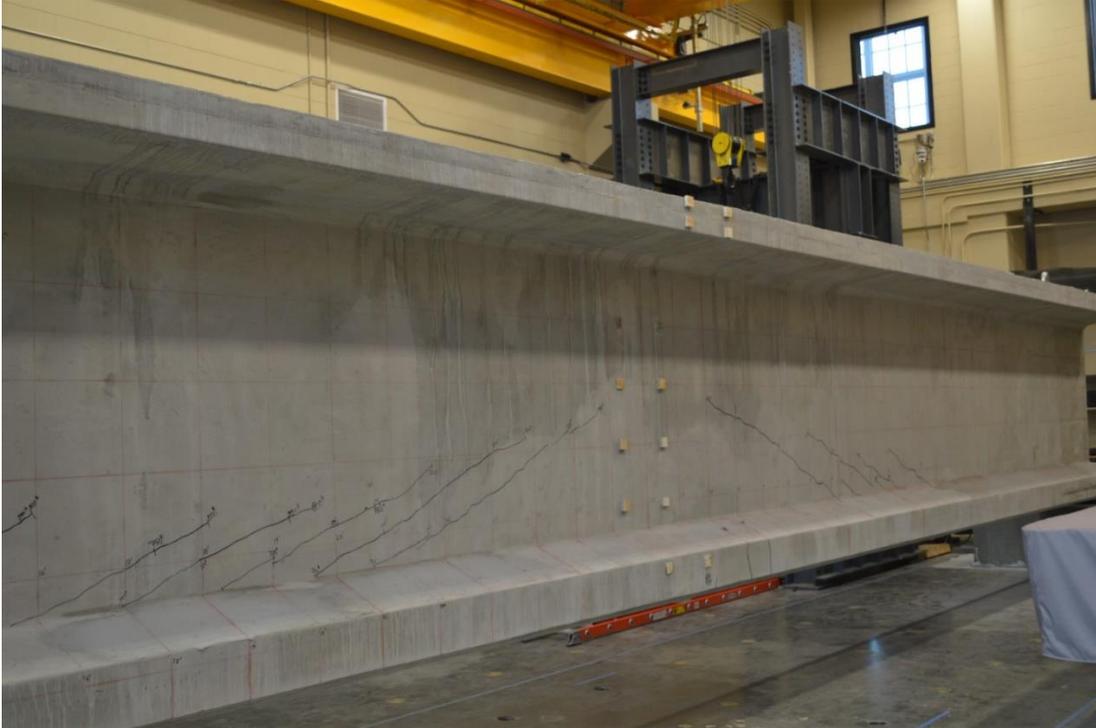
Figure 6-31 Specimen 1 web shear cracking after load test

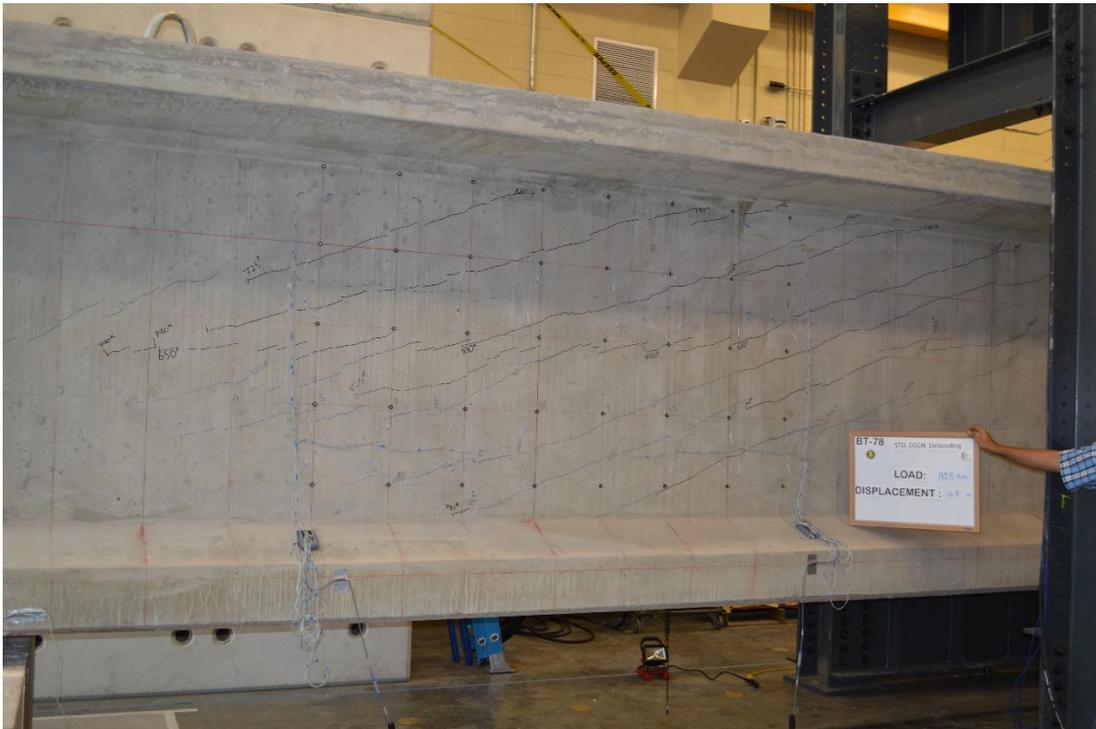
Figure 6-32 Specimen 2 web shear cracking after load test

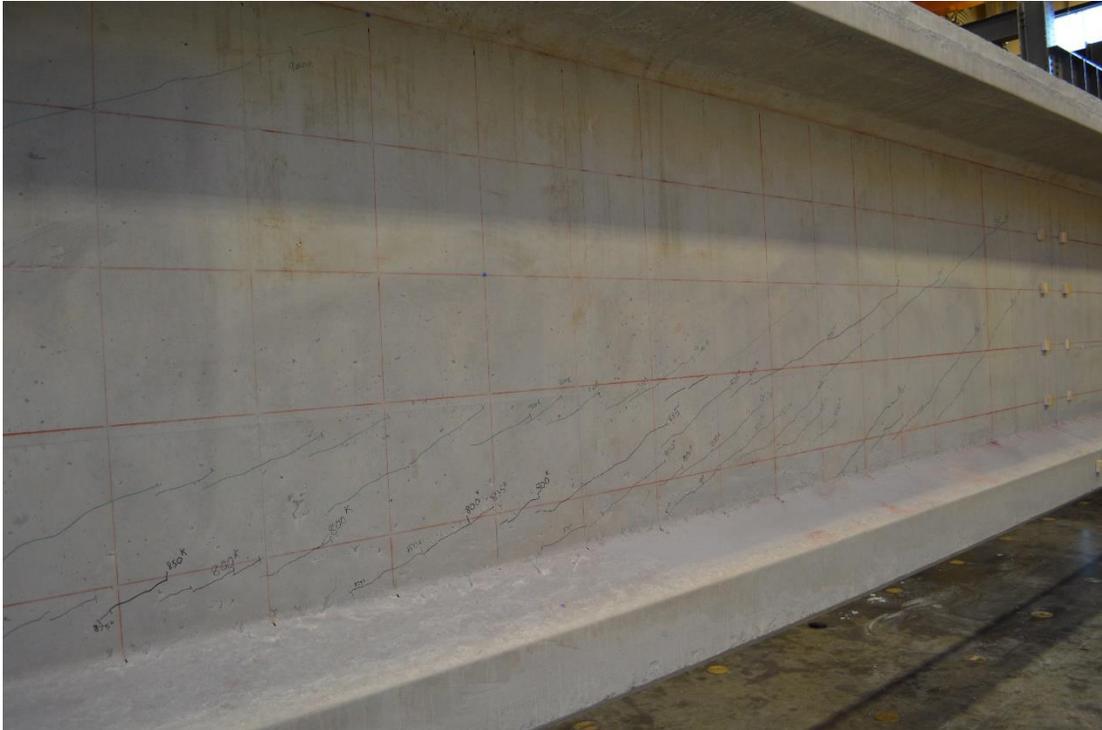
Figure 6-33 Specimen 3 web shear cracking after load test

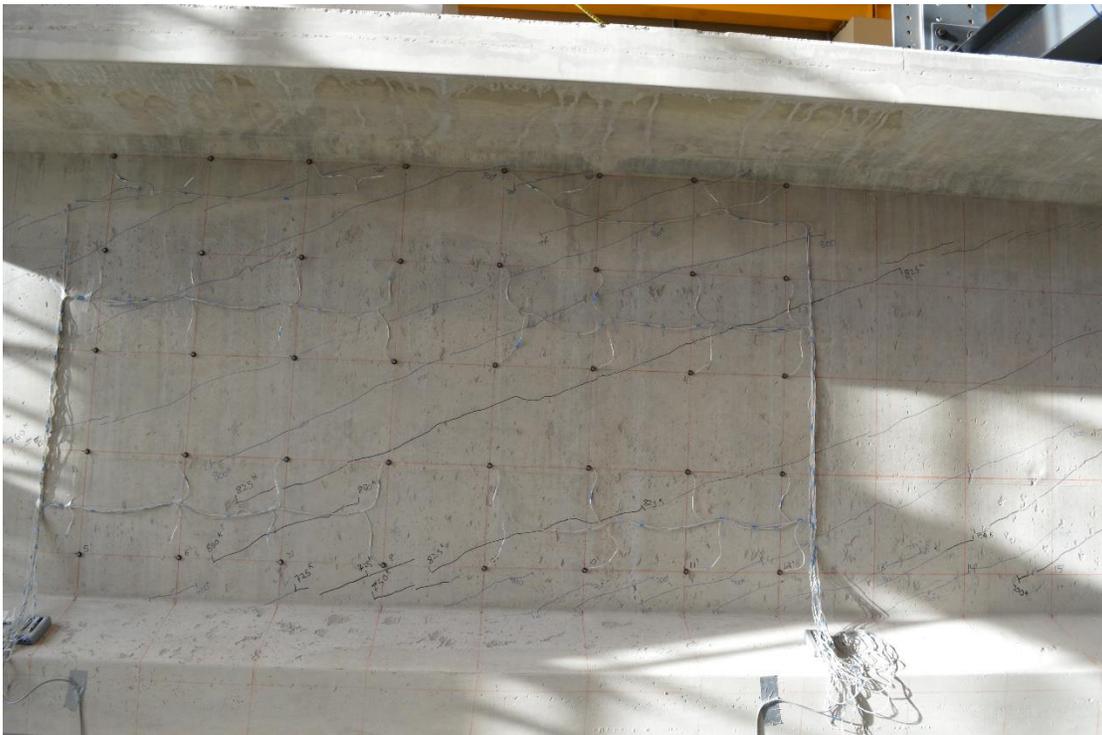
Figure 6-34 Specimen 4 web shear cracking after load test (with NDI sensors)

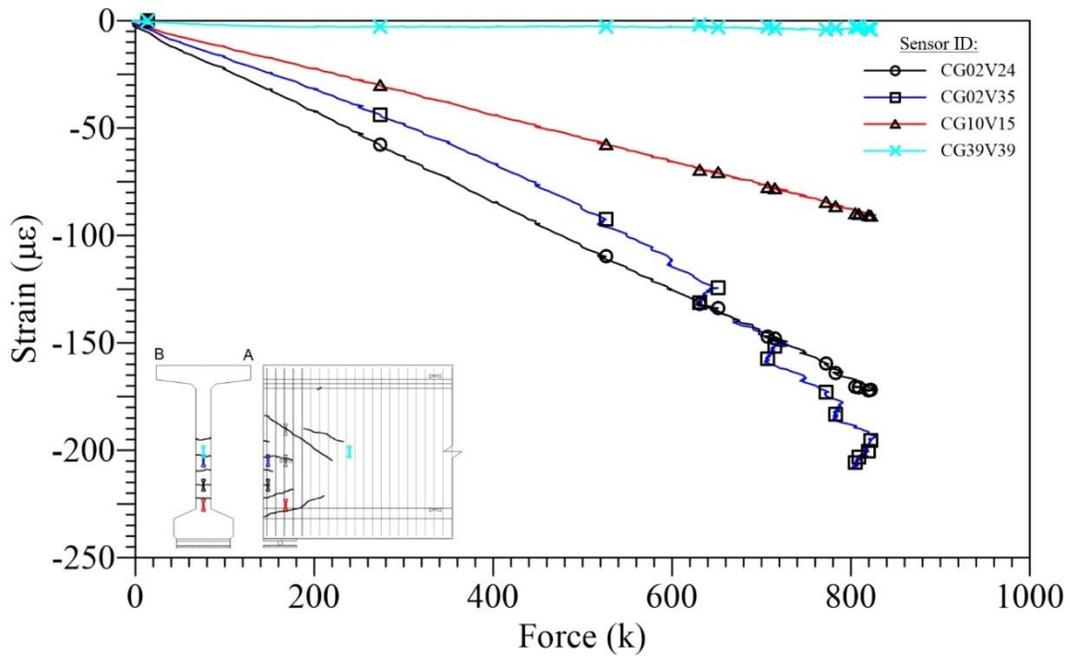
Figure 6-36 Load test strains from vertical concrete gauges on Specimen 2
